**AIRPROX REPORT No 2019110**

Date: 19 May 2019 Time: 1503Z Position: 5210N 00004W Location: Gransden Lodge

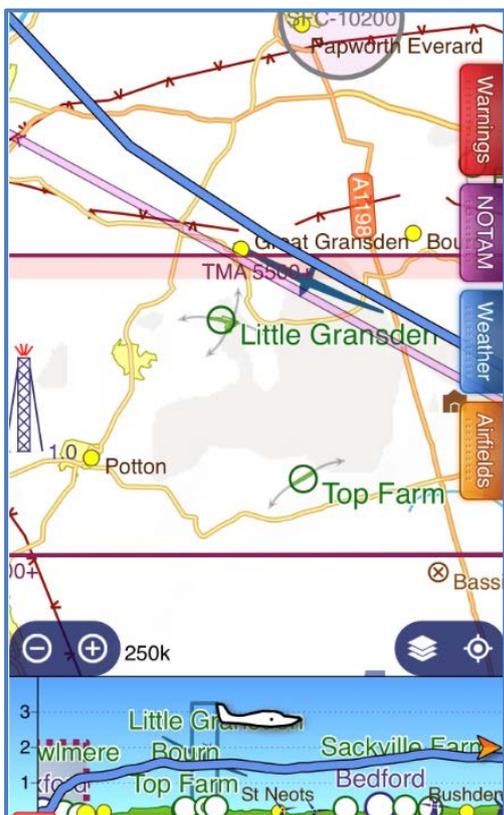
Figure 1 – Mustang Pilot's Screenshot

The Mustang pilot provided a screenshot of his SkyDemon track (Figure 1). It was noted that the information as presented has Gransden Lodge marked with a glider symbol, unlike Little Gransden which was marked with a circle. [UKAB note: glider sites can be deselected from display on SkyDemon and it is likely that this was the case in the Mustang pilot's case. Figure 2 shows a similar area on SkyDemon Light with the Gransden Lodge specific glider site displayed].

A Glider/Tug combination has limited manoeuvrability and is best given a wide berth. We are again disappointed to see aircraft overflying Gransden Lodge below the promulgated maximum winch launch height. The SkyDemon image illustrates the risks introduced by deselecting certain classes of airspace to display; the BGA is actively seeking ways to resolve this issue.

This situation had also occurred in another Airprox seen by the Board this month (2019101) and so the Board resolved to re-iterate a recommendation made for that Airprox that SkyDemon review the selection and depiction of sites used for aerial sporting and recreational activities.

Recommendation: SkyDemon review the selection and depiction of sites used for aerial sporting and recreational activities.

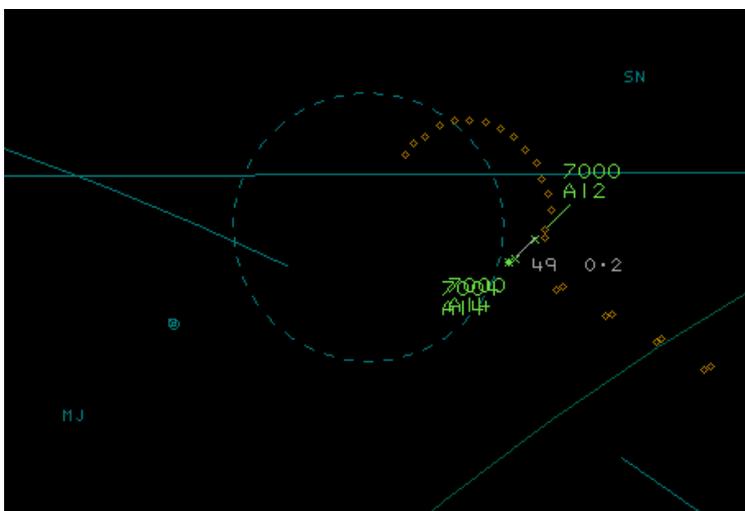
Figure 3 CPA: 1503:47

Although neither aircraft was receiving an ATS, the incident could be seen on the NATS area radar. CPA was at 1503:47 (Figure 3), both aircraft were squawking 7000, the tug and glider were to the east of the airfield and had just commenced the right/left turn as described by the tug pilot.
