AIRPROX REPORT No 2019111

Date: 21 May 2019 Time: 1619Z Position: 5043N 00209W Location: 2nm ENE Eyres Field

PART A: SUMMARY OF INFORMATION REPORTED TO UKAB

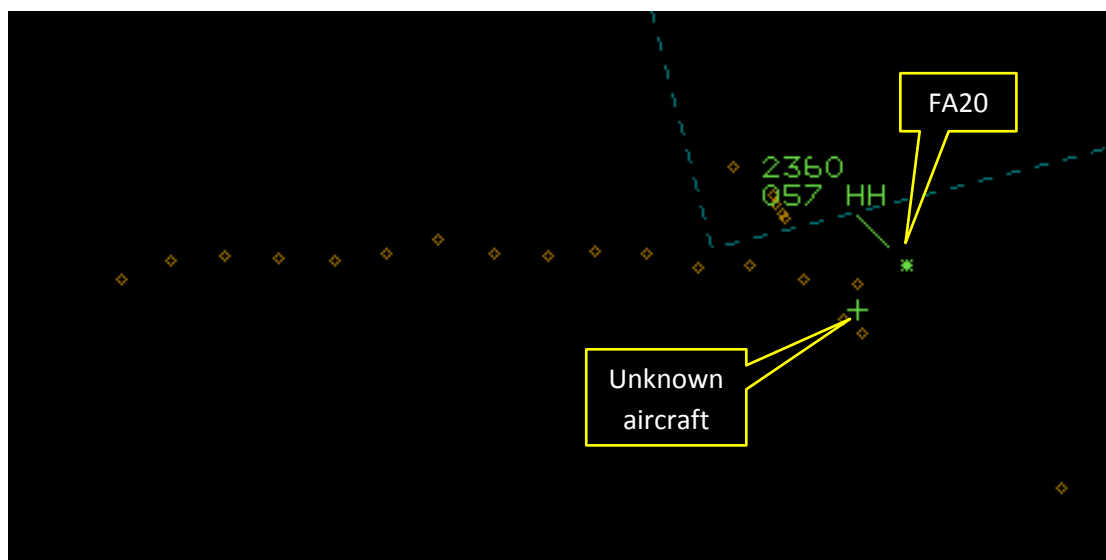
Figure 1: FA20 transponding 2360

The glider was not visible on the Bournemouth radar display. A different radar to that used by Bournemouth shows intermittent primary returns around the FA20's reported position at the time of the Airprox.
