AIRPROX REPORT No 2019121

Date: 23 May 2019 Time: 0946Z Position: 5045N 00154W Location: Bournemouth CTR

PART A: SUMMARY OF INFORMATION REPORTED TO UKAB

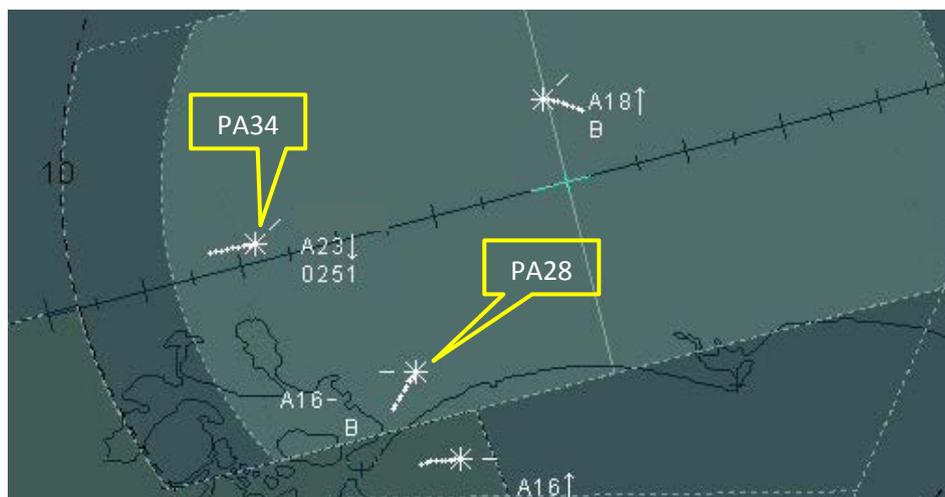
Figure 1: 0944:16

At 09:44:16 (Figure 1), the PA28 pilot contacts Bournemouth Tower, joining from the SW at Sandbanks and is advised by Bournemouth Tower to report final and that they are No2 to a PA34 on 5-mile final. This is acknowledged by the PA28 pilot but, when the investigator reviewed the radar recording, the position of the Seneca was closer to 6nm than 5nm on the final approach track.

Initial contact from the PA28 to the SSW with the PA34 on final approach track

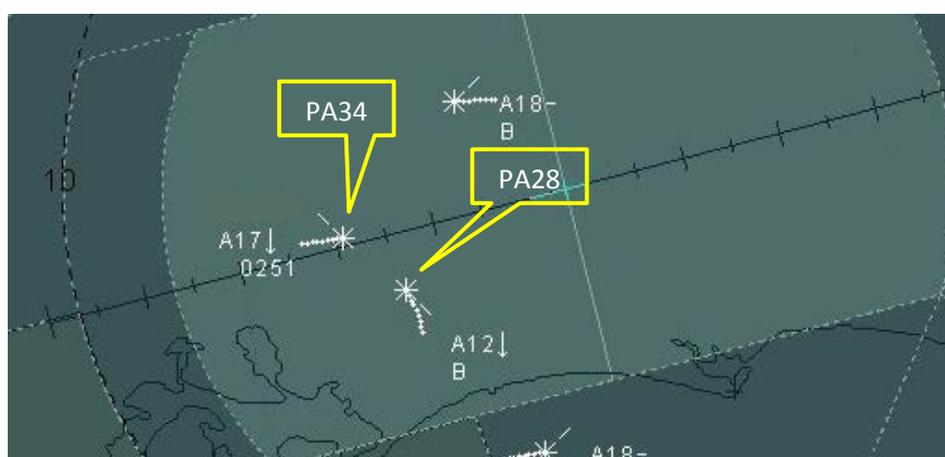
Figure 2: 0945:20

At 09:45:20 the Bournemouth Tower controller issues clearance to the PA34 pilot for a touch and go RW08 which is acknowledged. At this point the PA28 is to the SE of the PA34 at 1200ft indicated, and approximately 1.5nm separation (Figure 2).

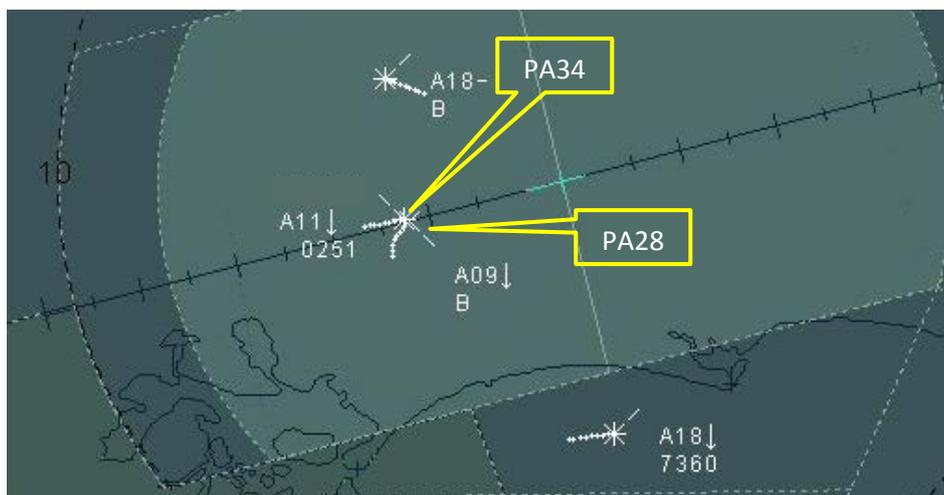
Figure 3: 0946:10

PA28 pilot instructed to turn south by Tower and PA34 pilot reports going around.

From the radar replay tapes the investigator estimates that the aircraft came within 200ft and less than 0.5nm of each other at 09:46:10 (Figure 3).
