AIRPROX REPORT No 2019125

Date: 29 May 2019 Time: 1324Z Position: 5210N 00005W Location: 1.2nm SE Gransden Lodge

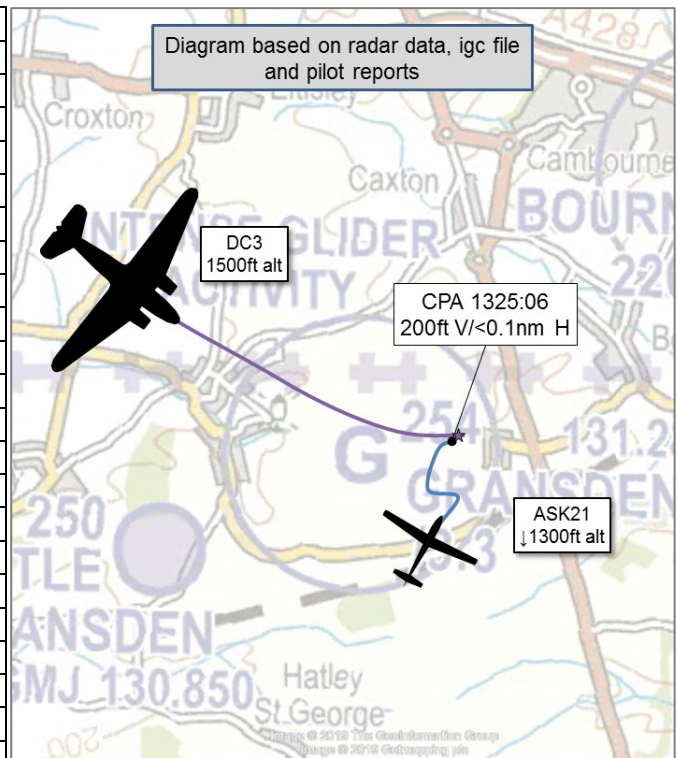
THE ASK21 PILOT reports that he had winch-launched from Gransden Lodge RW22 at 13:20 to 2200ft AMSL. At 1323 he was making a 360° turn to the left in a weak thermal at 1500ft AMSL (1200 ft AGL), 1.7km south-east of Gransden Lodge. A Douglas DC3 was sighted by P2 at about 3km range, bearing 300°, at the same altitude, flying wings level directly towards them on a heading of 120°. P2 warned him and he took avoiding action by making a descending turn to the right. The DC3 continued directly across the centre of Gransden Lodge, crossing perpendicular to the runway at approximately its midpoint, maintaining the same altitude, flying towards them. At the closest approach, the DC3 passed about 100ft above the still-descending ASK21 and displaced by perhaps 20m laterally. They continued turning to the right to observe the DC3 departing south-eastwards towards Duxford without deviating or taking any apparent avoiding action. The incident was witnessed from the ground by the gliding club launch marshal, who immediately obtained the DC3 registration using FlightRadar24 on his mobile phone. The igc file shows the launch and flight until a few seconds after the Airprox, but for unknown reasons ends at 1325, shortly after the Airprox and before the glider landed back at Gransden Lodge.

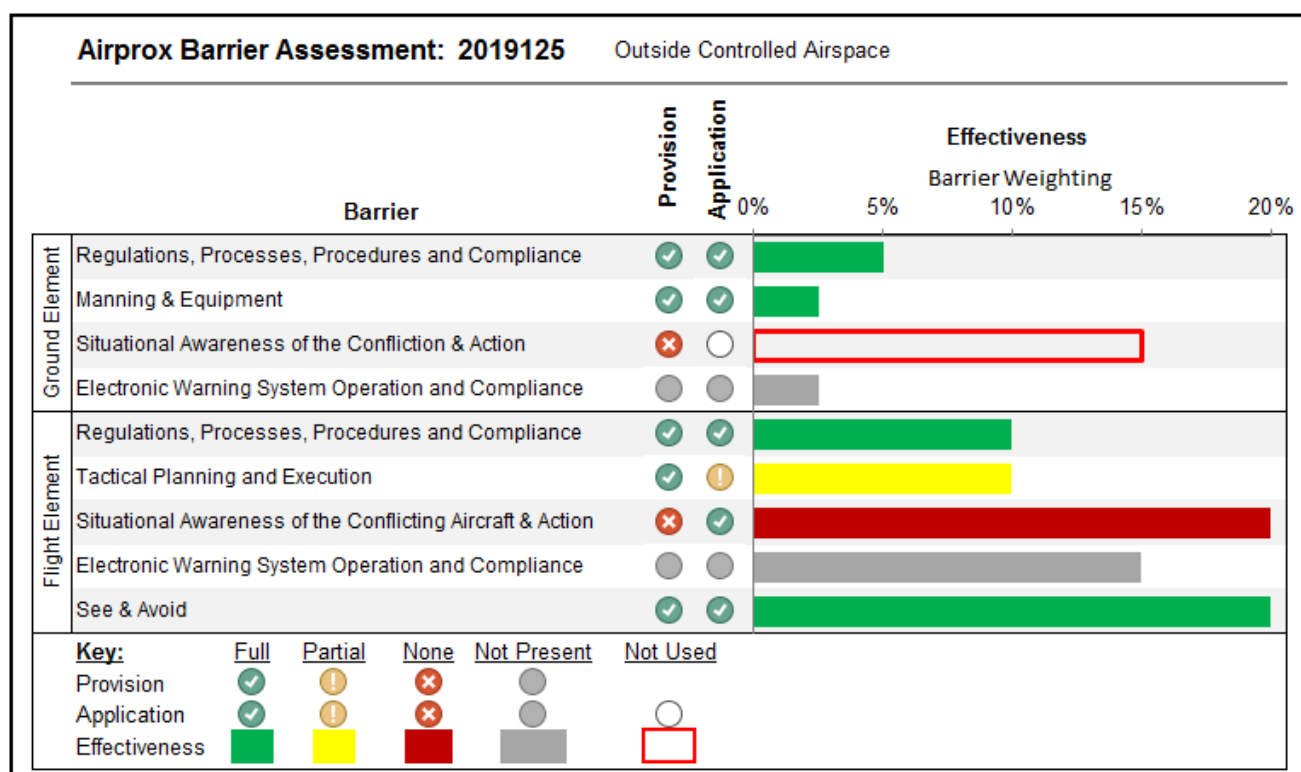
Situational Awareness of the Confliction and Action were assessed as **not used** because the controller was not aware of the presence of the glider.

Tactical Planning and Execution was assessed as **partially effective** because the DC3 pilot should have avoided the gliding site by a greater margin and not have flown over the gliding site.

Situational Awareness of the Conflicting Aircraft and Action were assessed as **ineffective** because there was no situational awareness available to either pilot regarding the other aircraft.
