AIRPROX REPORT No 2019126

Date: 30 May 2019 Time: 1532Z Position: 5243N 00039W Location: 10nm NW Wittering

PART A: SUMMARY OF INFORMATION REPORTED TO UKAB

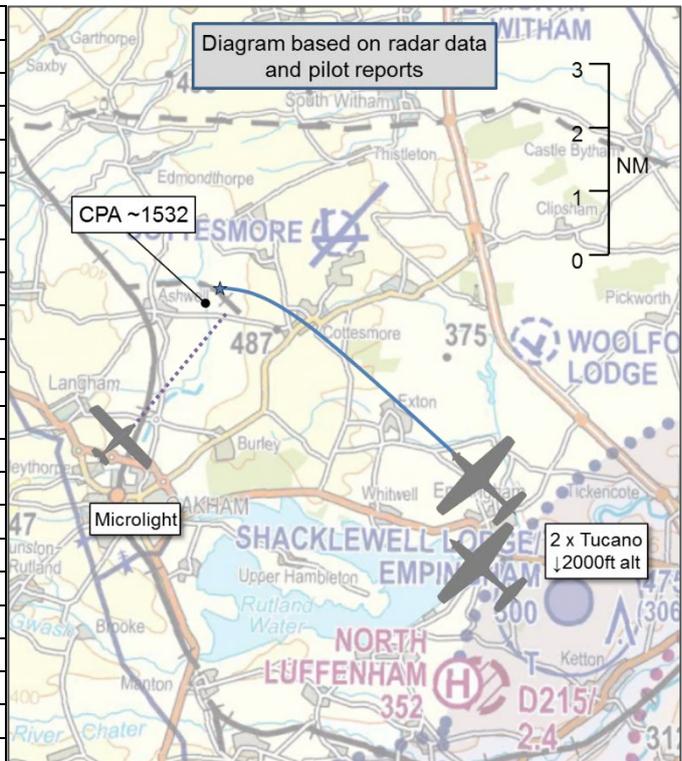
THE TUCANO PILOT reports that he was the No2 in a formation of two Tucanos. The formation was in fighting-wing with No2 swept at approximately 200m in the leader's left 7 o'clock. As the formation was entering low-level to the NW of RAF Wittering and descending through 2000ft, the leader came left for positioning for the entry point and, as No2 followed, the captain saw a red microlight pass down their left side at approximately 100m range at the same altitude. The microlight appeared to be heading NE at low speed maintaining straight-and-level. He watched the microlight continue behind the formation and ensured they were clear of the conflict. He decided not to call an Airprox at that time as they were on low-level common frequency and the Tucano only has one radio. He commented that this event highlights the importance of effective lookout, especially in low-level and during the descent. No other member of the formation was ever visual with the microlight and he opined that had the formation turned a few seconds earlier, one aircraft in the formation would have collided with the microlight.
