AIRPROX REPORT No 2019127

Date: 25 May 2019 Time: 1140Z Position: 5155N 00158W Location: 7.5NM E Gloucester

PART A: SUMMARY OF INFORMATION REPORTED TO UKAB

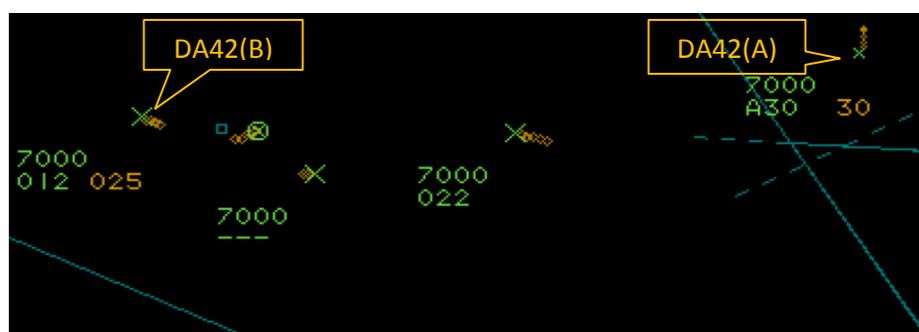
Figure 1 - 1135:30

At 1135:30 (Figure 1), the controller turned their attention back to the DA42(A) pilot and asked them to pass their details. The pilot advised that they were a DA42 from [departure] inbound to Gloucester, were currently 15 miles northwest at 3000ft and would like to join long-final for RW27. The controller requested a range from the pilot of an unrelated aircraft that was well ahead of the DA42(A) and then asked the DA42(A) pilot to confirm that they were to the east of the airfield. The pilot confirmed that they were east by 15 miles. A Basic Service was agreed, and the pilot was instructed to make a straight-in approach RW27 and report at 5 miles. The pilot provided a full and accurate readback. The controller then turned their attention to other unrelated aircraft.

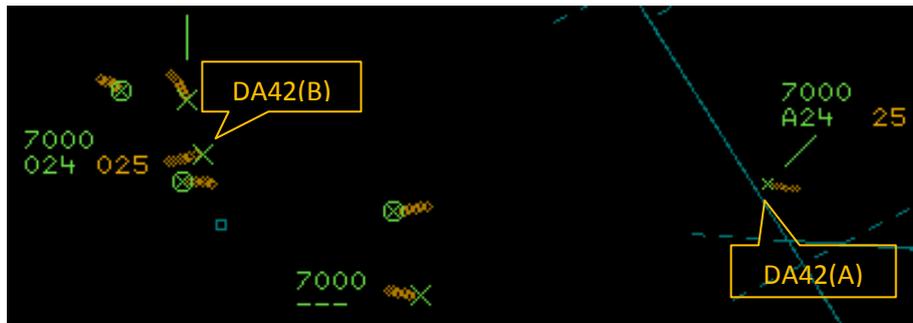
Figure 2 - 1136:50

At 1136:50 (Figure 2), the DA42(B) pilot was advised that it was now a Basic Service and advised to report leaving the frequency. This was readback accurately. The controller then turned their attention to other unrelated aircraft.

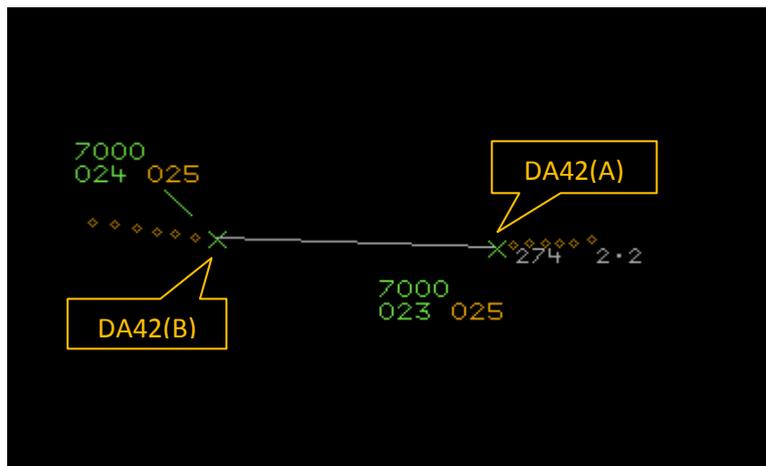
Figure 3 - 1139:30

At 1139:30 (Figure 3), the DA42(B) pilot advised the controller that they were changing to the Oxford frequency and the controller replied free call Oxford.

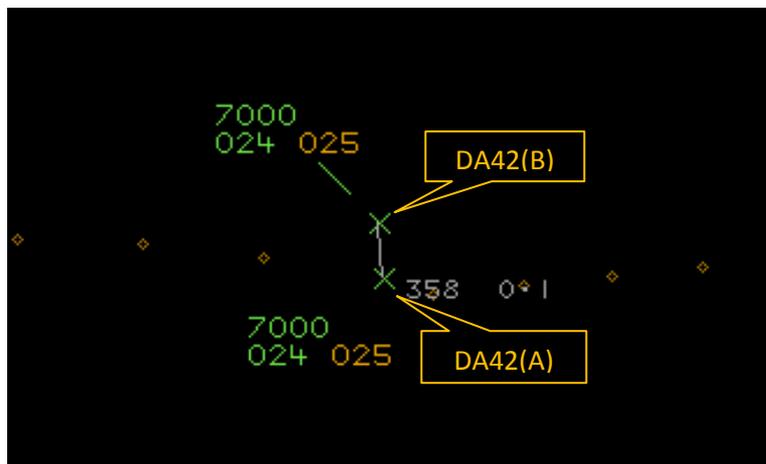
Figure 4 - 1140:02 CPA

CPA occurred at 1140:02 (Figure 4), with the aircraft separated by 0.1NM laterally and 0ft vertically.
