AIRPROX REPORT No 2019131

Date: 01 Jun 2019 Time: 0918Z Position: 5118N 00007E Location: 3nm SE Biggin Hill

PART A: SUMMARY OF INFORMATION REPORTED TO UKAB

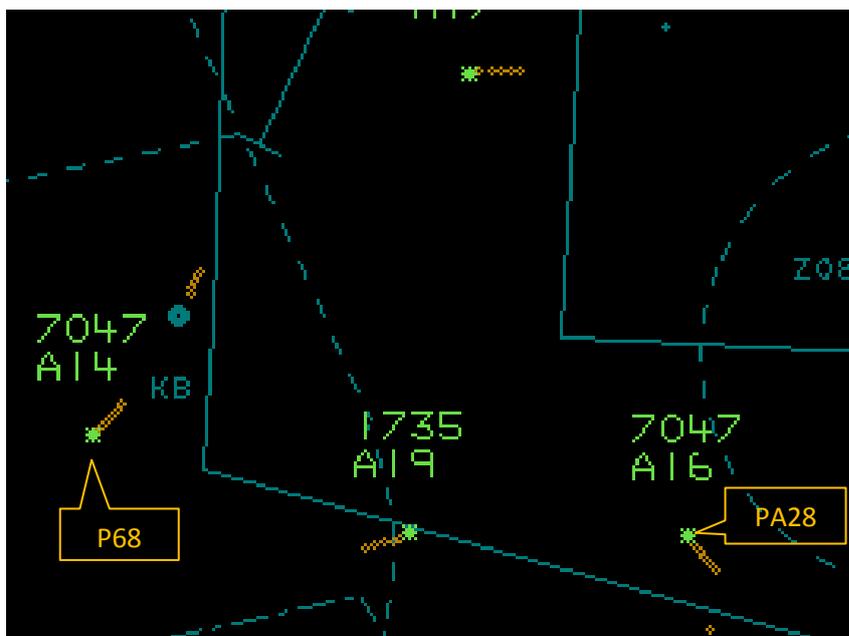
Figure 1 - 0916:45

At 0916:45 (Figure 1), the Tower controller instructed the P68 pilot to contact Biggin Hill Approach.

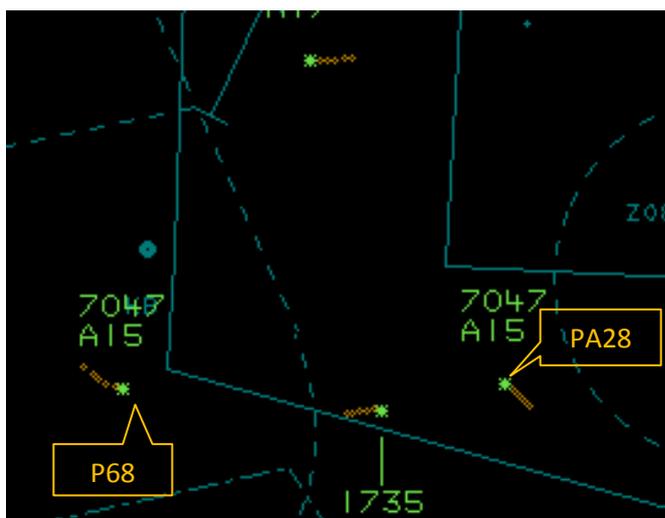
Figure 2 - 0917:15

At 0917:15 (Figure 2), the P68 pilot called the Approach controller and advised that they were at 1.5 miles. The controller instructed the pilot to report passing abeam Swanley and asked what level they were climbing to. The pilot responded with “report abeam Swanley and 2400 feet”.

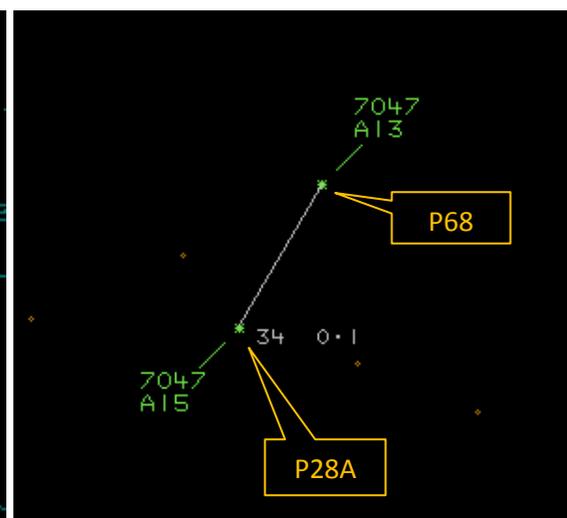
Figure 3 - 0918:58 CPA

CPA occurred at 0918:58 (Figure 3), with a separation of 0.1nm laterally and 200ft vertically.
