AIRPROX REPORT No 2019150

Date: 20 Jun 2019 Time: 1016Z Position: 5247N 00030W Location: 6nm NE of Cottesmore

PART A: SUMMARY OF INFORMATION REPORTED TO UKAB

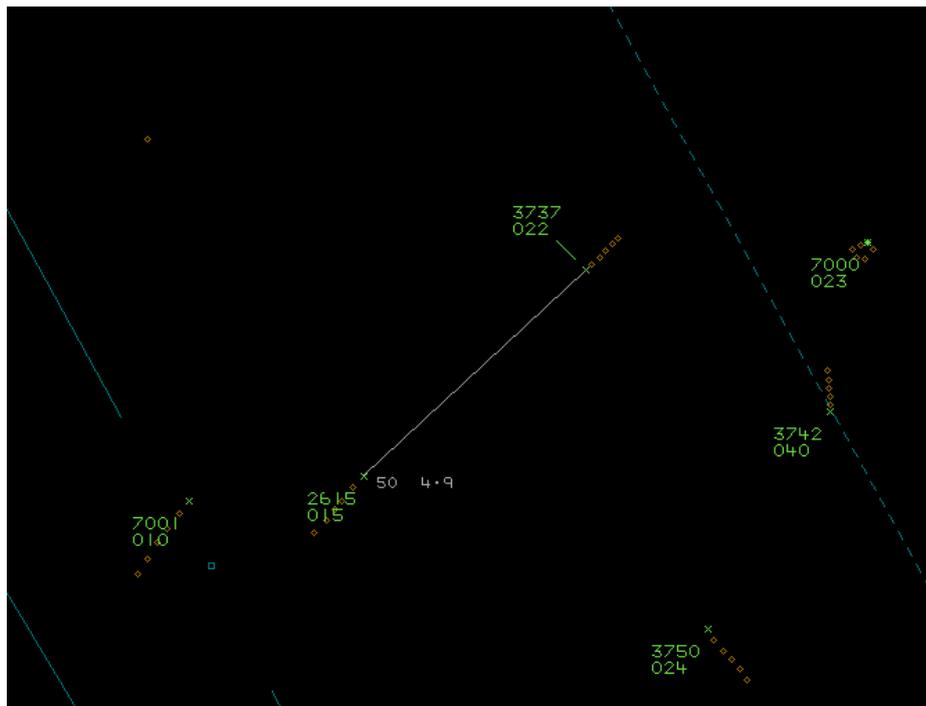
Figure 1

Following the Prefect conducting a PFL it began a slow climb heading North East. The Cranwell Zone Controller passed Traffic Information on the Tutor at 1015:36 (Figure 1). Separation at this point was 4.9nm and 700ft.

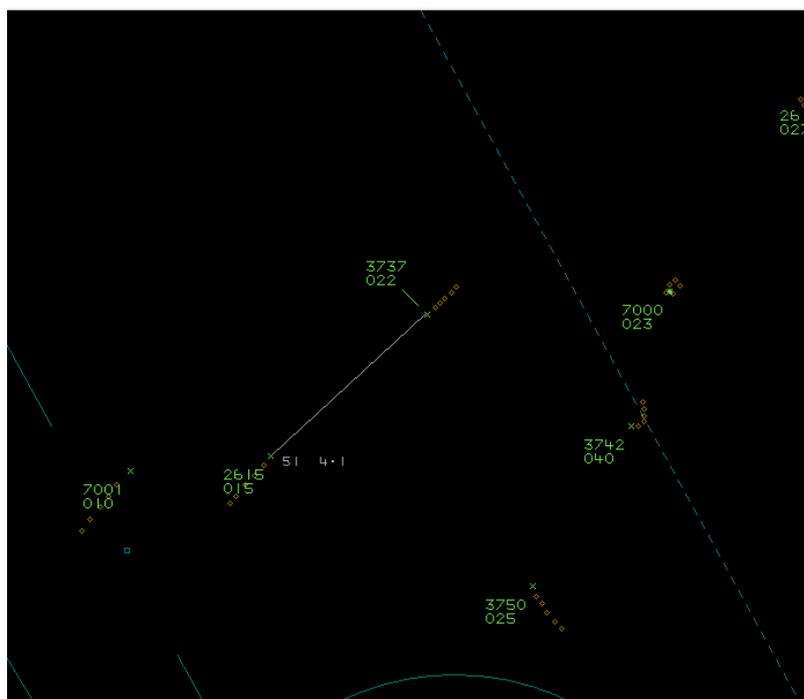
Figure 2

At 1015:48 (Figure 2), the Wittering Zone Controller passed Traffic Information to the Tutor about the Prefect, to which the Tutor reported not being visual with the conflicting traffic. The R/T up to this point had been reasonably congested with transmissions every 15 secs for the previous five minutes. Separation at this point was measured at 4.1nm and 700ft.

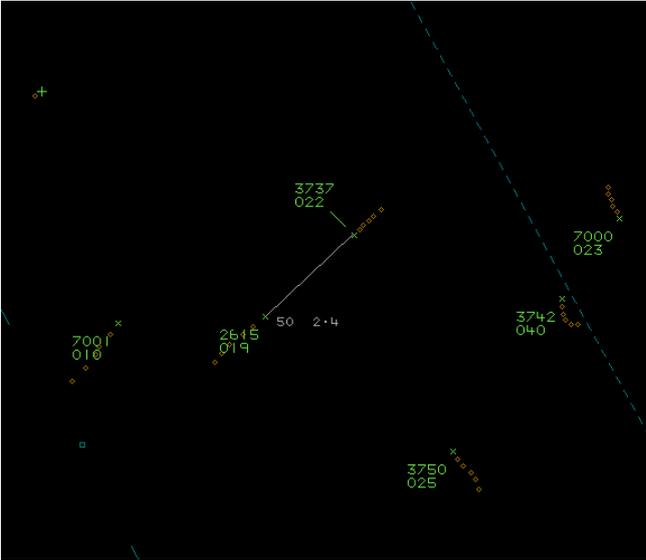
Figure 3

The Wittering Zone Controller updated Traffic Information to the Tutor at 1016:06 (Figure 3), and the Tutor again reported not being visual with the Prefect. The Cranwell Zone Controller updated the Traffic Information to the Prefect six seconds later and the Prefect reported not being visual with the conflicting traffic. Separation at this point had decreased to 2.4nm and 300ft.

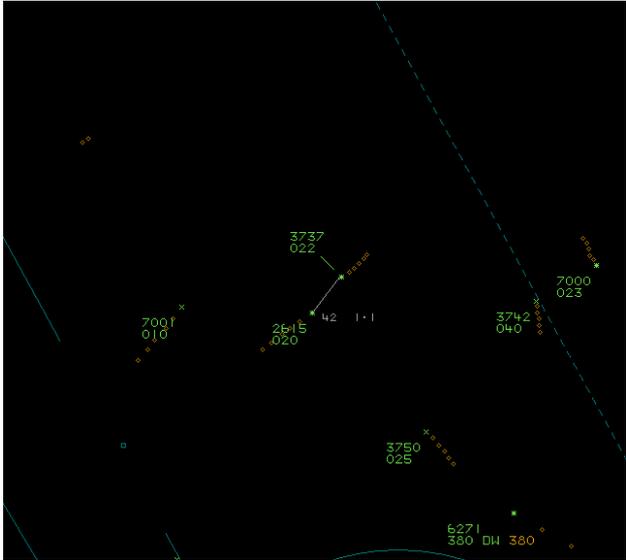
Figure 4

The Wittering Zone Controller passed further Traffic Information to the Tutor at 1016:21 and then for a fourth and final time at 1016:32 and this was concurrent with the Cranwell Zone Controller passing Traffic Information to the Prefect for a third time. The Prefect reported visual with the Tutor and noted in their report that they sighted the Tutor at a range of ¼-½nm, 300ft above and no avoiding action was necessary. The Tutor reported visual with the Prefect after this final piece of Traffic Information and immediately reported the Airprox. At the time of this Traffic Information, separation was 1.1nm and 200ft (Figure 4).

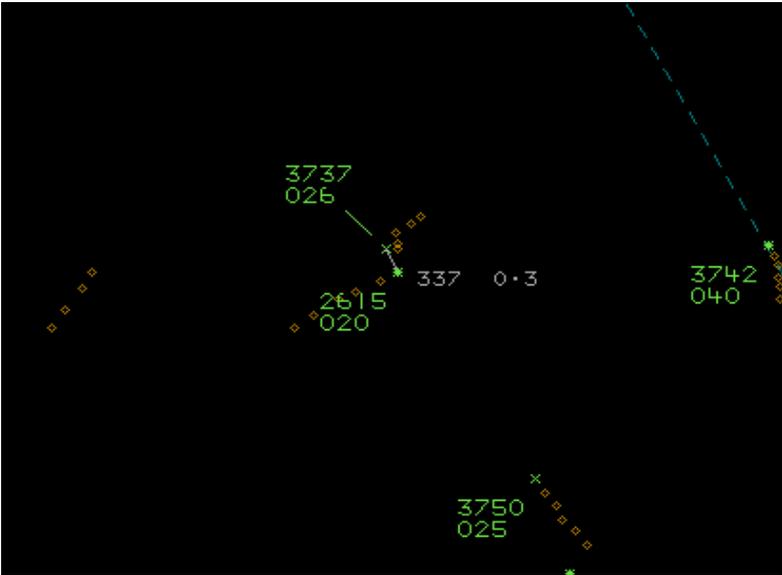
Figure 5 - CPA

CPA occurred at 1016:50 and was measured at 0.3nm and 600ft.
