AIRPROX REPORT No 2019162

Date: 27 Jun 2019 Time: 1247Z Position: 5531N 00434W Location: Prestwick Airport – elev 66ft

PART A: SUMMARY OF INFORMATION REPORTED TO UKAB

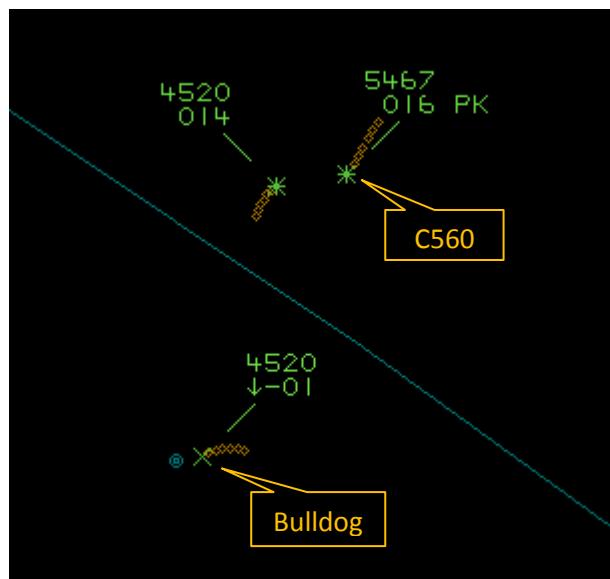
Figure 1 - 12:44.40

At 12:44.20 (Figure 1), the Bulldog pilot asked if there was any chance of a right-hand circuit. A right-hand circuit was agreed at 12:44.40 and the Bulldog pilot was cleared for the low approach.

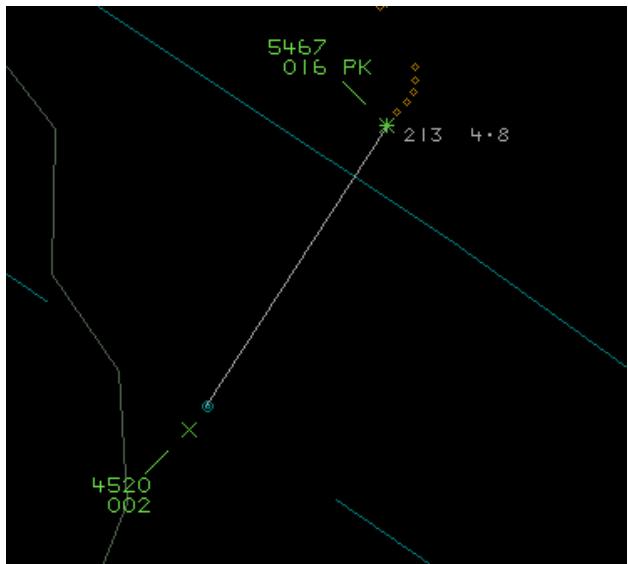
Figure 2 - 12:45.20

At 12:45.20 (Figure 2), the C560 pilot reported to the Radar controller that they were at the final approach fix (FAF). There was a change of Radar controller and the new controller asked the pilot to confirm their altitude. The pilot advised that they were at 2100 ft. The controller instructed the pilot to change to the Tower frequency.

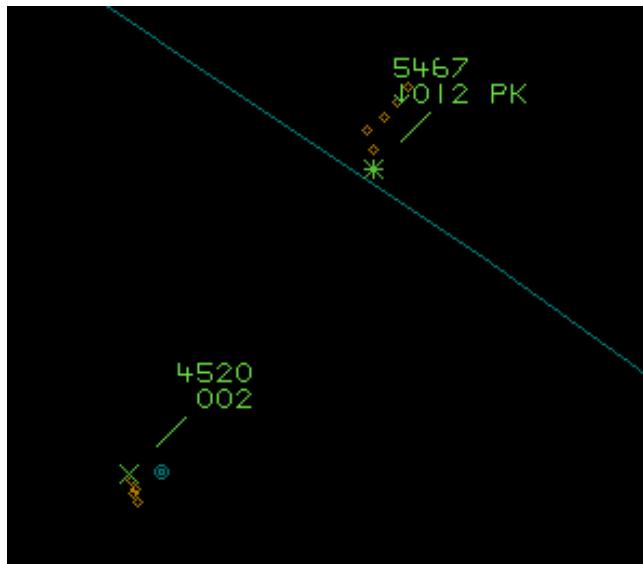
Figure 3 - 12:45.30

At 12:45.30 (Figure 3), the Bulldog pilot reported ready for base and the controller instructed them to hold at the end of the downwind leg and advised that they would be No2 to the Citation at 4 miles. The pilot readback *"number 2 hold at the end of downwind"*.

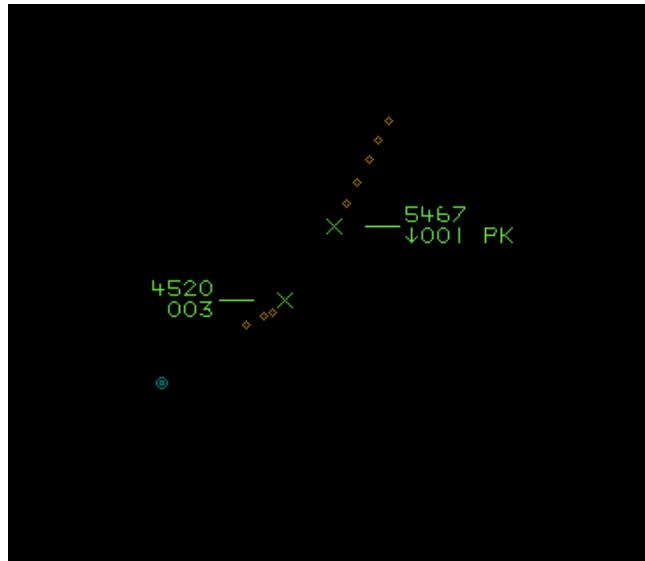
Figure 4 - 12:46.50

At 12:46.50 (Figure 4), the Bulldog reappeared on the radar display in direct conflict with the C560. CPA occurred at 12:46.55 (Figure 5), with the aircraft separated by 0.1nm laterally and 300ft vertically.

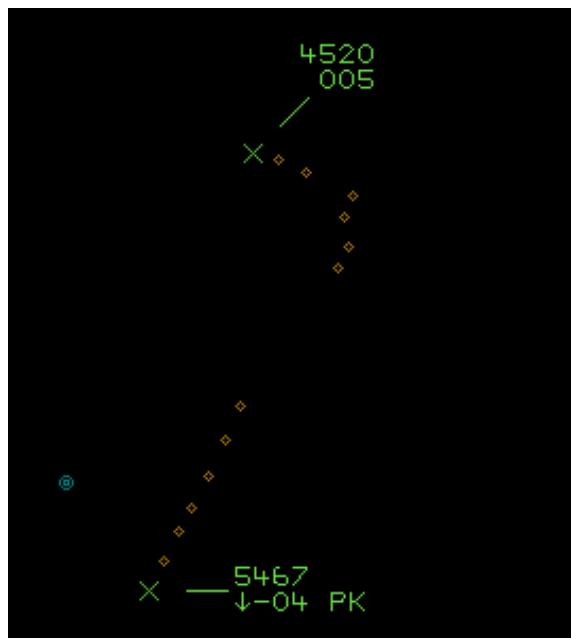
Figure 6 - 12:47.30

At 12:47.00, the C560 pilot advised the Tower controller that a single-engine aircraft was just passing over them. The controller advised the pilot that this aircraft was in the visual circuit and that the pilot had the C560 in sight. The C560 pilot advised that the aircraft was less than 100 ft above them. The controller advised the Bulldog pilot to exercise caution when holding and the pilot responded that they had seen the C560 and didn't think it was that close. The Bulldog pilot was observed to have flown the wrong way up the final approach track before commencing a left-hand orbit (Figure 6 displays the position of the aircraft at 12:47.30).
