AIRPROX REPORT No 2019163

Date: 22 Jun 2019 Time: 1046Z Position: 5152N 00129W Location: 8nm NW Oxford airport

PART A: SUMMARY OF INFORMATION REPORTED TO UKAB

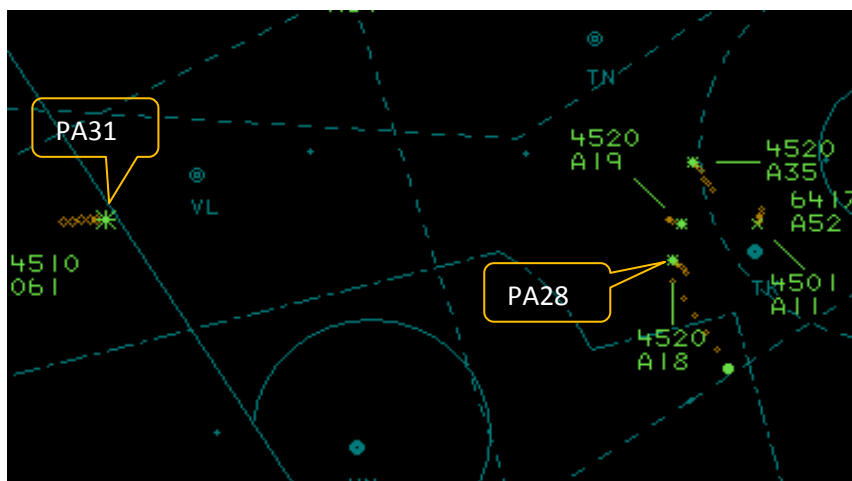
Figure 1- 1041:30.

At 1041:30 (Figure 1), the PA28 pilot reported on the frequency and a Basic Service was agreed. Traffic Information was passed on an unrelated helicopter that planned to route through the overhead at 2000ft. The controller advised the PA28 pilot that they would pass well clear of this traffic and that there was no level restriction against this traffic. The pilot advised that they had copied the traffic and read back *“no level restriction”*.

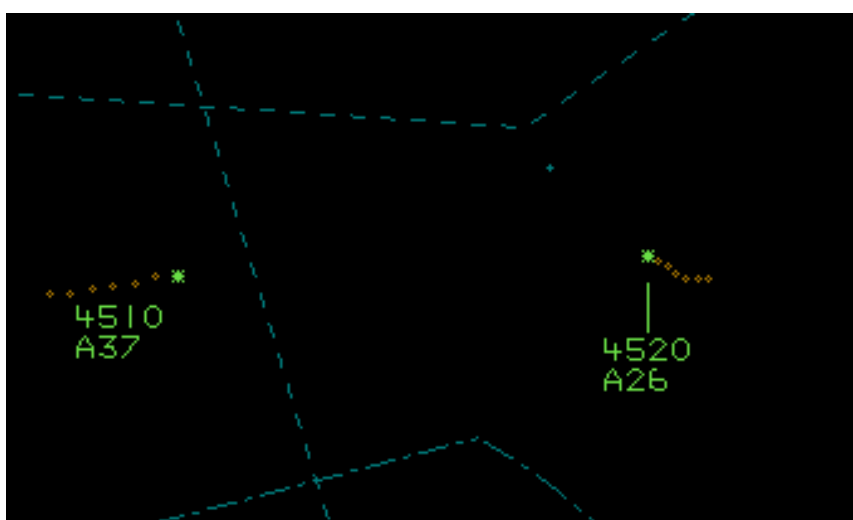
Figure 2 – 1043:50.

At 1043:50 (Figure 2), the PA31 pilot was instructed to descend to altitude 2300ft and the controller advised the pilot of “*traffic right one o’clock, range of six miles, tracking toward you, indicating 2700 feet*”. The pilot responded, “*traffic copied, descend to altitude 2300 feet*” and then advised that they had the field in sight. The controller then passed Traffic Information to the pilot of the PA28 advising them “*traffic five miles to your west routeing towards you passing through 3900 feet to descend below you is a PA31*”. The pilot responded that they were looking for the traffic.

With the PA31 pilot still locked on the same heading and now in conflict with the PA28, the pilot was given descent clearance to altitude 2300ft. This descent would take the aircraft through the level of the PA28 before the PA31 pilot had been made aware of the presence of the PA28 and the PA28 pilot made aware of the presence of the PA31.

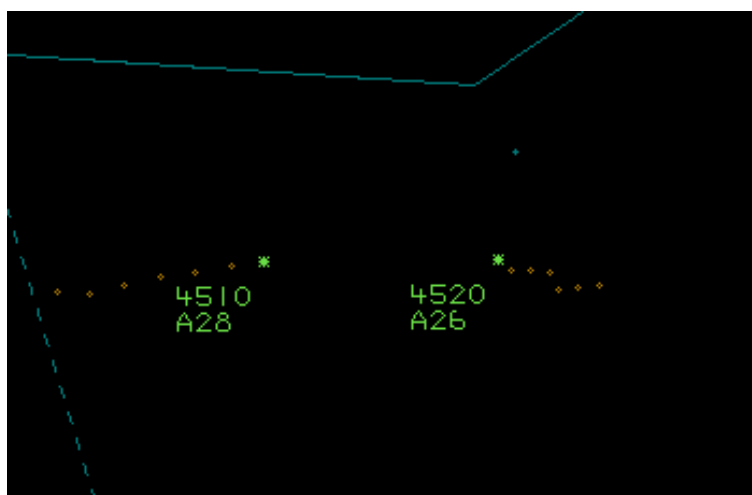
Figure 3 – 1044.30.

At 1044:30 (Figure 3), the controller instructed the PA31 pilot “*turn left 30 degrees just to pass clear of the P28A*”. The pilot responded, “*left 20 degrees [C/S] we are negative on the traffic*”. The controller advised “*(unintelligible word) will keep you clear, he’s on your right*” The pilot responded, “*OK thanks*”. The controller expanded on the information and said, “*as he turns toward you*”. The instruction given to the PA31 pilot to turn left 30° to avoid the PA28 was at odds with action the pilots may find necessary to take under the Rules of the Air for the avoidance of collisions i.e. when traffic is head-on both pilots are required to alter course to the right.

The controller then asked the PA28 pilot, “*do you have the PA31 in sight, one mile to your west, 100 feet above*”. The PA28 pilot did not have time to respond before the PA31 pilot advised the controller that they had turned to the north to avoid the traffic and the controller advised the pilot that the PA28

had also turned to the north. The controller then asked the PA28 pilot again if they got the PA31 in sight and the pilot responded, “*yeah we got him, and we turned*”.

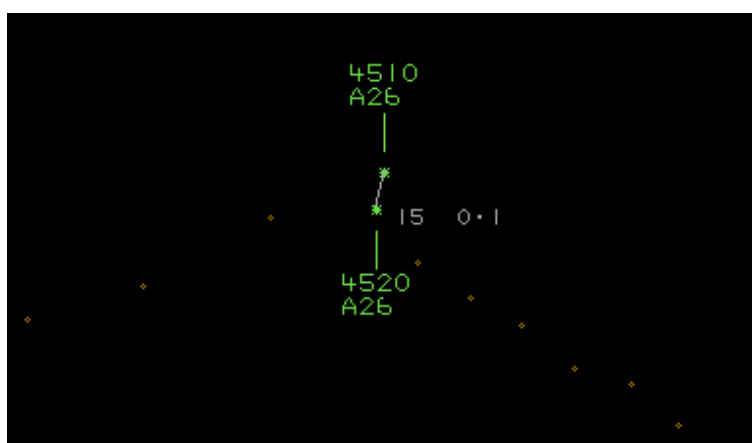
Figure 4 – 1044.50 CPA.

CPA took place at 1044:50 (Figure 4), with the aircraft separated by <math><0.1\text{nm}</math> laterally and 0ft vertically.

In summary, the controller locked the PA31 pilot on a heading that subsequently brought the aircraft into conflict with the PA28 and, subsequently, issued descent instructions that would result in the PA31 having to pass through the level of the PA28. The subsequent instruction to the PA31 pilot to turn left to avoid, further exacerbated the situation.
