**AIRPROX REPORT No 2019190**

Date: 09 Jul 2019 Time: 1148 & 1150Z Position: 5222N 00128W Location: Coventry Airfield

**PART A: SUMMARY OF INFORMATION REPORTED TO UKAB**

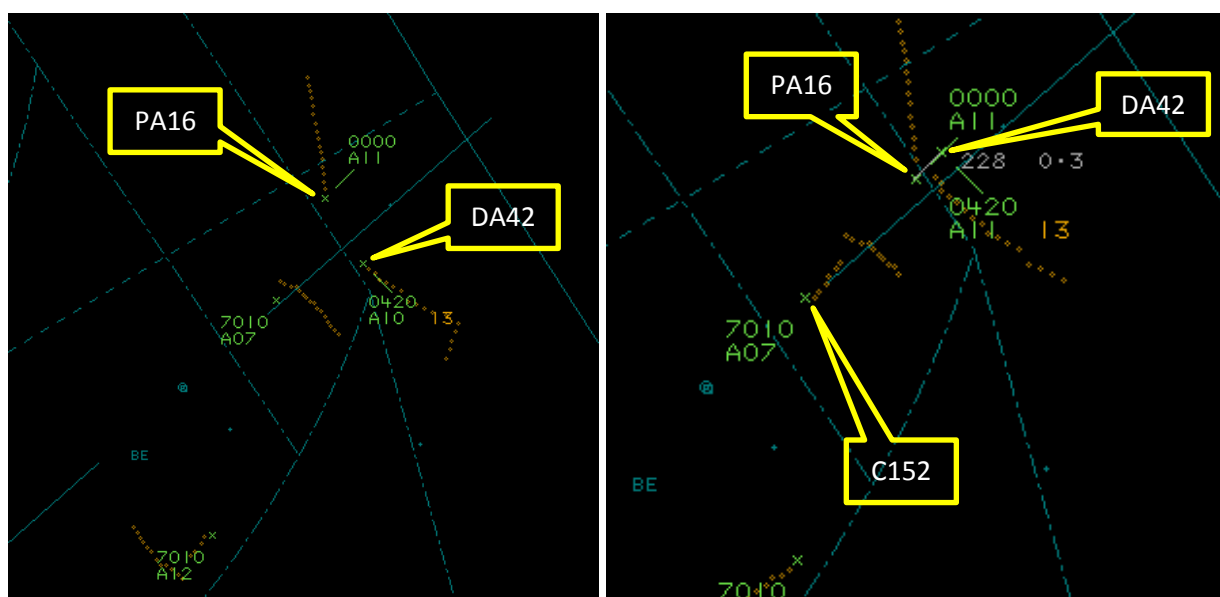
Figure 1: 1148:10

At 1148:10 (Figure 1), the PA16 pilot called Coventry whilst outside the ATZ but approaching the inbound lane for RW23, the DA42 was approaching the end of base-leg, about to turn final for RW23.

At 1148:35 (Figure 2), the DA42 pilot turns right to avoid the PA16 crossing the final approach track at CPA (1).

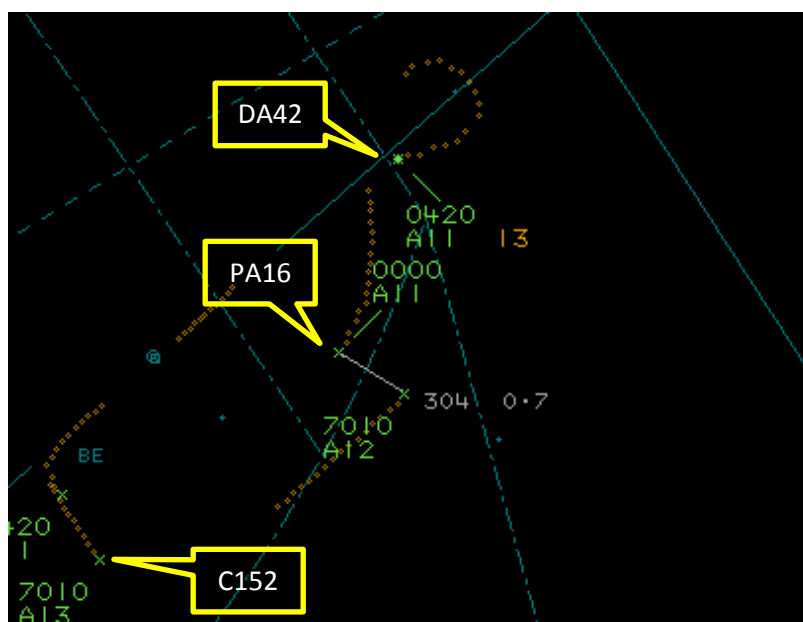
Figure 3: 1149:55 DA42 repositioning onto final approach after CPA (1)

The PA16 then turns right and flies into the ATZ at circuit height the wrong way downwind. At 1149:55 (Figure 3), the DA42 pilot has carried out a right-hand orbit and repositions onto final. The C152 pilot is just about to commence a turn onto downwind.

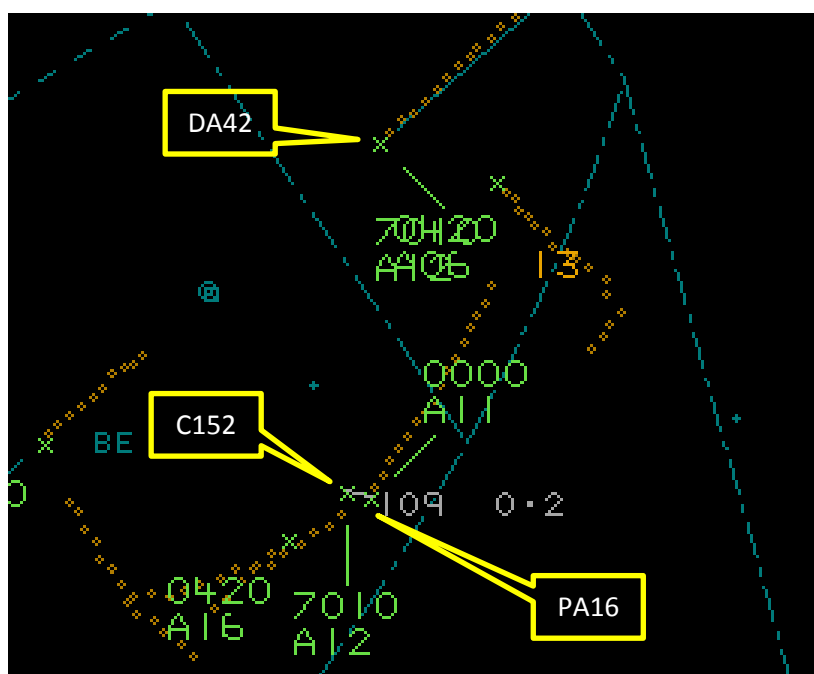
Figure 4: 1150:58 CPA (2)

At 1150:58 (Figure 4) the C152 pilot is now tracking downwind and turns left to avoid the PA16 at CPA (2). Shortly after, the PA16 pilot turns left to route to Draycote Water.
