AIRPROX REPORT No 2019199

Date: 18 Jul 2019 Time: 1512Z Position: 5245N 00019W Location: 10nm NE Wittering

PART A: SUMMARY OF INFORMATION REPORTED TO UKAB

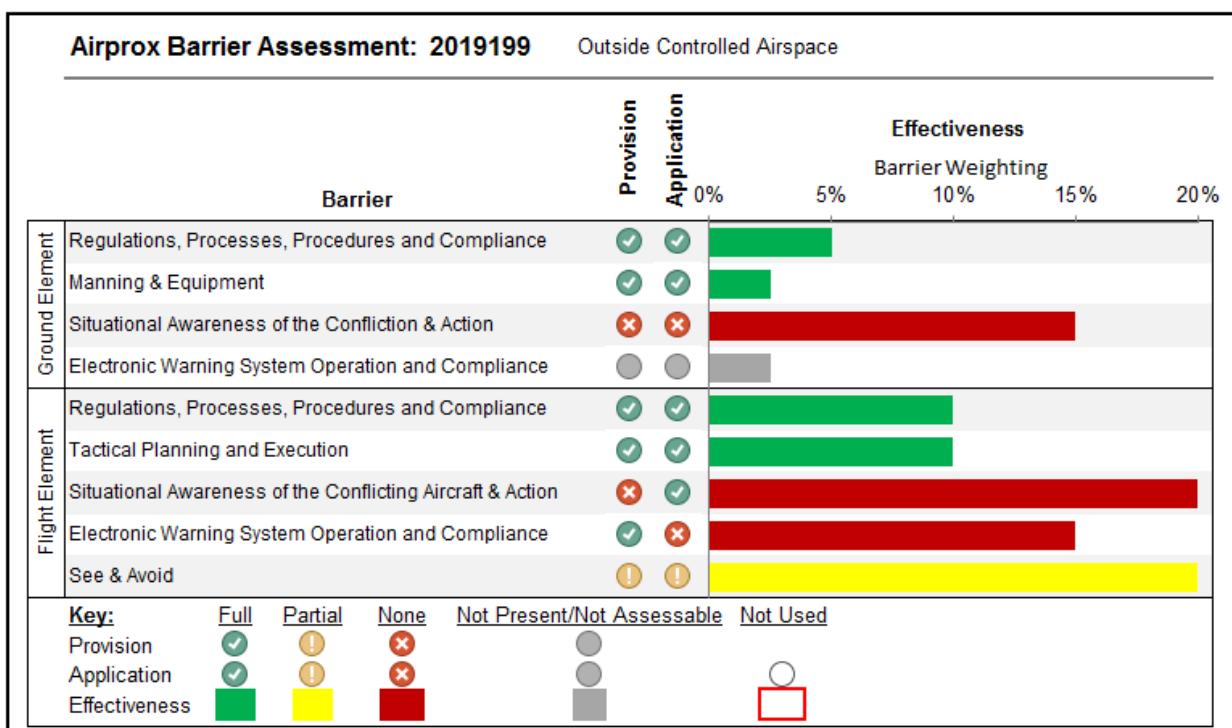
In assessing the effectiveness of the safety barriers associated with this incident, the Board concluded that the key factors had been that:

Situational Awareness of the Confliction and Action were assessed as **ineffective** because the glider was not visible on the controller's radar screen.

Situational Awareness of the Conflicting Aircraft and Action were assessed as **ineffective** because neither pilot had information on the other aircraft.

Electronic Warning System Operation and Compliance were assessed as **ineffective** because the Tutor pilots FLARM did not alert as expected and the Ventus' FLARM probably alerted on another aircraft.

See and Avoid were assessed as **partially effective** because the Tutor pilot saw the glider late and the glider pilot did not see the Tutor.
