AIRPROX REPORT No 2019210

Date: 28 Jul 2019 Time: 1001Z Position: 5153N 00205W Location: Gloucestershire Airport

PART A: SUMMARY OF INFORMATION REPORTED TO UKAB

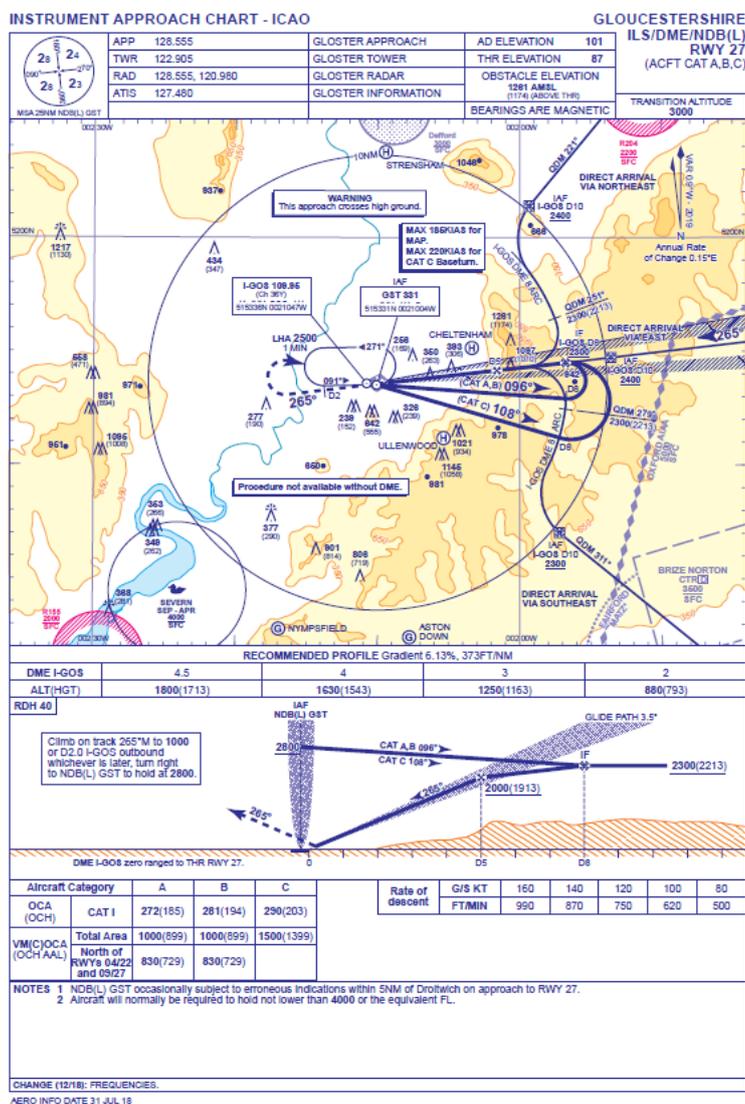
The Gloucestershire RW27 Instrument approach Chart is reproduced alongside.

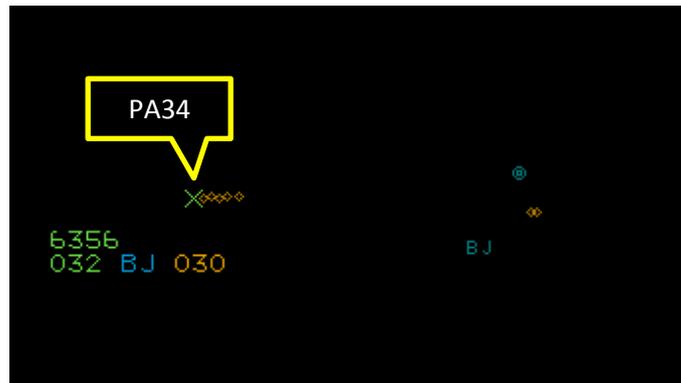
Figure 1 - 09:57.25 PA34 Squawking 6356

At 09:57.15, the PA34 pilot reported reaching altitude 3000ft, was cleared to the Golf Sierra Tango at 3000ft and was asked if they were ready to go straight outbound. The pilot readback the clearance and advised that they were ready to go outbound for the ILS. The pilot was cleared for the ILS approach and instructed to report at the Golf Sierra Tango outbound. At 09:57.25, the C206 pilot was cleared for take-off, instructed to turn after noise abatement, and passed an update on the previous unrelated helicopter (Figure 1).

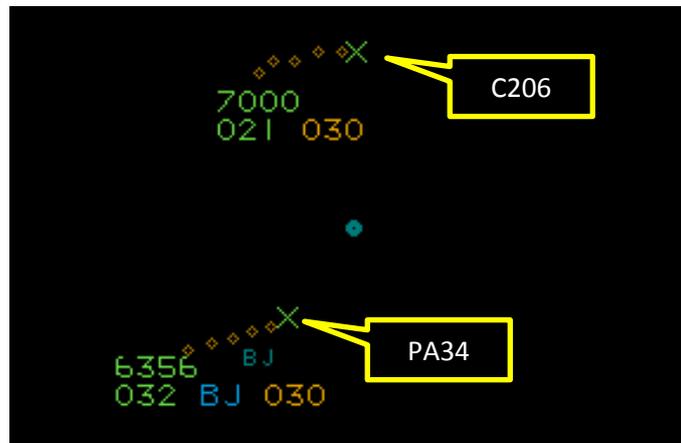
Figure 2 - 09:59.48 (C206 squawking 7000)

At 09:59.48, the C206 could be seen on the radar having made a right turn-out after take-off and was passing to the north of the airfield (Figure 2).

The direct track from Gloucester to Blackbushe would probably lead the controller to believe that the C206 pilot would be making a left turn-out after departure. There was no ATM available to verify the direction of turn taken due to the radar being out of service.

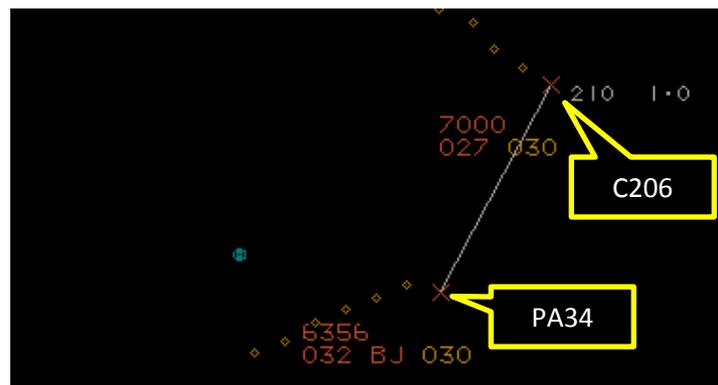
Figure 3 - 10:00.25

At 10:00.25, the PA34 pilot reported beacon (GST) outbound and was instructed to report established on the localiser (Figure 3).

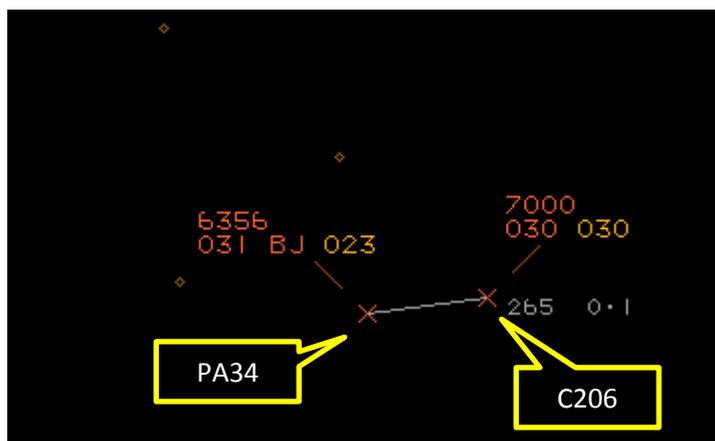
Figure 4 - 10:01.11 (CPA)

CPA occurred at 10:01.11 (Figure 4), with 0.1nm lateral and 100ft vertical separation.

At 10:01.45, the PA34 pilot asked the controller if they were in communication with a Cessna that had come very close to them outbound, at approximately 2800 ft. The controller responded that they were not working a Cessna but that it might be a 206 that they were working. The controller then asked the C206 pilot for a position report and they responded that they were 5 miles to the southeast and had the PA34 on TCAS.

In assessing the risk of the Airprox the Board debated the separation between the two aircraft and the fact that neither pilot had seen the other until CPA. In the end, it was agreed that the action taken by the PA34 pilot in stopping his descent after receiving his TAS alert had been timely and effective in ensuring separation. They therefore agreed that although safety had been degraded, the risk of collision had been averted by the PA34 pilot; risk Category C.
