AIRPROX REPORT No 2019216

Date: 25 May 2019 Time: 1147Z Position: 5136N 00052W Location: IVO Wycombe

PART A: SUMMARY OF INFORMATION REPORTED TO UKAB

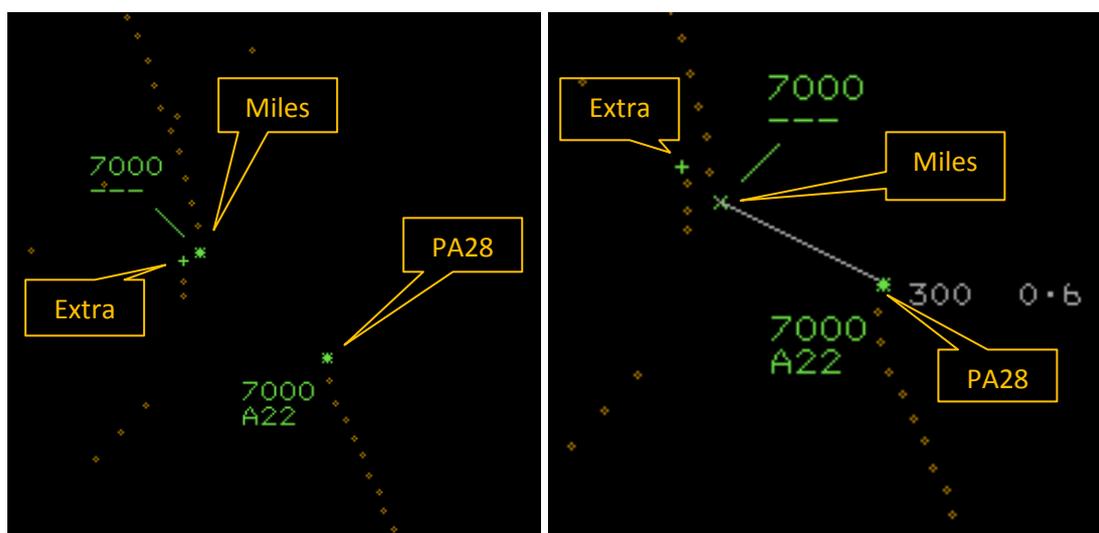
Figure 1:1147:15

At 1147:15, the Miles Whitney (squawking 7000) can be seen on the NATS radar approximately 3nm to the NW of Wycombe Airpark, heading south. A primary only contact, believed to be the Extra, can be seen just to the south-west of the Miles Whitney, this contact continues northbound. The only other contact in close proximity is an aircraft squawking 7000, believed to be a PA28, this aircraft closes to within 0.6nm before turning to the north-east.
