AIRPROX REPORT No 2019224

Date: 05 Aug 2019 Time: 1244Z Position: 5131N 00054W Location: 1nm S Henley-on-Thames

PART A: SUMMARY OF INFORMATION REPORTED TO UKAB

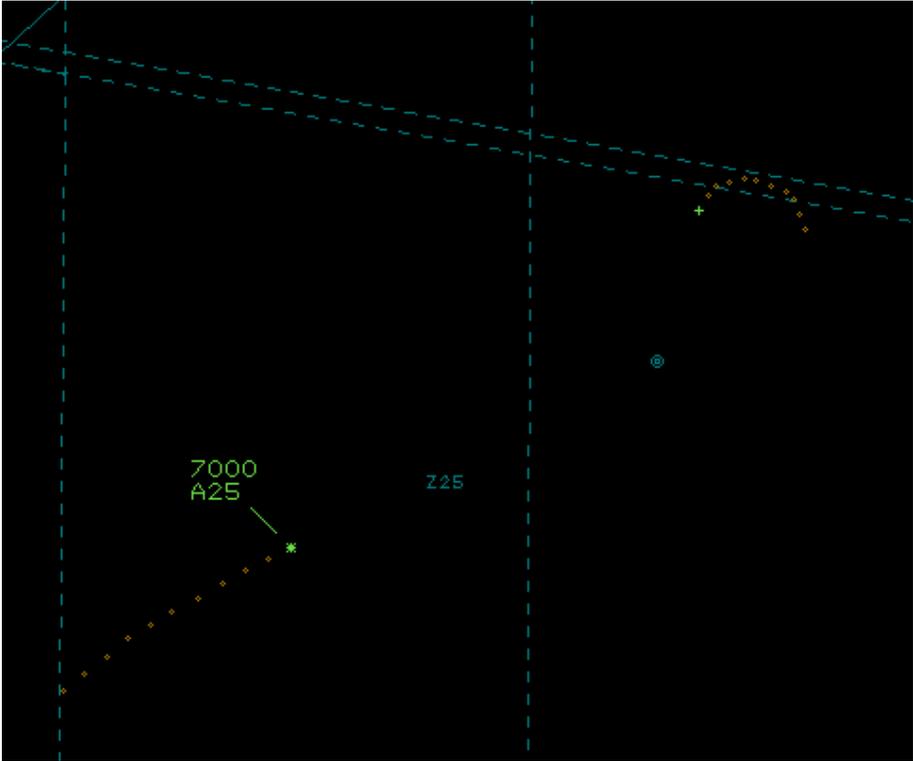
Figure 1 – 1243:18

Radar replays show the Mooney and the unknown light-aircraft, the latter being a primary radar track only. The radar screenshot at Figure 1 is taken at 1243:18 and shows the Mooney (7000) to the south-west and the unknown light-aircraft (primary track only, no SSR) to the north-east. The unknown light-aircraft has just completed a turn onto a south-westerly heading.

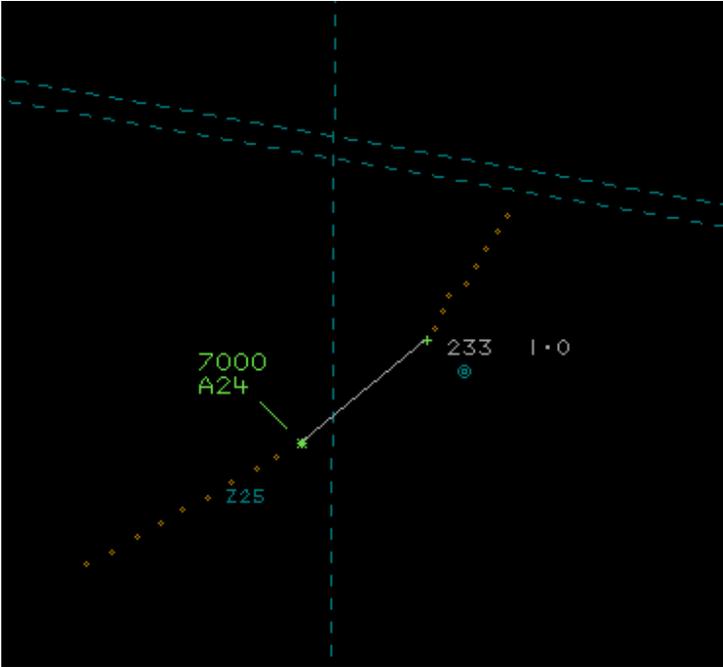
Figure 2 – 1243:54

In Figure 2, the Mooney has continued on its north-eastbound track and the unknown light-aircraft is now steady on a south-westerly track; the aircraft are separated by 1nm horizontally (vertical separation unknown).

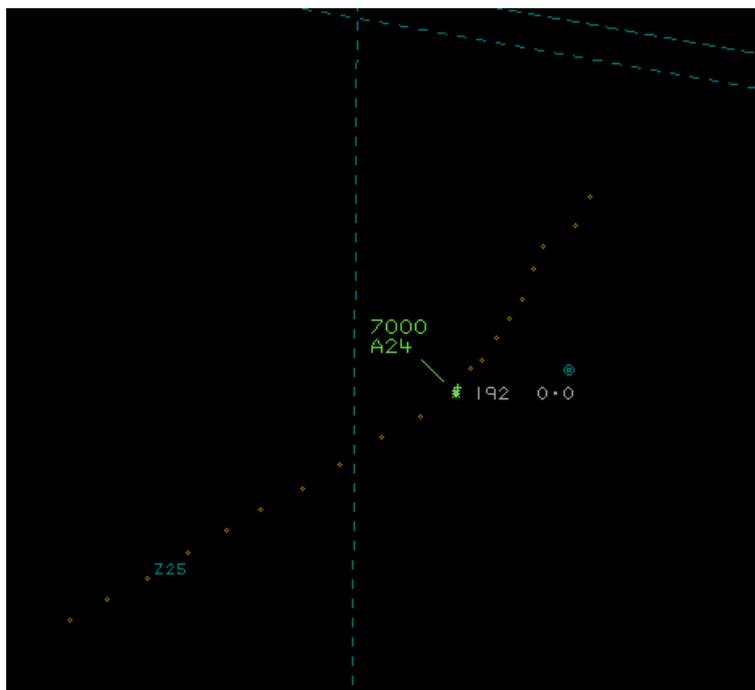
Figure 3 – CPA at 1244:10

Figure 3 shows the CPA between the 2 aircraft at the point at which the radar returns merge. There are no deviations in the Mooney’s flight path detected on the radar. The radar track on the unknown light-aircraft indicates that its pilot may have commenced a gentle right turn immediately prior to CPA, but this deviation might also be due to radar jitter and the lack of a stable SSR return. Vertical separation cannot be measured due to the unavailability of height information for

the unknown light-aircraft but horizontal separation is <0.1nm (although 0.0 is indicated on the radar replay, radar resolution accuracy means that it is not possible to conclusively state separation to that level of accuracy).
