AIRPROX REPORT No 2019225

Date: 03 Aug 2019 Time: 1559Z Position: 5133N 00015E Location: Upminster

PART A: SUMMARY OF INFORMATION REPORTED TO UKAB

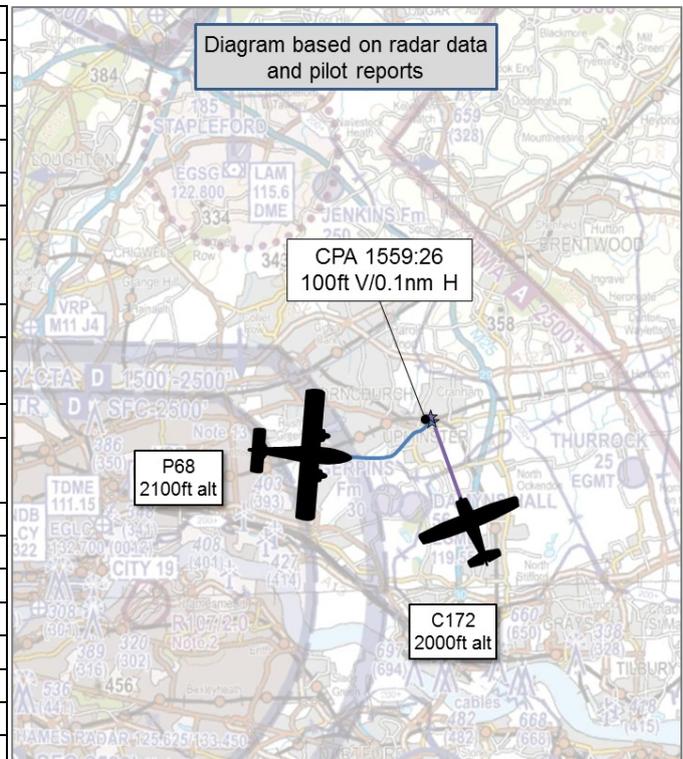
At 1558, the P68 was tracking eastbound on a survey run. The service was changed to a Basic Service as it left the EGLC zone and the controller passed Traffic Information on an unknown 7000 squawk: "traffic, same level, northbound." Both the service change and the traffic information were acknowledged by the P68 pilot.

At 1559:10, the P68 pilot requested a right turn (onto a westbound leg). The controller approved the turn back onto a westbound leg and passed Traffic Information again "traffic right off your right-hand side, possibly 100ft below." The P68 pilot reported visual with the traffic.

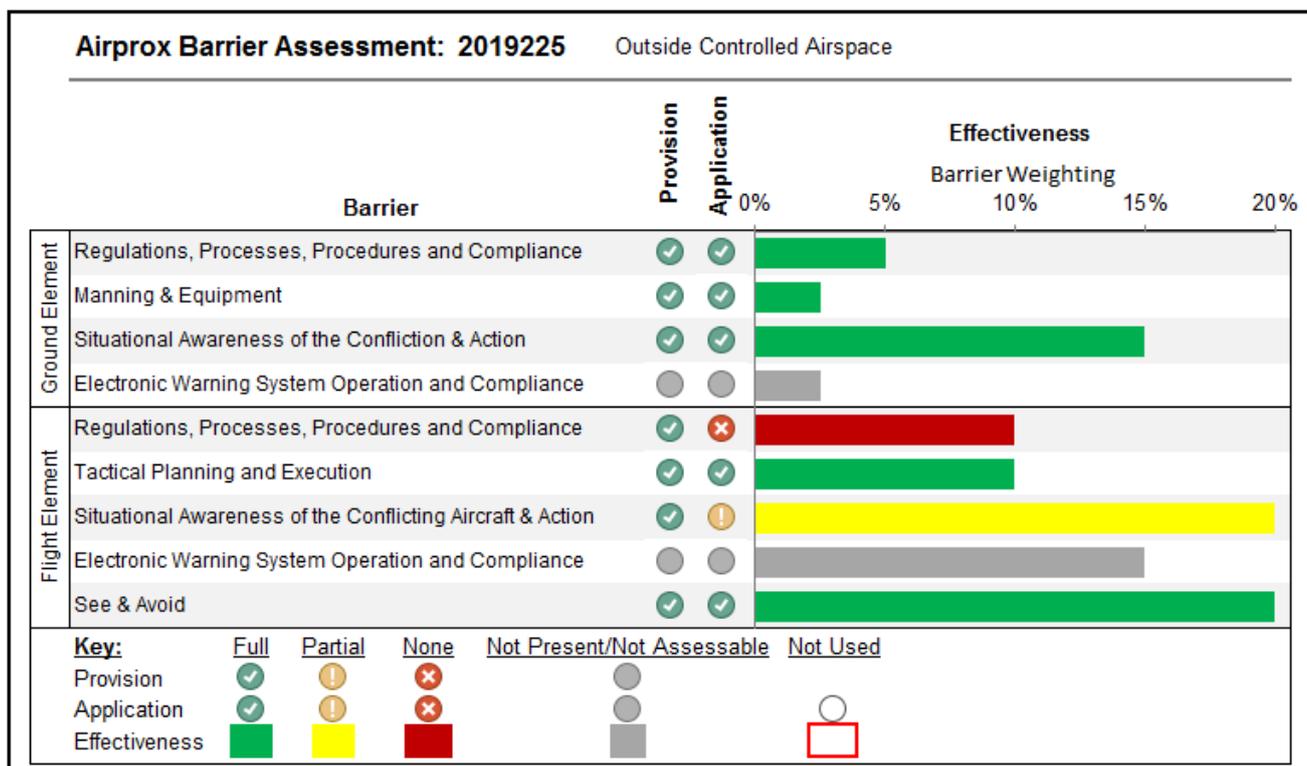
Regulations, Processes, Procedures and Compliance was assessed as **ineffective** because despite Traffic Information the P68 pilot flew closer than desirable to the C172 and didn't comply effectively with SERA.3205.

Situational Awareness of the Conflicting Aircraft and Action were assessed as **partially effective** because the P68 pilot did not fully utilise the Traffic Information to suitable separation from the C172.
