AIRPROX REPORT No 2019226

Date: 05 Aug 2019 Time: 1409Z Position: 5127N 00018E Location: Tunbridge Wells VRP

PART A: SUMMARY OF INFORMATION REPORTED TO UKAB

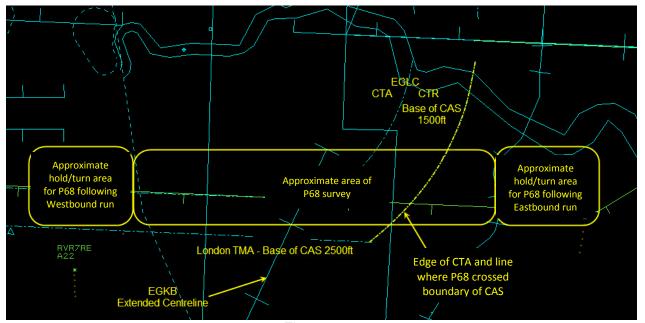
Figure 1.

The P68 pilot contacted the Thames Radar controller at 1231:46 (all times UTC) to request Zone entry to the London City Control Area (CTA) for a survey flight. The pilot was issued a clearance to enter the zone, VFR, not above 2400ft at 1233:44. He reported he would be conducting a survey by flying east-west tracks, crossing the boundary of Class D to Class G, and therefore being outside Controlled Airspace on the eastern portion of each run. Figure 1 shows the approximate turn/hold area that the P68 occupied with straight east-west runs being made between the two.

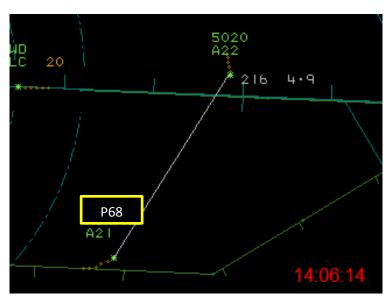
Figure 2. Squawk 5020 PA28.

The P68 left the London City CTA, and therefore left Controlled Airspace, at 1405:14. There was then a controller change, with the new controller being in place and beginning their first transmission at 1406:18. Shortly before this transmission, the P68 was at 2100ft and the PA28, which was displaying mode A code 5020 and tracking in a southerly direction. was at 2200ft. The 2 aircraft were 4.9nm apart. See Figure 2.

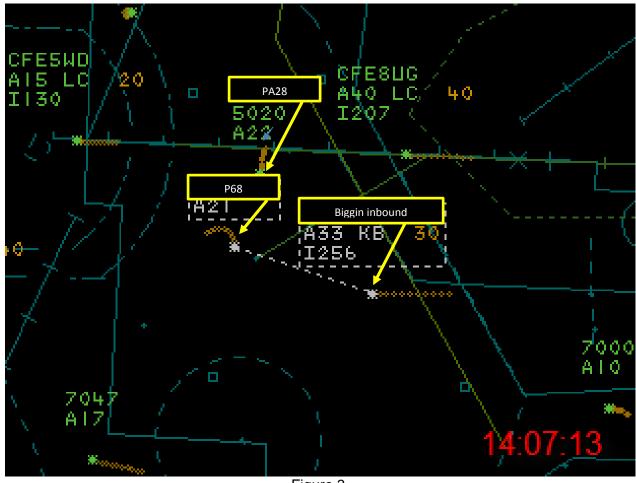
Whilst the P68 was holding in a right-hand orbit outside Controlled Airspace, Low Level Short Term Conflict Alert (STCA) activated with a Biggin Hill inbound at 1407:13, see Figure 3. Traffic information on the P68 was passed to the pilot of the Biggin inbound five secs later, as STCA deactivated.

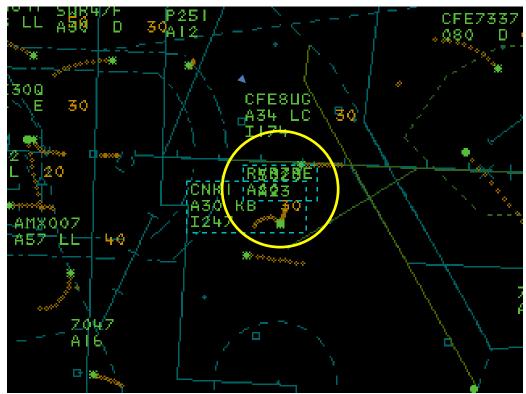
Figure 5. (P68/PA28 callsigns overlapping.)

NATS ATSI Note: Figure 4 shows a screenshot of CPA1 from the Node Replay system, Figure 5 shows a screenshot from the Thames Radar controller's radar display at this point illustrating the clutter and overlap of the P68/PA28 information.
