AIRPROX REPORT No 2019229

Date: 04 Jul 2019 Time: 1303Z Position: 5058N 00221W Location: Henstridge circuit.

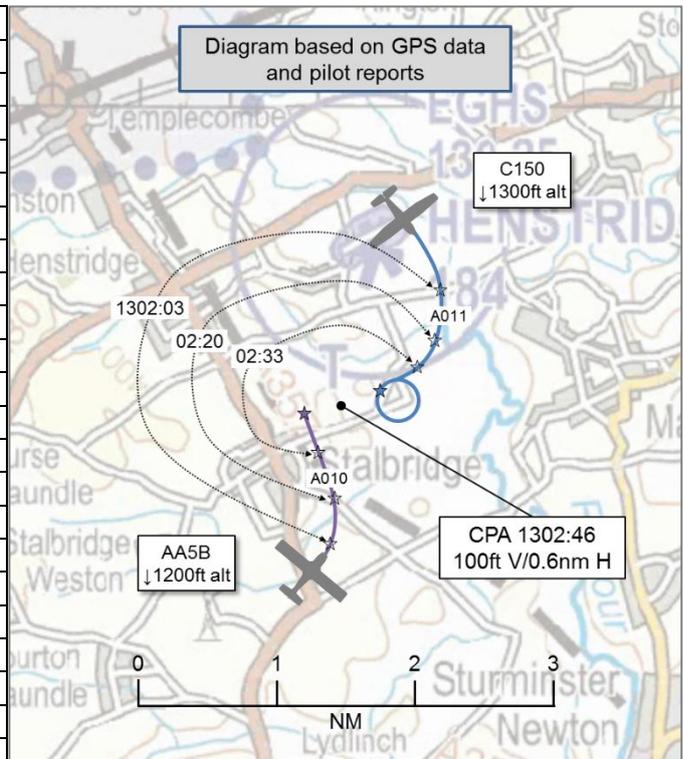
Recorded	Aircraft 1	Aircraft 2
Aircraft	C150	AA5B
Operator	Civ FW	Civ FW
Airspace	London FIR	London FIR
Class	G	G
Rules	VFR	VFR
Service	AGCS	AGCS
Provider	Henstridge	Henstridge
Altitude/FL	1081ft	1015ft
Transponder	A, C, S	A, C
Reported		
Colours	White/Blue	White/Red/Blue
Lighting	Strobes	
Conditions	VMC	VMC
Visibility	>10km	>10km
Altitude/FL	1073ft	800ft
Altimeter	Not Reported	Not Reported
Heading	245°	~315°
Speed	80kt	110kt
ACAS/TAS	Not fitted	Not fitted
Alert	N/A	N/A
Separation		
Reported	0ft V/200m H	Not Reported
Recorded	66ft V/ 0.57nm H

An Airprox was reported when a C150 and an AA5B flew into proximity in the Henstridge visual circuit at 1303hrs on Thursday 4th July 2019. Both pilots were operating under VFR in VMC and in receipt of an AGCS from Henstridge.

When considering the risk, the Board took into account the fact that the AA5B pilot was unaware of the presence of the C150 but that this had been mitigated by the C150 pilot remaining visual with the AA5B throughout the downwind leg. With a CPA measured from the pilots' respective GPS log files of circa 70ft vertically and 0.57nm laterally, members agreed that, although safety had been degraded, there had been no risk of collision because the C150 pilot was always visual with the AA5B; risk Category C.

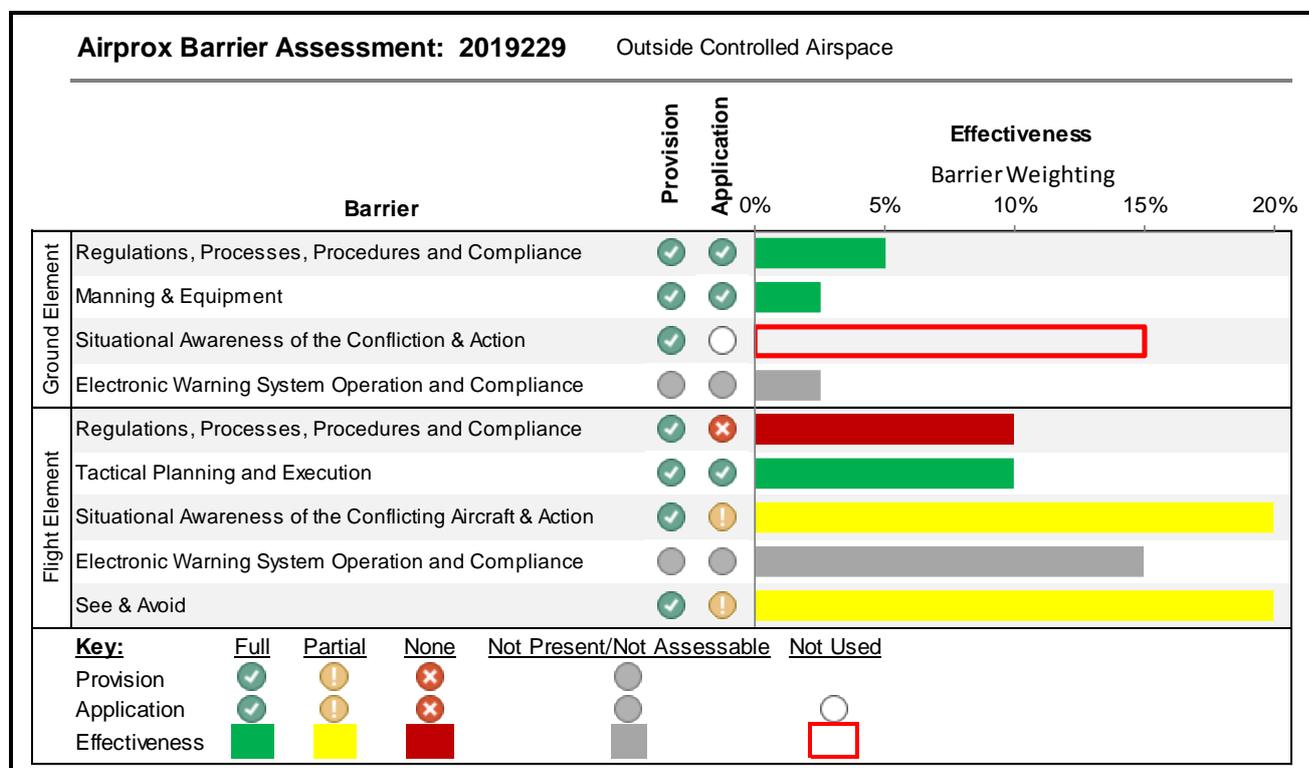
Situational Awareness of the Confliction and Action were assessed as **not used** because the Henstridge Air/Ground Operator was not required to monitor the aircraft.

Regulations, Processes, Procedures and Compliance were assessed as **ineffective** because the AA5B pilot did not integrate with the C150 already established in the visual circuit.

Situational Awareness of the Conflicting Aircraft and Action were assessed as **partially effective** because the C150 pilot heard the joining call from the AA5B pilot, was alerted to the potential conflict, and transmitted a 'downwind' call. However, the AA5B pilot did not assimilate the information from the C150 pilot.

See and Avoid were assessed as **partially effective** because the C150 pilot, although visual with the AA5B throughout the duration of his downwind leg, continued to the point where he had to take late avoiding action.
