AIRPROX REPORT No 2019245

Date: 22 Aug 2019 Time: 1205Z Position: 5201N 00003W Location: Royston

PART A: SUMMARY OF INFORMATION REPORTED TO UKAB

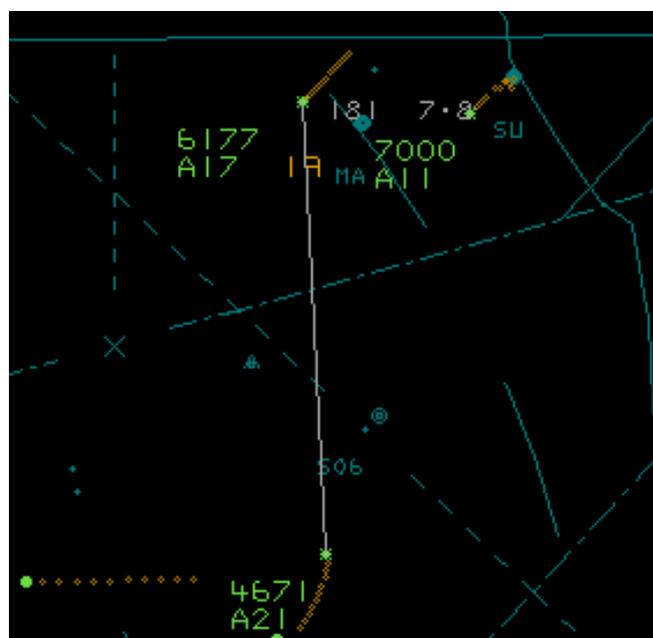
Figure 1 - 12:02.09

At 10:37:20, the P68 pilot passed their initial contact details to the controller and advised that they were currently at 1800ft and that their survey route would take them through the Cambridge ATZ. The controller instructed the pilot to squawk 6177 (the Cambridge Conspicuity code) and a Basic Service was agreed. The flight continued as expected and the screenshots below illustrate the Airprox unfolding. CPA took place at 12:05.10 with the aircraft separated by 0.2nm laterally and 100ft vertically (Figure 4).

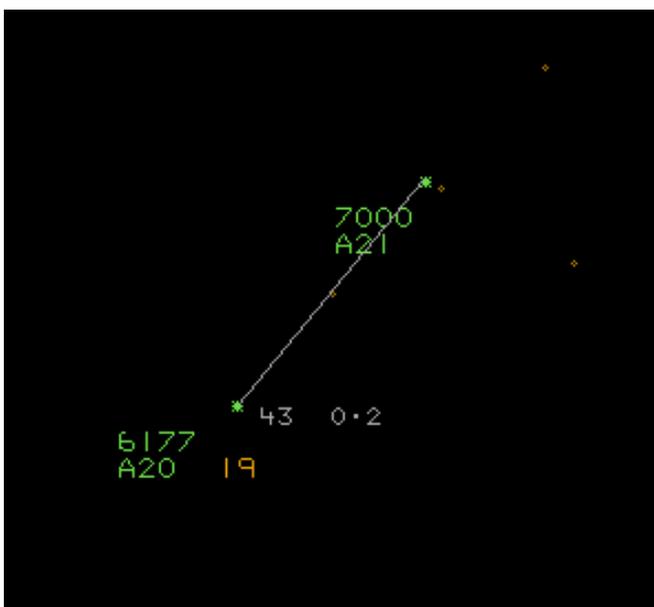
Figure 4 – 12:05:10 CPA

In assessing the risk, the Board quickly agreed that there had not been any risk of collision because the P68 pilot was visual with the C172 at all times. Some members thought that with a radar separation of 0.2nm this could be considered normal operations, however, because the C172 pilot had not been visual with the P68 it was agreed that safety had been degraded and therefore the risk was judged to be Category C.
