**AIRPROX REPORT No 2019246**

Date: 22 Aug 2019 Time: 1559Z Position: 5212N 00010E Location: Cambridge Airport

**PART A: SUMMARY OF INFORMATION REPORTED TO UKAB**

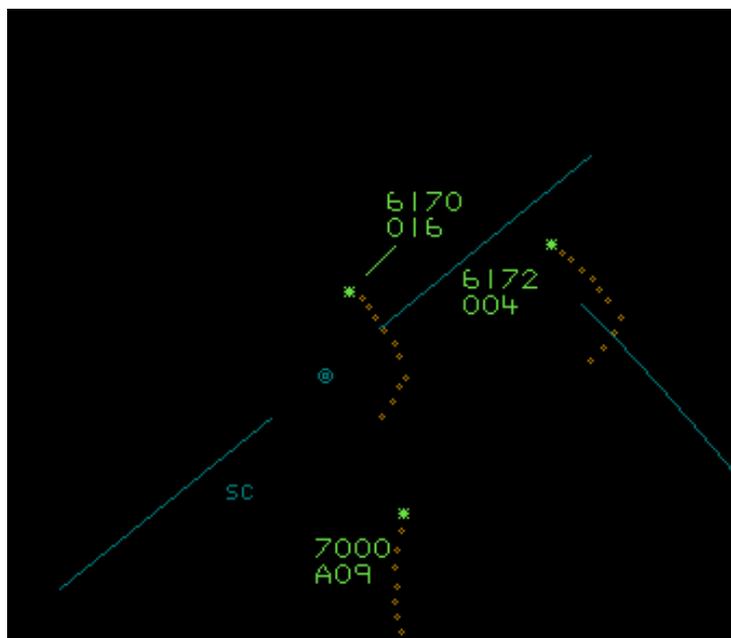
Figure 1-15:58.40 (C172 6170 Squawk)

At 15:58.40 (Figure 1), the P68 pilot was cleared for take-off RW23 (P68 not yet visible on radar).

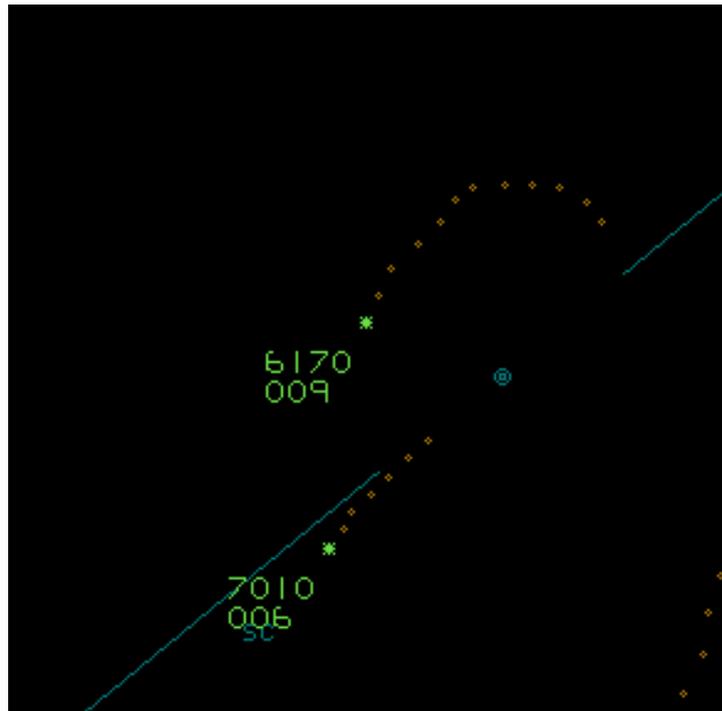
Figure 2-15:59.10

At 15:59.10 (Figure 2), and having omitted the overhead report, the C172 pilot reported descending deadside. The controller responded, *“roger descend deadside, roger report ready to turn crosswind, traffic on the roll now departing straight ahead, Partenavia.”* The pilot responded, *“roger that (callsign)”*. [Note: the 7010 squawk in Figure 2 is the E200 that departed just ahead of the P68].

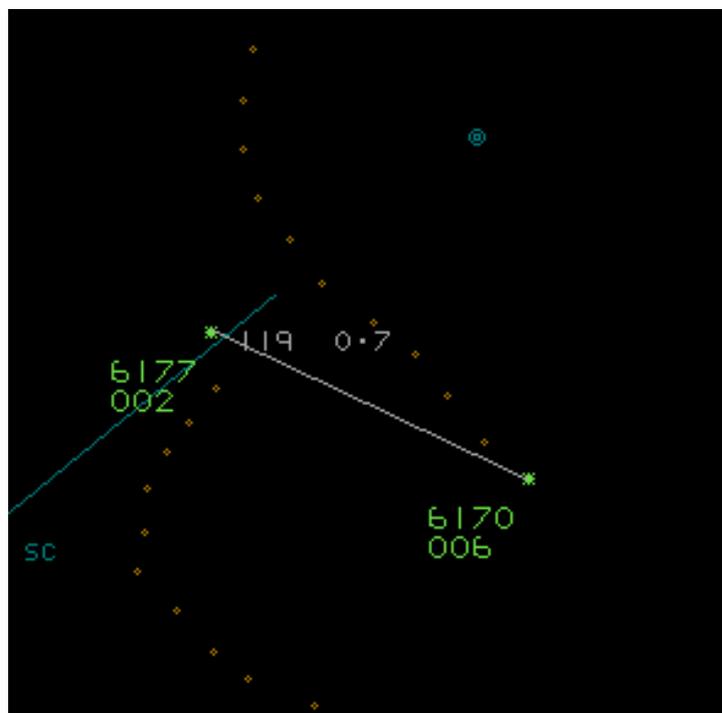
Figure 3-15:59.50. P68 6177 Squawk (closest point that could be measured)

At 15:59.50 (Figure 3), the P68 first appeared on the radar replay with the aircraft separated by 0.7nm laterally and 400ft vertically. Although the 2 aircraft flew closer than this as they crossed tracks, this was the closest point that could be measured using the available radar pictures.

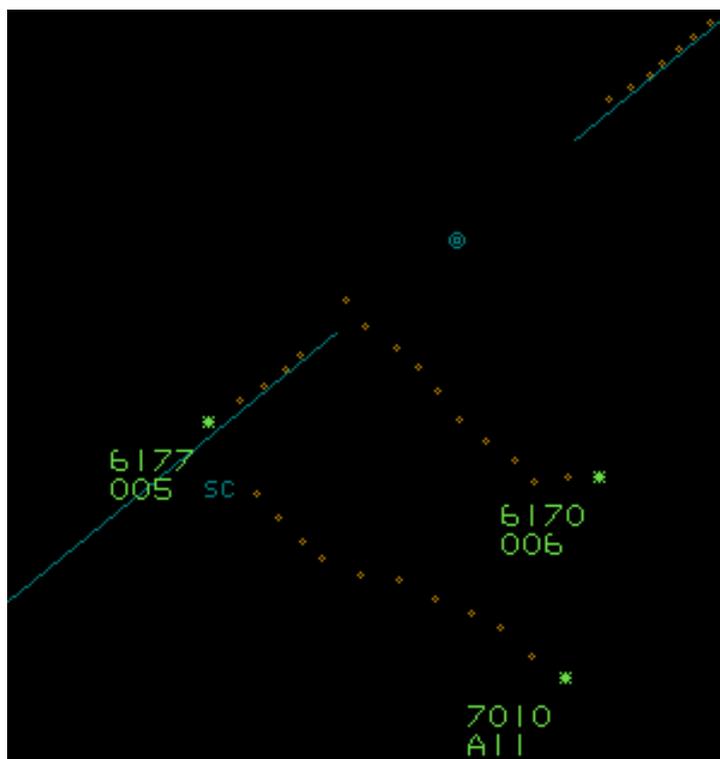
Figure 4-16:00.10

At 16:00.10 (Figure 4), the controller asked the C172 pilot to report their position. The pilot responded, "*currently turning onto downwind*". the controller responded, "*the instruction was to report ready to turn crosswind.*" The pilot responded, "*my bad (callsign)*".
