**AIRPROX REPORT No 2019255**

Date: 29 Aug 2019 Time: 1206Z Position: 5142N 00008E Location: North Weald

**PART A: SUMMARY OF INFORMATION REPORTED TO UKAB**

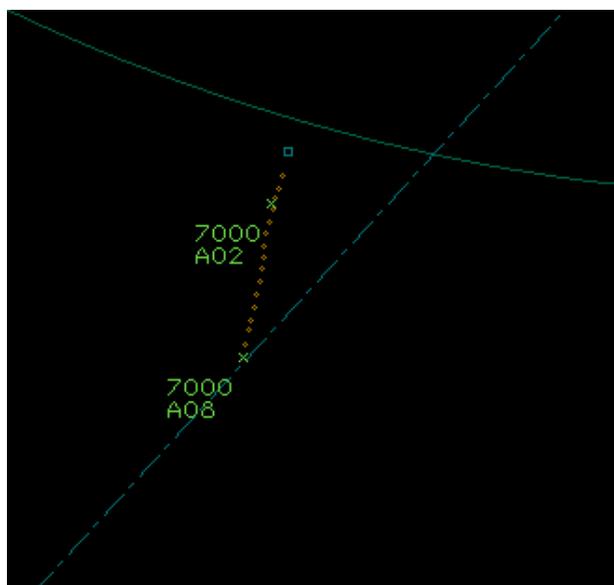
Figure 1: 1205:59

At 1205:59 (Figure 1) the RV6 can be seen on the NATS radar, passing 200ft in the climb out from North Weald. At 1206:34 (Figure 2) the C152 can be seen turning downwind and the RV6 is turning onto a southwesterly heading. CPA occurs at 1206:46 with the two aircraft 300ft vertically and 0.1nm apart.
