## AIRPROX REPORT No 2019263

Date: 01 Sep 2019 Time: 1542Z Position: 5111N 00103W Location: Lasham Gliding Site

### PART A: SUMMARY OF INFORMATION REPORTED TO UKAB

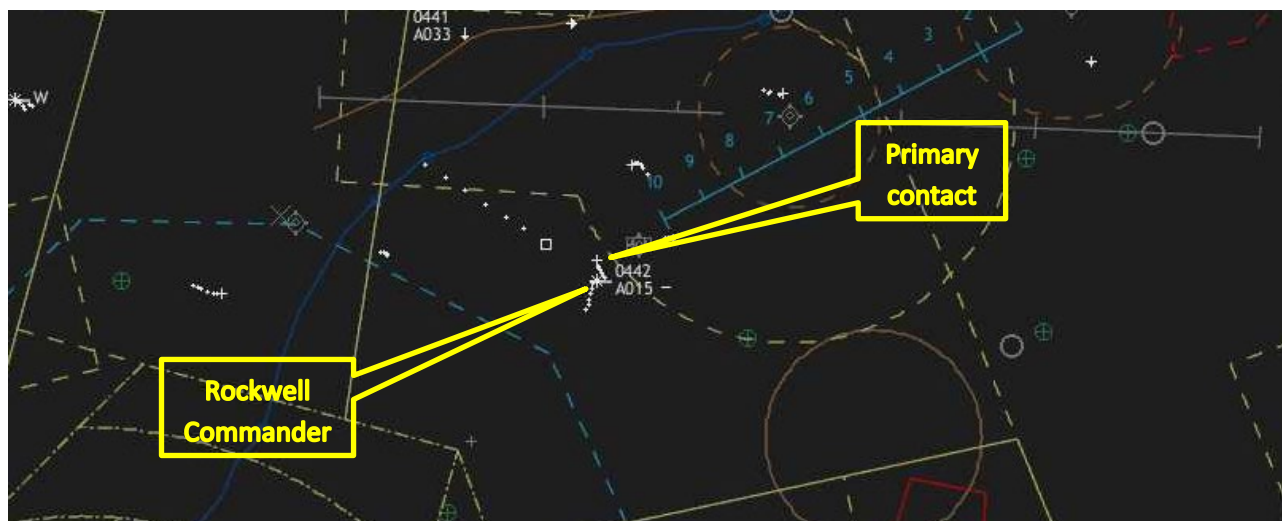
Figure 1 – 1541:33

15:41:15 - "Rockwell Commander C/S, unknown contact north of your position, north/north east of your position, 1nm on your nose northbound, no height or type, may be a glider".

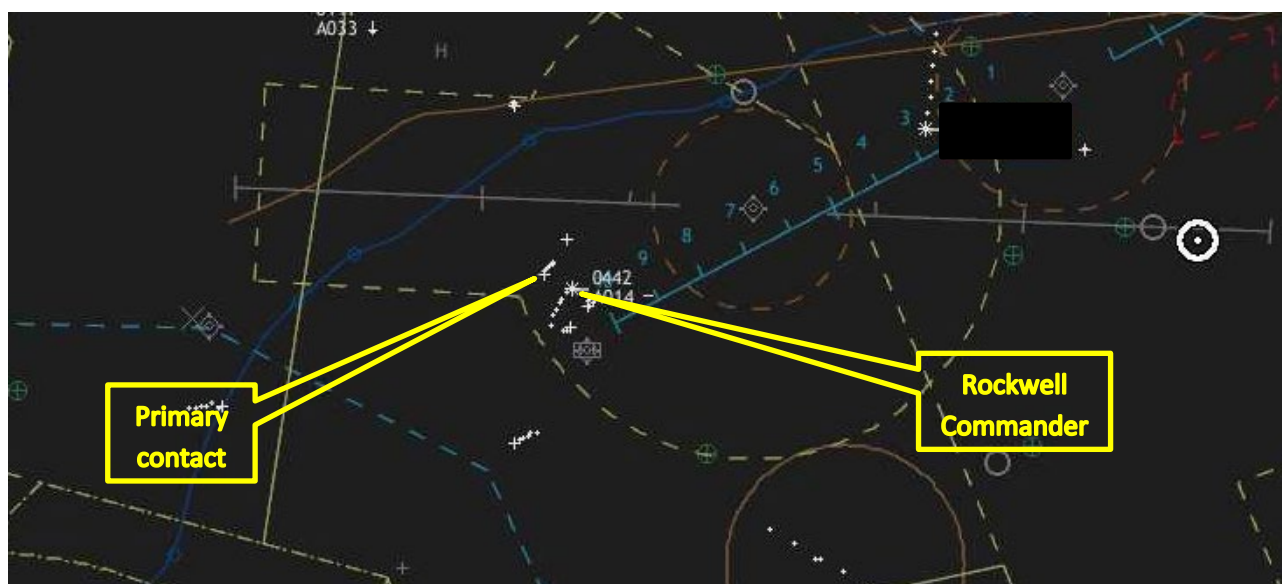
Figure 2 – 1542:41

15:42:39 - "Rockwell Commander C/S, unknown contact west/north west of your position, 1nm southbound, no height".

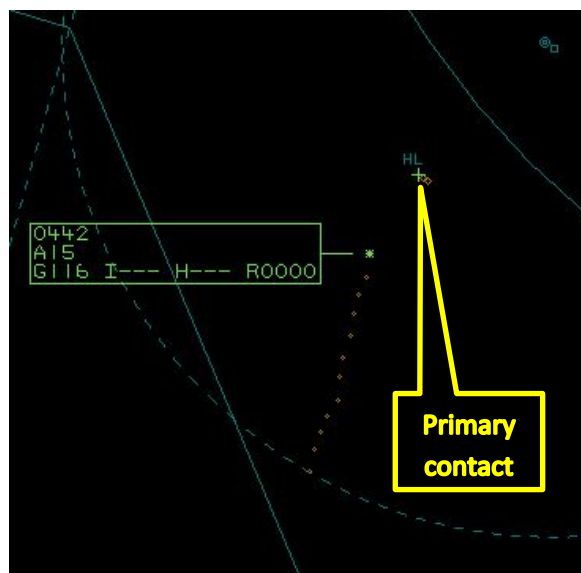
Figure 3 – NATS radar screenshot at 1541:14

The NATS radar shows the Rockwell Commander (squawk 0442) approaching the vicinity of Lasham from the south at an altitude of 1500ft. There is a brief appearance (for three radar sweeps) of a primary return in the area of the Ventus CT (see Figure 3); it is assumed that this is the return on which the Farnborough LARS controller issues Traffic Information to the pilot of the Rockwell Commander. This primary radar return fades at 1541:14. It cannot be stated whether or not this primary return is the Airprox glider or a different aircraft.
