AIRPROX REPORT No 2019284

Date: 21 Sep 2019 Time: 0835Z Position: 5109N 00135W Location: Middle Wallop

PART A: SUMMARY OF INFORMATION REPORTED TO UKAB

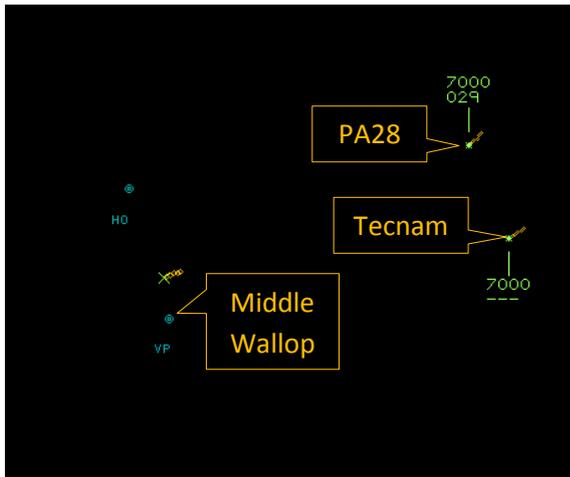
Figure 2 - 0824:20

Figure 2 shows the relative positions of the Tecnam and the PA28 at **0824:20**. The PA28 had already called for joining instructions and was routing towards a left-base join for RW17. At this time, the Tecnam pilot called for join and the tower controller instructed them to “*join left-base RW17. Believe a PA28 is joining left-base also about similar position*”, all of which was correctly read back by the pilot of the Tecnam.

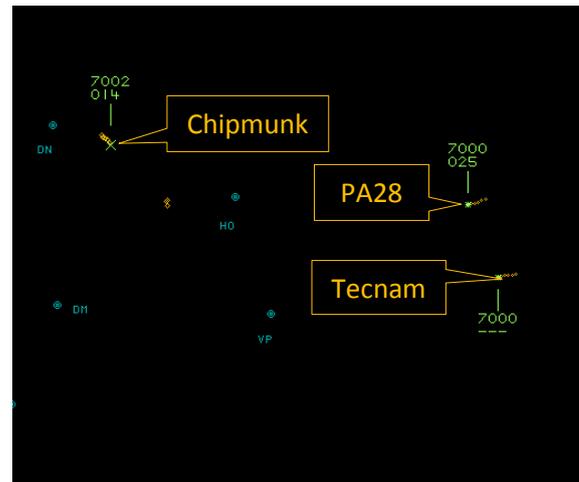
Figure 3 - 0826:00

At **0825:30**, the Chipmunk pilot made their initial call inbound from the NW, advising that they were intending to route via Grateley, (a small village/railway station 2.3nm NW of the airfield). The tower controller asked the pilot if they could accept an overhead join due to the two aircraft joining left-base, which they declined, at **0826:00** (Figure 3), requesting a right-base join for RW17. The controller acknowledged this, advising them that they would be number 3 to the two on left-base, which the pilot acknowledged. The controller then became involved with the first landing aircraft and then with a call from another joining aircraft with a very poor radio. At **0827:18**, the PA28, (now 5nm NE), reported on a wide left-base and was instructed by the controller to report final (Figure 5).

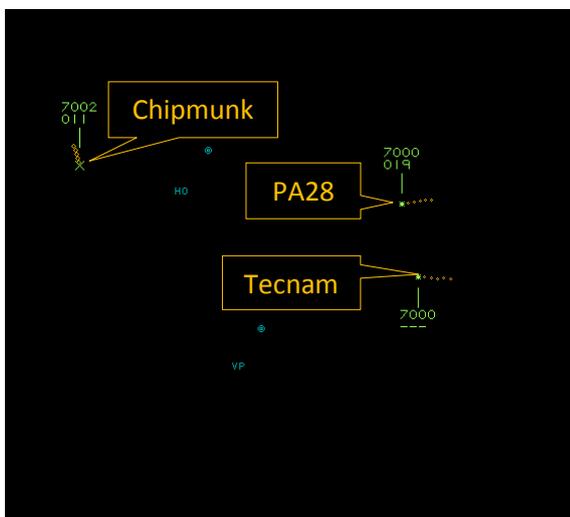
Figure 4 - 0828:00

At **0827:48**, the controller asked the Tecnam pilot if they were visual with the PA28, to which the pilot replied that they were not. The controller then asked the Tecnam pilot for their position which the pilot reported, at **0828:00**, as “*just approaching your airfield, er virtually behind the water tower*” (located 0.7nm N of the airfield) (Figure 4).

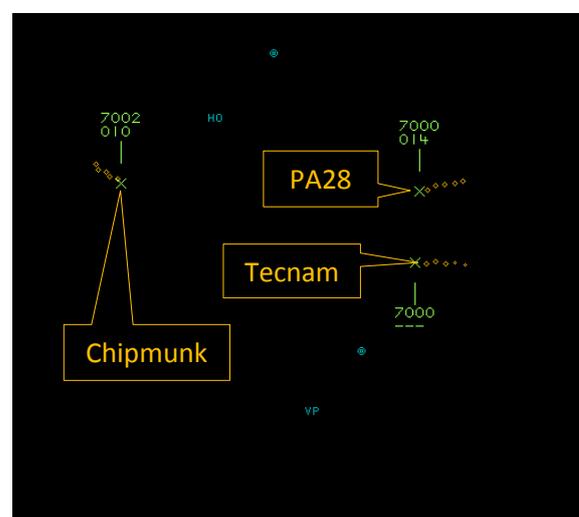
Figure 5 - 0829:22 (Tecnam 1.3nm NNE)

At **0829:22**, the controller asked the Tecnam pilot “*confirm are you almost due north of the tower*”, to which the pilot replied “*affirmative*”, in response to which the controller instructed them to report final, adding that they were “*Number 1*” which was acknowledged by the pilot (Figure 5).

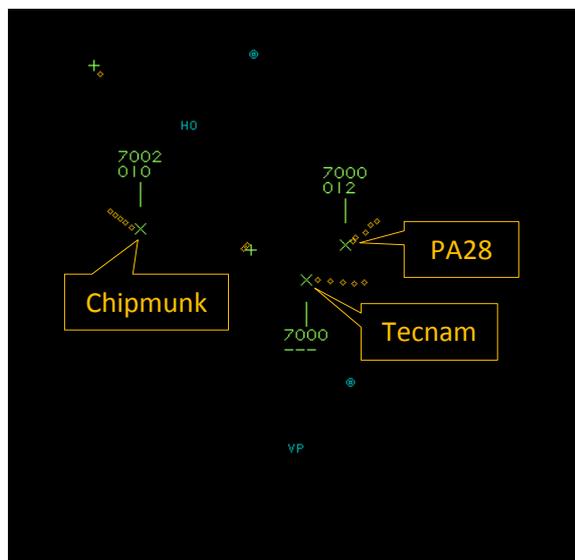
Figure 6 - 0829:57

At **0829:57**, the PA28 pilot reported turning final, to which the controller responded, “*roger, OK, (PA28 callsign), you are Number 1 RW17, land at your discretion*” which was acknowledged by the pilot of the PA28 (Figure 6).

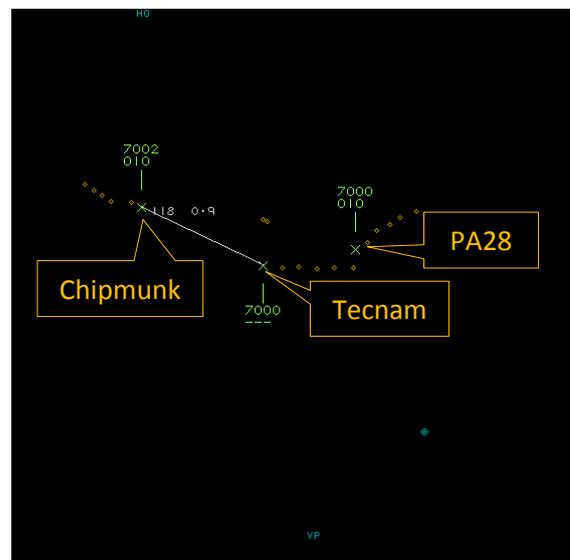
Figure 7 - 0830:18

The controller acknowledged this, and advised the Tecnam pilot that they had another aircraft joining right-base via Grateley, overhead Grateley at that time, which was not acknowledged by the pilot of the Tecnam. The Chipmunk pilot, at **0830:18**, advised “*I’m orbiting at Grateley until the others are on final, just to avoid any confusion*” (Figure 7).

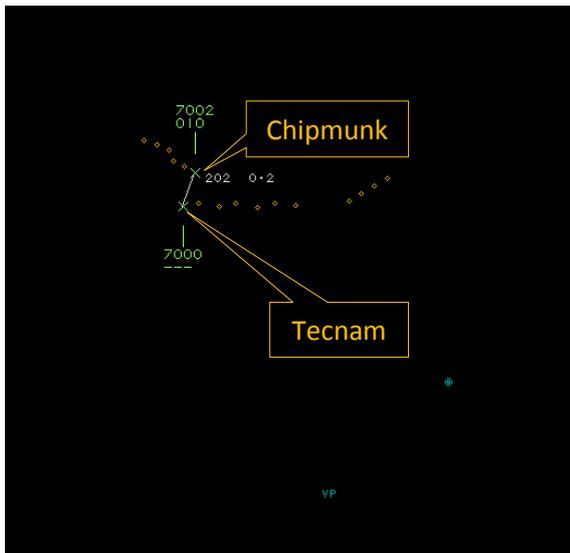
The Tecnam can be seen on the radar recording to pass ahead and within 0.2nm of the Chipmunk at **0830:35**, but it’s altitude could not be determined and neither pilot mentioned seeing the other (Figure 8).

Figure 8 - 0830:35 (landing PA28 disappeared from radar replay)

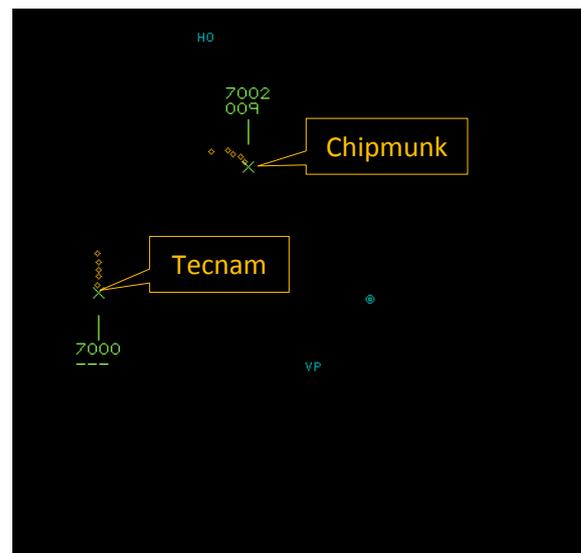
Figure 9 - 0831:58

At **0831:58**, the controller again requested the position of the Tecnam, whose pilot replied “*is turning onto finals*”. The controller instructed the pilot to continue their approach. On the radar replay, the Tecnam appears to be on left-base for RW08 (Figure 9).

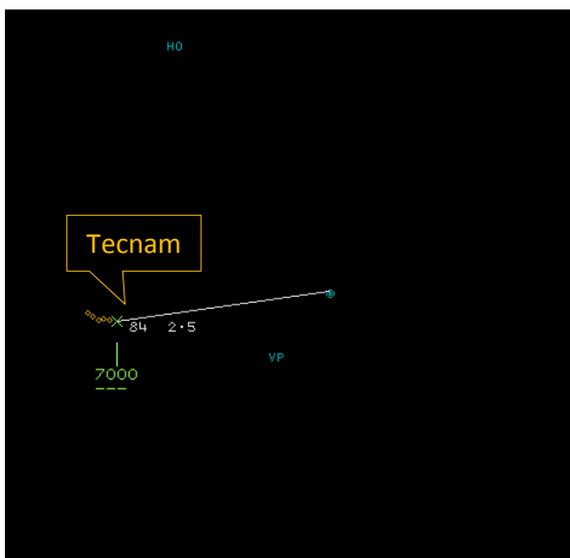
At **0832:08** (Figure 10), the controller asked the pilot of the previously landed PA28 to confirm that they had vacated the runway, which the pilot confirmed. The controller then advised the Tecnam pilot to “(c/s) RW17 land at your discretion”, which was read-back by the pilot but omitting the RW designator.

Figure 10 - 0832:36 (Chipmunk disappeared from radar replay)

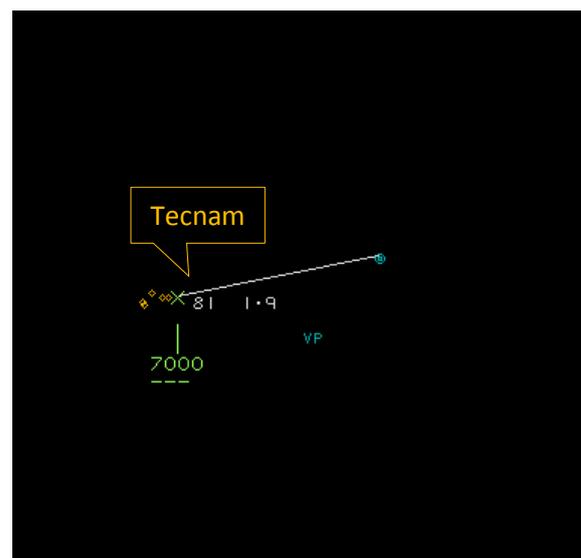
Figure 11 - 0833:17

At **0833:17**, the controller requested the Tecnam pilot to report their position. The pilot replied “final for landing”. The controller asked “confirm you’re on final for RW17?” the pilot replied “er final for 17” (Figure 11).

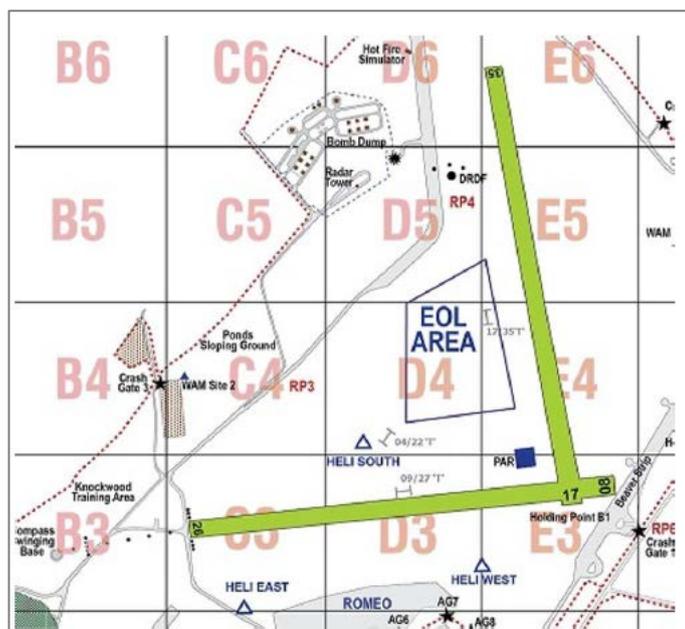
Figure 12

An investigation report was completed by Middle Wallop. It reported that an organised fly-in had been arranged with [another local airfield]. It confirmed that a briefing pack had been made available to the pilots. It included the graphic below, (Figure 12), which is wrongly orientated [south-up], with no compass rose or directional indicator, and may have added to the Tecnam pilot’s confusion and hence explain why they flew through the RW17 final approach and on into the circuit for RW08.

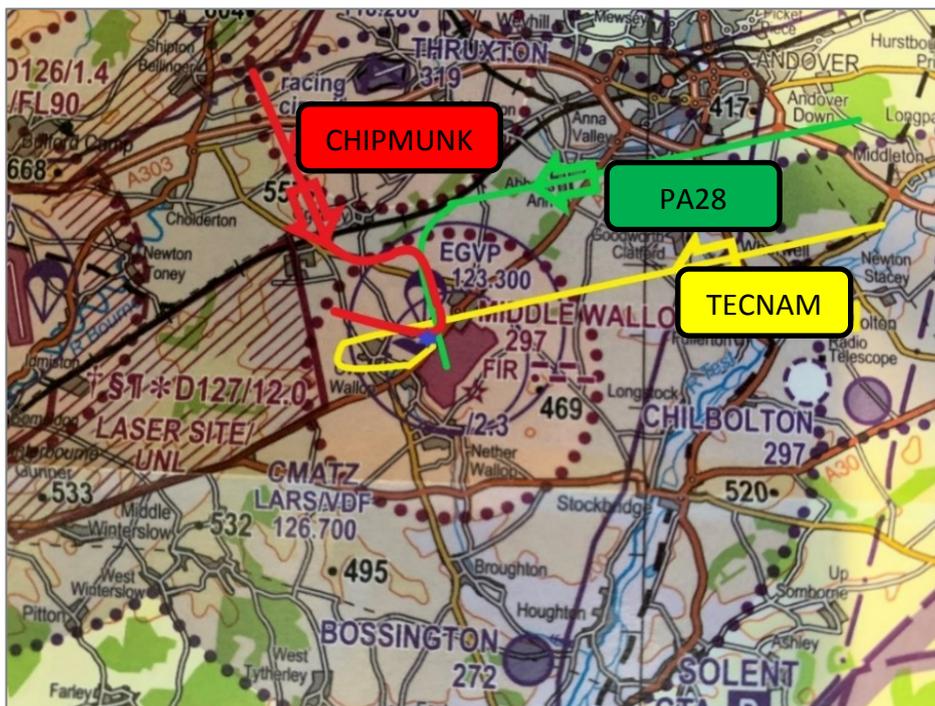
Figure 13

A representative diagram of the relevant arrival routes is as below in Figure 13, although the actual final approach positions were outside of radar coverage and are placed based on the incident reports:

The pilot of the Tecnam positioned his aircraft on final for the closed RW08 instead of RW17; it is possible that he was using a briefing pack not designed for navigational purposes to help with his positioning. The charts should have been marked accordingly with 'Not to be used for Navigational Purposes'.

It is recommended that, if airfield layout maps are placed within a briefing pack, they should contain a clear statement of 'Do not use for navigational purposes' unless they are specifically sourced and approved charts. It is also recommended that, for a fly-in event such as this, company callsigns should not be used. All arrivals had been booked-in with aircraft registrations and this caused a significant increase in workload for the ATCO and, possibly, the pilot might not have been focussing on the callsign if they were expecting the company callsign to be used. It is recommended that [the operating authority] be debriefed on this and consider this for future events.
