AIRPROX REPORT No 2019285

Date: 19 Sep 2019 Time: 1603Z Position: 5207N 00002E Location: 7nm SW Cambridge

PART A: SUMMARY OF INFORMATION REPORTED TO UKAB

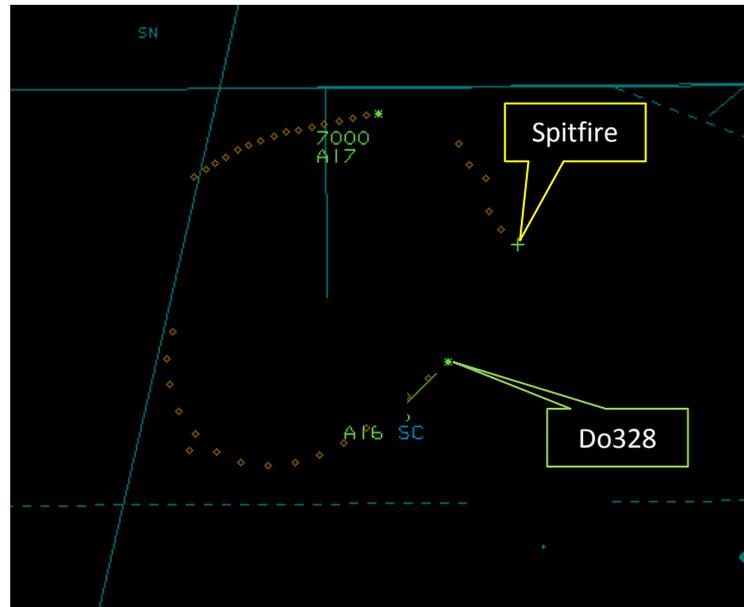
Figure 1: 1602:51 aircraft separated by 1.6nm

The Do328 pilot completes the Base-Leg turn as the Spitfire is crossing the extended centreline (Figure 1). The controller passes Traffic Information on the Spitfire to the Do328 pilot.

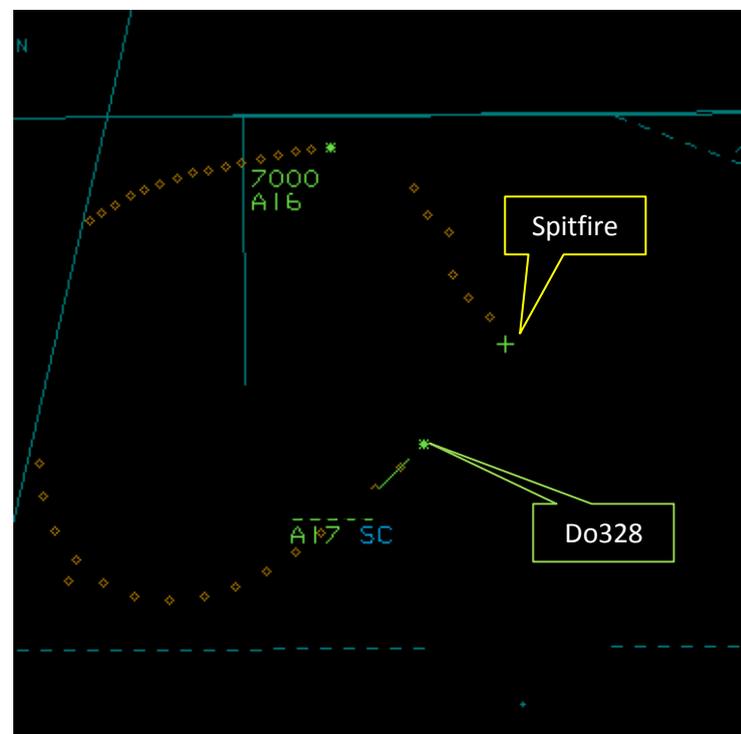
Figure 2: 1602:37 aircraft separated by 1.2nm

The Spitfire pilot flies through the 12 o'clock of the Do328 (Figure 2).

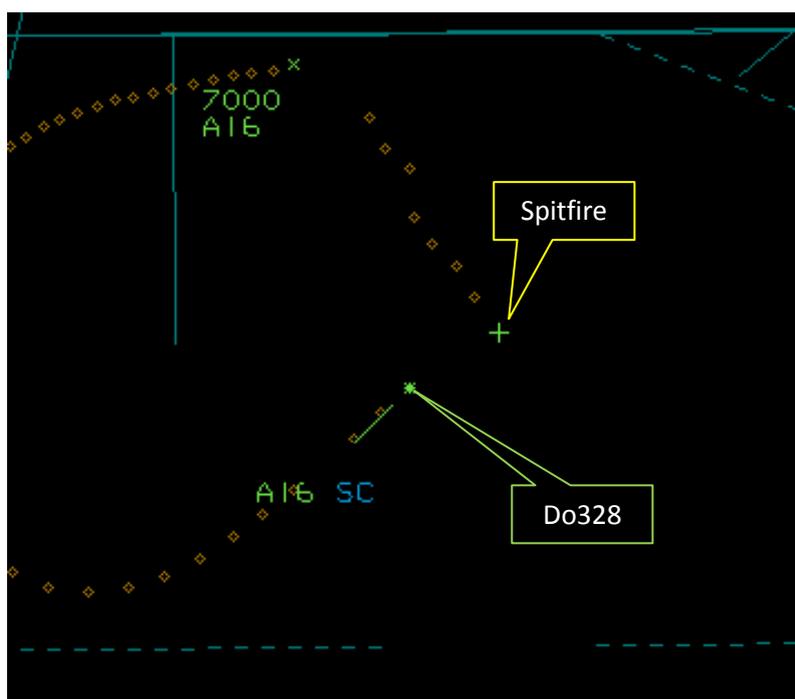
Figure 3: CPA 1603:03 aircraft separated by 0.8nm

At CPA the Spitfire has flown through the 12 o'clock of the Do328 (Figure 3). The Spitfire does not display any Transponder information prior to or after CPA.

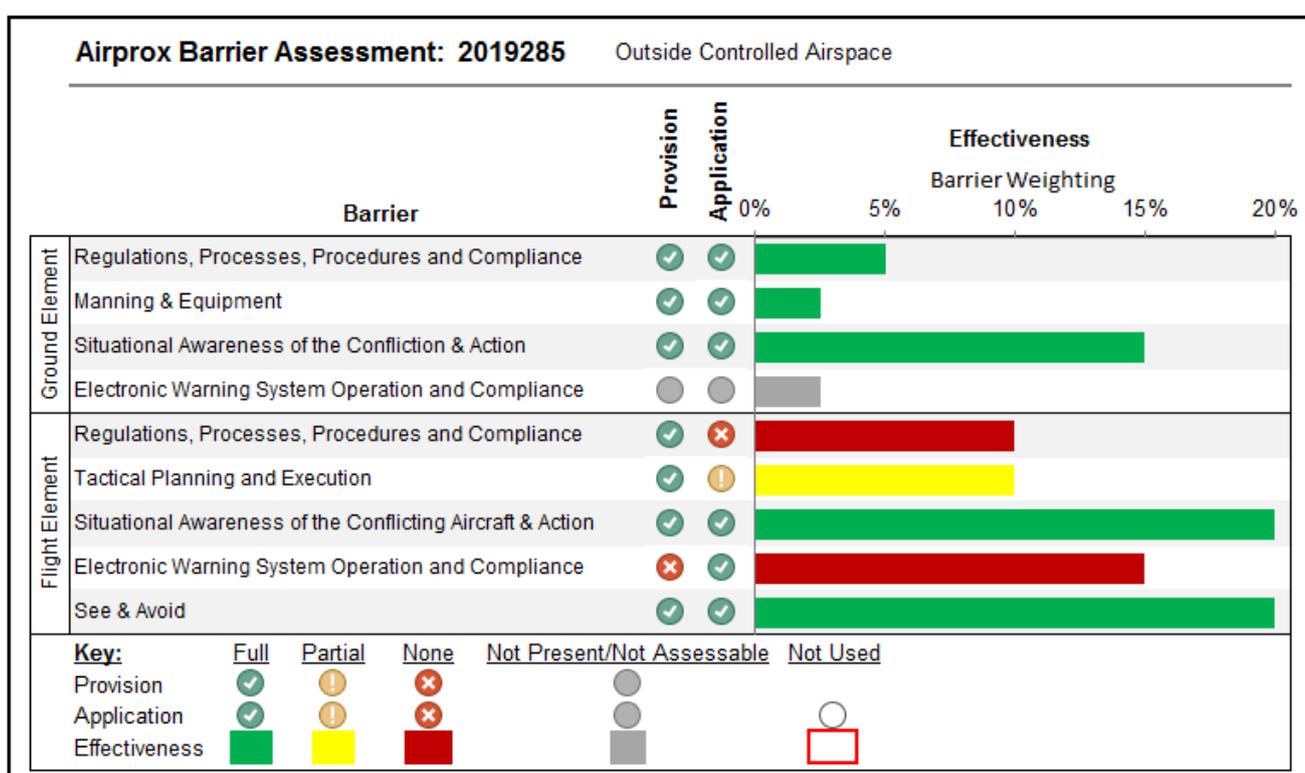
Regulations, Processes, Procedures and Compliance were assessed as **ineffective** because the Spitfire pilot was not transponding in accordance with EU Regulation SERA.13001.

Tactical Planning and Execution was assessed as **partially effective** because pilots are strongly advised to contact the aerodrome ATSU when transiting within 10nm of the IAP, which the Spitfire pilot did not do.

Electronic Warning System Operation and Compliance were assessed as **ineffective** because the Do328's TCAS II could not detect the non-transponding Spitfire.
