## AIRPROX REPORT No 2019290

Date: 21 Sep 2019 Time: 1217Z Position: 5150N 00058W Location: 1.5nm south of Westcott NDB

### PART A: SUMMARY OF INFORMATION REPORTED TO UKAB

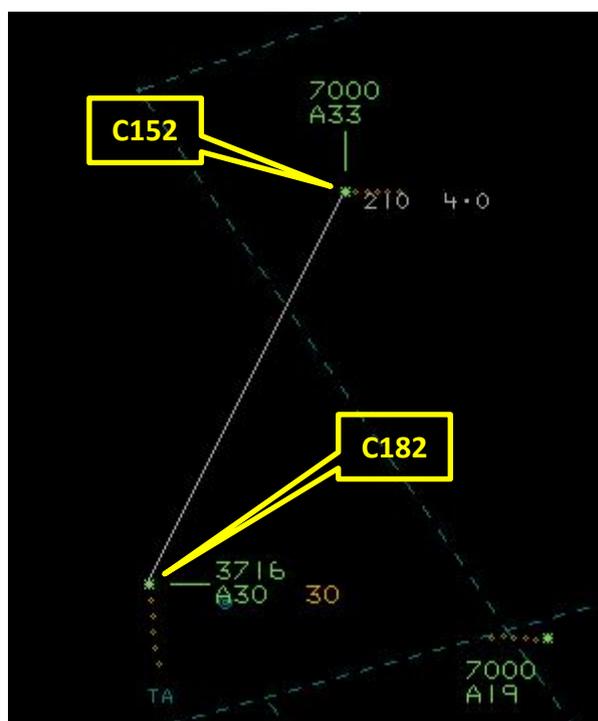
Figure 1 – 12:15:20

The NATS radar recording shows both aircraft operating in the vicinity of Westcott. At 12:15:20, the aircraft are separated laterally by 4nm and vertically by 300ft (see Figure 1).

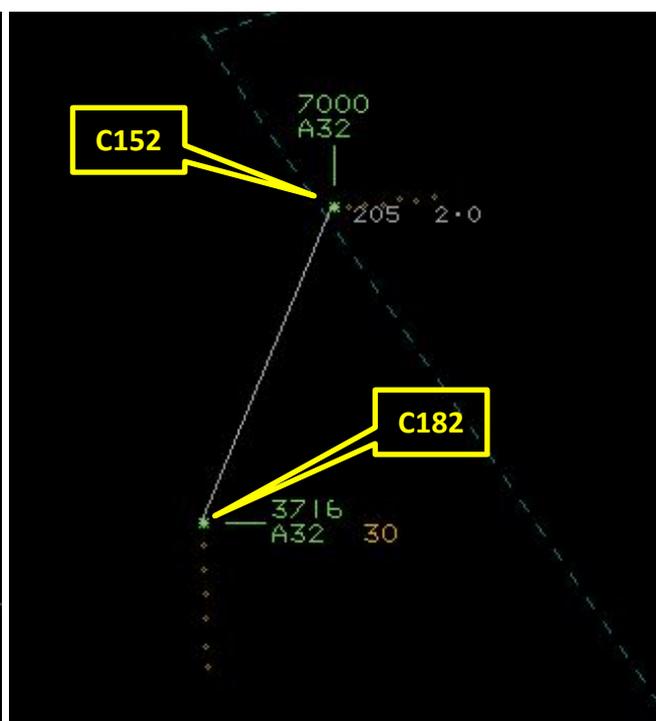
Figure 2 – 12:16:03

Over the next 40 secs, the C152 descends by an indicated 100ft and the C182 climbs by an indicated 200ft, leading to a separation, at 12:16:03, of 2nm laterally with no vertical separation (Figure 2).

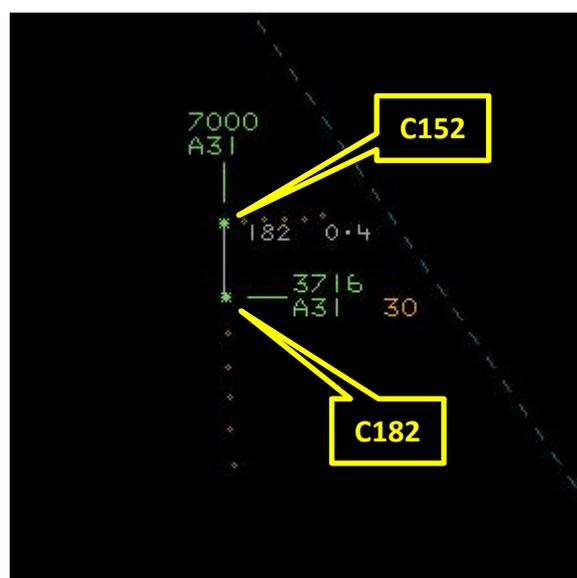
Figure 3 – 12:16:39

The 2 aircraft continue on their respective tracks, on a constant relative bearing to each other (thus reducing the likelihood of visual acquisition for both pilots as there would have been little-to-no relative movement) and both descending by an indicated 100ft; the C152 passes in front of the C182, co-altitude, at a range of 0.4nm at 12:16:39 (Figure 3).

CPA occurs some 5 secs later as the C182 passes behind the C152 at a range of 0.2nm as measured on the NATS radar.

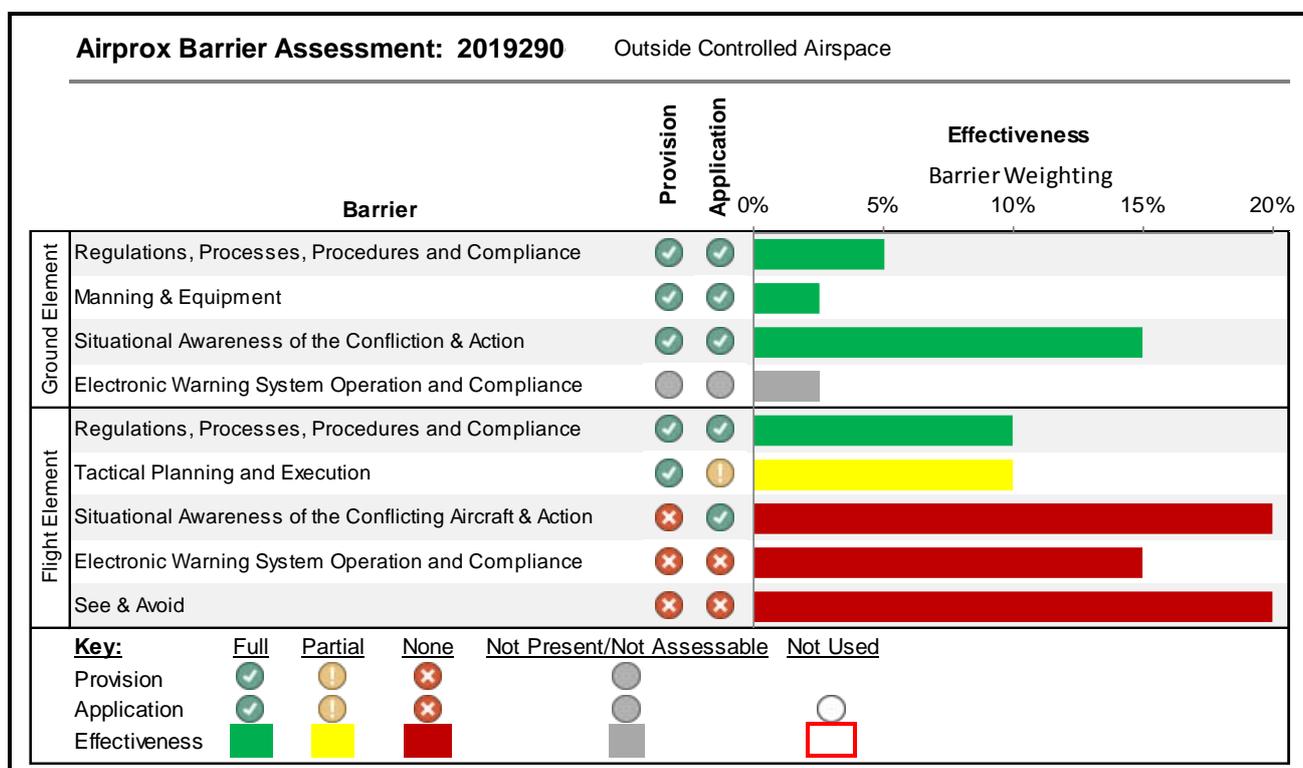
In assessing the effectiveness of the safety barriers associated with this incident, the Board concluded that the key factors had been that:

**Tactical Planning and Execution** was assessed as **partially effective** because both pilots could have requested a surveillance-based Air Traffic Service form their respective controllers.

**Situational Awareness of the Conflicting Aircraft and Action** were assessed as **ineffective** because, notwithstanding the immediacy of the Traffic information passed to the pilot of the C152 on initial contact with Oxford radar, neither pilot received any prior warning of the other aircraft's presence.

**Electronic Warning System Operation and Compliance** were assessed as **ineffective** because the FLARM on the C152 did not detect the presence of the C182.

**See and Avoid** were assessed as **ineffective** because the C152 pilot did not see the C182 until it was already passing behind his aircraft, and the C182 pilot probably did not see the C152.
