AIRPROX REPORT No 2019291

Date: 02 Oct 2019 Time: 1414Z Position: 5053N 00037W Location: 6nm NW of Littlehampton

PART A: SUMMARY OF INFORMATION REPORTED TO UKAB

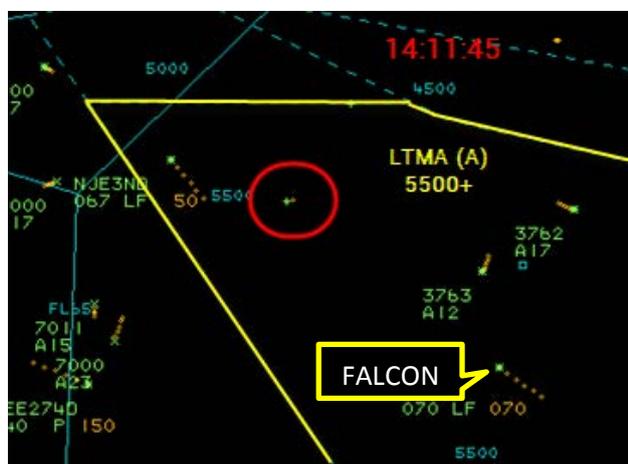
At 14:11:45, the WILLO controller instructed the pilot of the [Falcon C/S] to “*descend altitude five thousand feet, London QNH one-zero-two-zero.*” See Figure 1 for the relative positions of the aircraft and the airspace boundary with the base of Controlled Airspace of 5500ft highlighted in yellow. The primary return associated with the glider is circled in red.

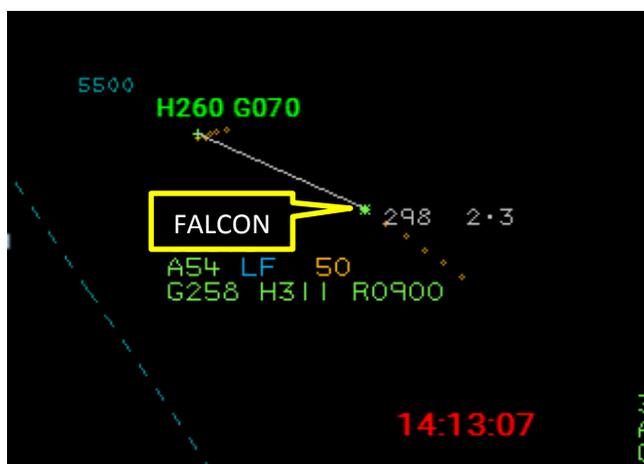
Figure 2

Coincident with this, deconfliction minima were eroded between the [Falcon C/S] and the glider, see Figure 2.

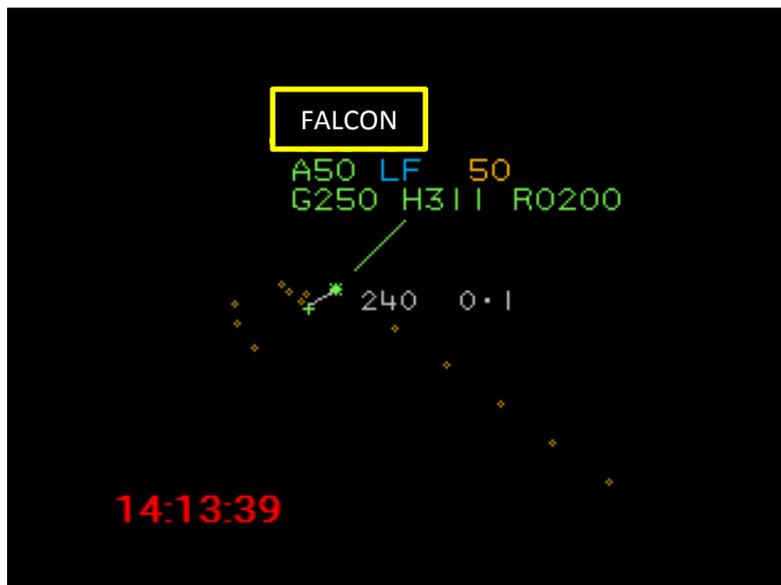
Figure 3

The Closest Point of Approach between the [Falcon C/S] and the glider occurred at 14:13:39 and was recorded on the LTCC Multi-Track Radar as 0.1nm and 200 feet (altitude was subsequent pilot estimate), see Figure 3.

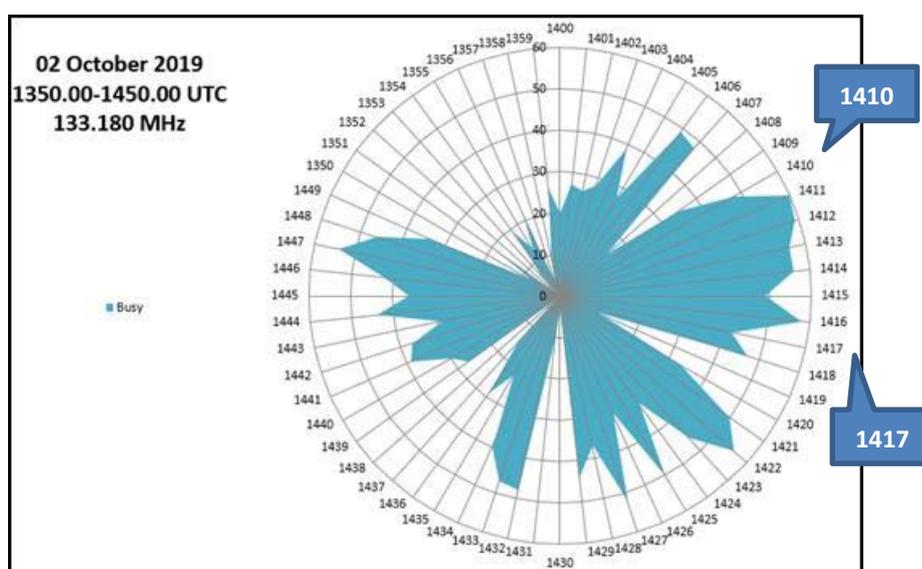
Figure 4

An R/T occupancy assessment was produced for the WILLO frequency as used throughout the event (Figure 4).⁴ This R/T diagram indicated a period of significant R/T loading between 14:10-14:17, corresponding with the WILLO controller’s narrative of the busy traffic period.

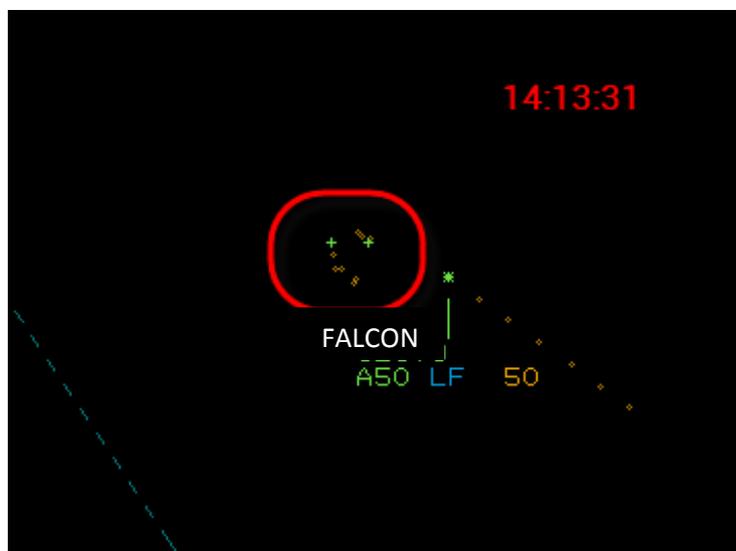
A sporadic primary radar return displayed approximately 5nm west of Shoreham airfield. This return was subsequently identified by the pilot of the [Falcon C/S] as a glider. At 14:13:19, the glider return was briefly displayed as two separate returns, see Figure 5 for the final update with two returns highlighted in red. There was only one glider reported by the pilot of the [Falcon C/S]. [UKAB note: subsequent analysis of the radar tracks indicates that there were 2 independent tracks – that of the LS8-18 heading north and an untraced glider heading south.]

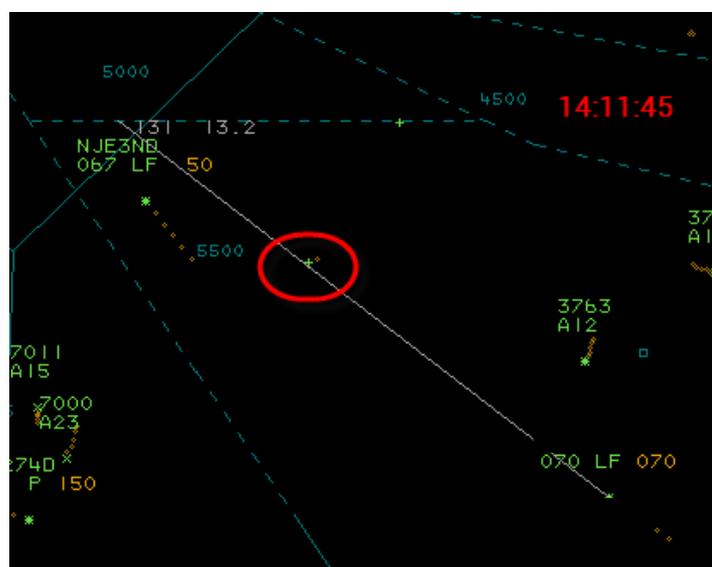
Figure 6

At 14:11:45, the controller instructed the pilot of the [Falcon C/S] to “descend altitude five thousand feet, London QNH one-zero-two-zero.” see Figure 6.

At the issuance of this descent clearance, the aircraft was 13.2nm from the boundary of Controlled Airspace where the base was 5000ft.

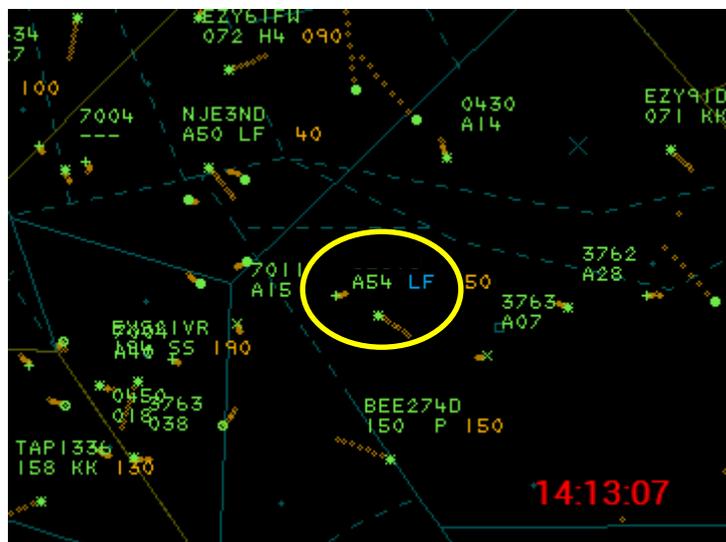
As the [Falcon C/S] vacated Controlled Airspace at 14:13:07, the outside Controlled Airspace Tool (oCAT) activated. oCAT displayed as a blue indication on the route field of the Track Data Block (TDB) of the [Falcon C/S], see Figure 7 for portion of WILLO slave radar replay. The WILLO controller reported that they did not see the oCAT alert on the radar display.
