AIRPROX REPORT No 2019294

Date: 09 Oct 2019 Time: 1244Z Position: 5141N 00220W Location: 1.3nm west Nympsfield

PART A: SUMMARY OF INFORMATION REPORTED TO UKAB

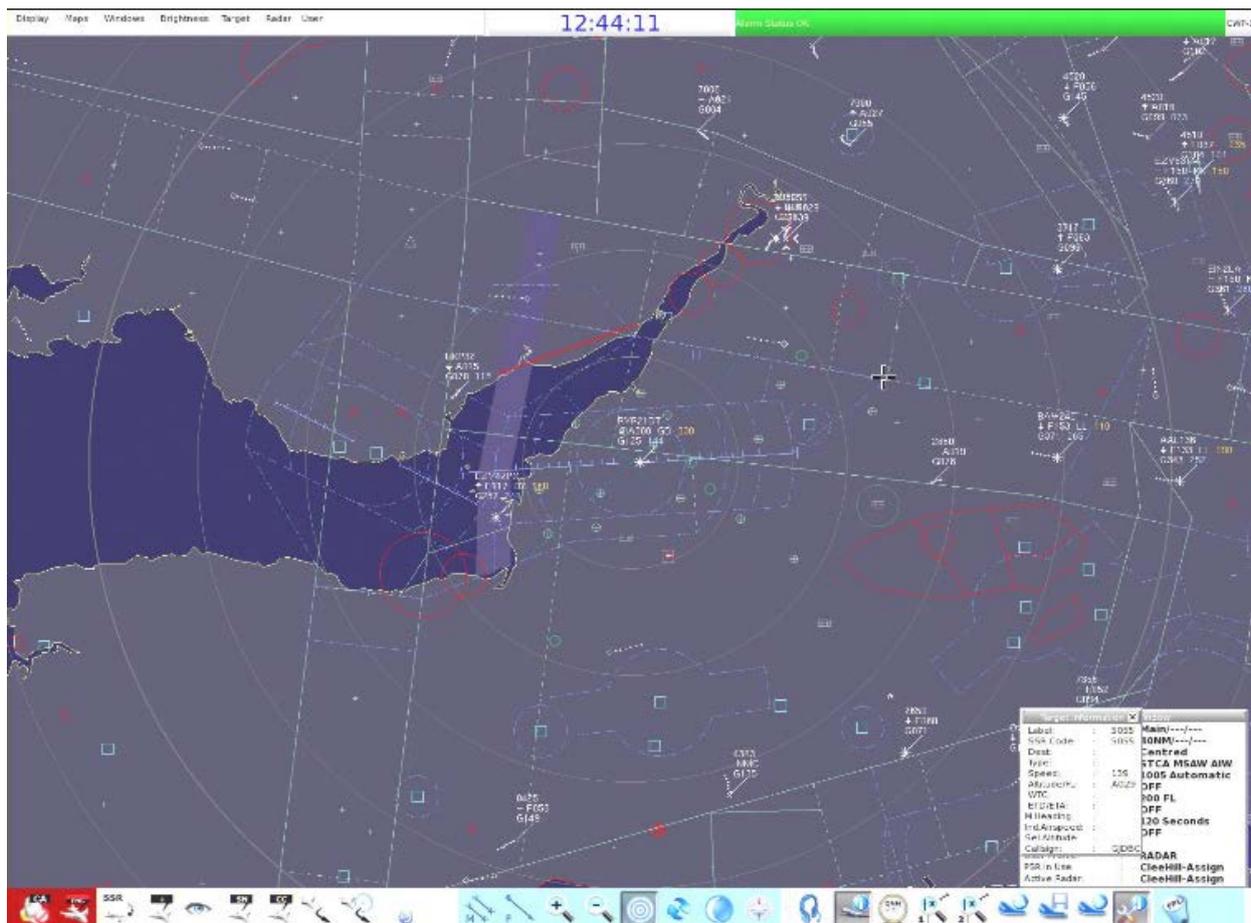
Figure 1: Normal operating range

1244.15 - #5050 squawk and [PA34 C/S] data blocks merge. A single primary cross appears 1.5nm SW of gliding site Nymphsfield 2.09nm SSE of [PA34 C/S] (Figures 1 and 2.)

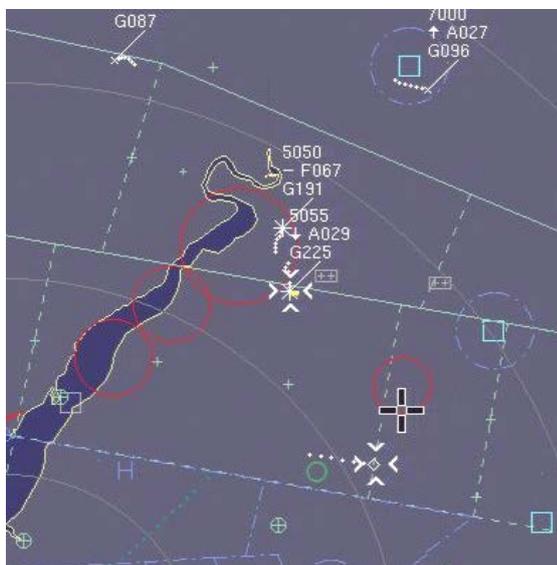
Figure 3

1244.40- The Primary return is moving slowly but it has a small yellow trail. It is inside the target highlighter tool. It appears to merge with the southbound [PA34 C/S], who is informed now that he is under a Traffic Service. No reduction in service level is passed. [PA34 C/S]'s level is 2900ft. (Figure 3)

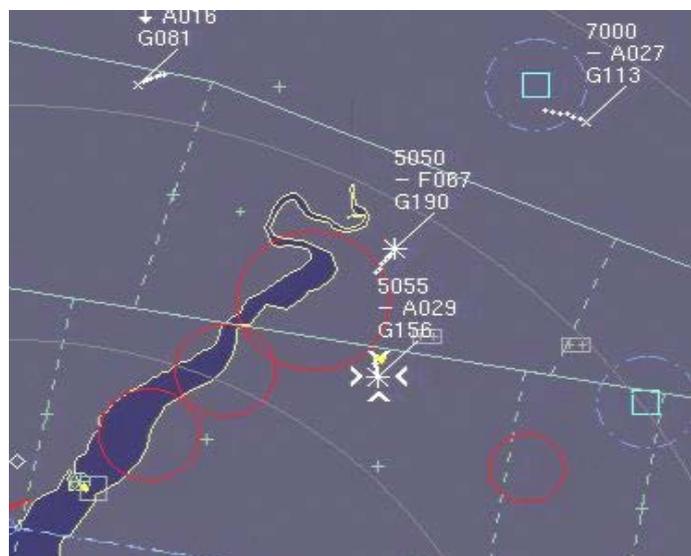
Figure 4

1245.13- Bristol Radar is in a dialogue with another aircraft to the north regarding reducing service level and changing squawk. [PA34 C/S] is now past the cross and primary trail which is still overlaid by the highlighter tool. (Figure 4)

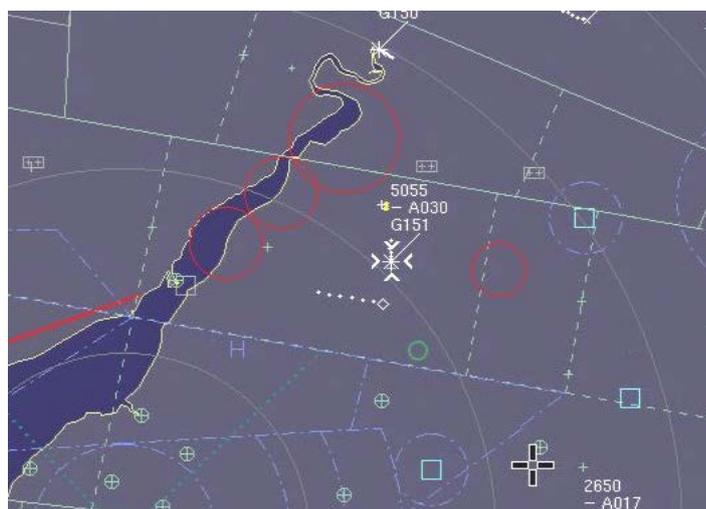
Figure 5

1246.33 - The unknown primary return is seen amongst the data block characters. (Figure 5)

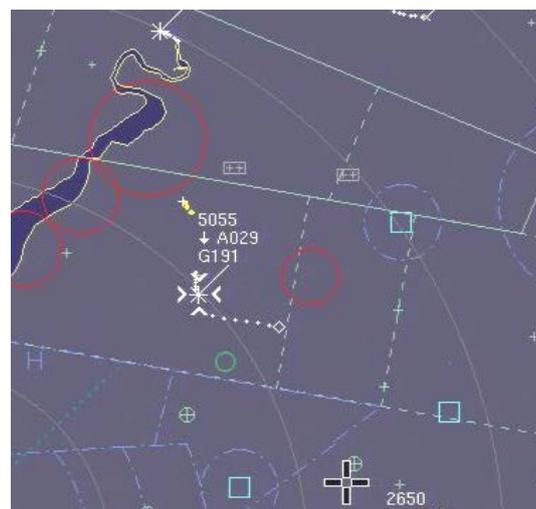
Figure 6

1247.15 – the unknown primary return is clear of data block. (Figure 6)
