AIRPROX REPORT No 2019296

Date: 03 Oct 2019 Time: 1027Z Position: 5802N 00247W Location: 27nm NE of Lossiemouth

PART A: SUMMARY OF INFORMATION REPORTED TO UKAB

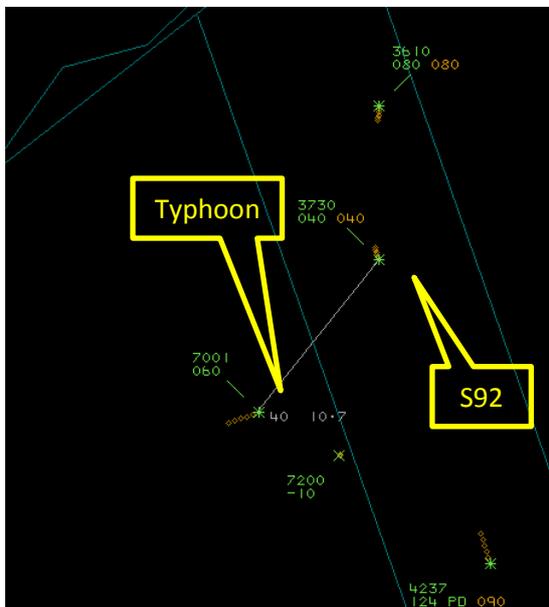
Figure 1 – 1st Traffic Information to the S92

Figures 1-4 show the positions of the S92 and Typhoons at relevant times in the lead-up to, and during, the Airprox. The Lossiemouth Approach Controller passed Traffic Information to the S92 on the Typhoons for the first time at a range of 10nm. At this point there was still 2000ft vertical separation between the aircraft.

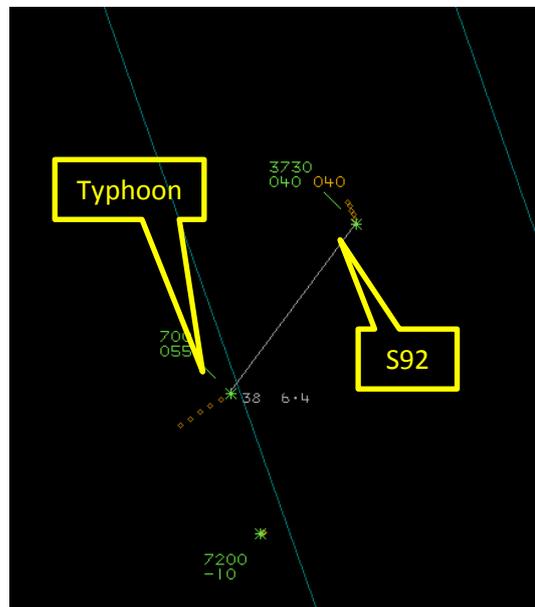
Figure 2 – Traffic Information to both aircraft

As the separation between the aircraft decreased, the Lossiemouth Approach Controller passed Traffic Information for a second time, and this was almost concurrent with the decision by [the aircraft carrier]’s SATCO to pass Traffic Information to the Typhoons. Separation at this point was 6.5nm and 1500ft.

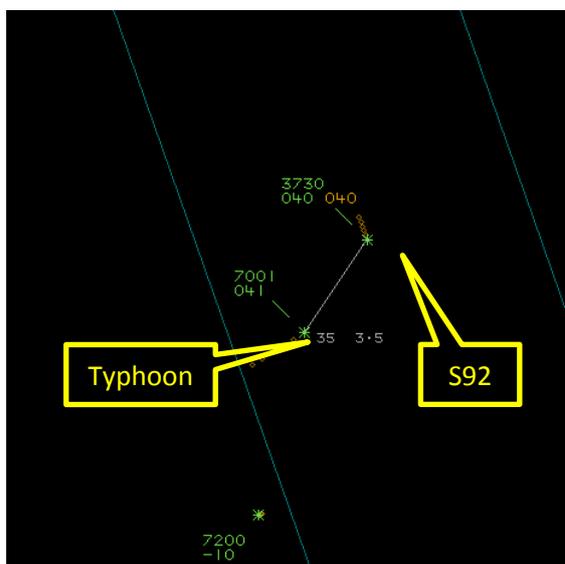
Figure 3 – Final Traffic Information

The Lossiemouth Approach Controller passed Traffic Information for a final time as the separation decreased to 3.5nm and 100ft. At the same time, the Typhoons reported visual with the S92 to the ACCO on [the aircraft carrier].

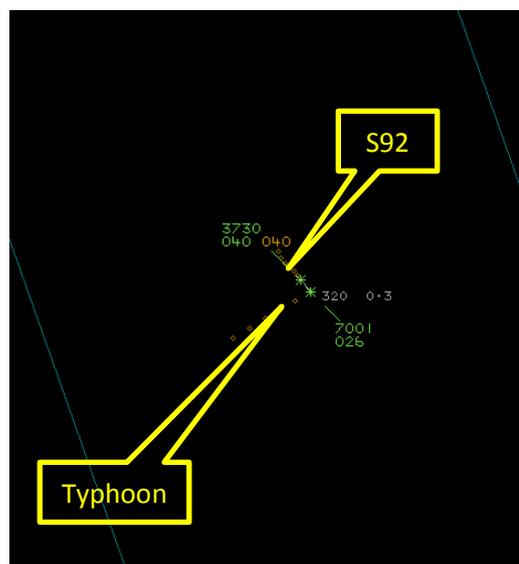
Figure 4 – CPA

CPA occurred some 30 secs after this final Traffic Information call, and was measured at 0.3nm and 1400ft.
