AIRPROX REPORT No 2019312

Date: 09 Nov 2019 Time: 1228Z Position: 5316N 00057W Location: Retford/Gamston ATZ

PART A: SUMMARY OF INFORMATION REPORTED TO UKAB

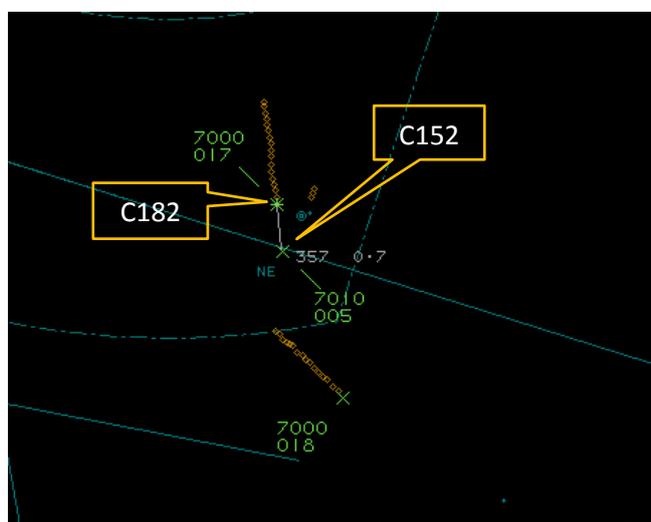
Figure 1

The following radar pictures are taken from NATS Ltd area replay and display aircraft altitude. The airfield elevation at Gamston is 87ft. At 1227:39 the C182 (Squawk 7000) joined through the overhead from the north. The C152 (Squawk 7010) has commenced its climb-out after a touch-and-go (Figure 1).

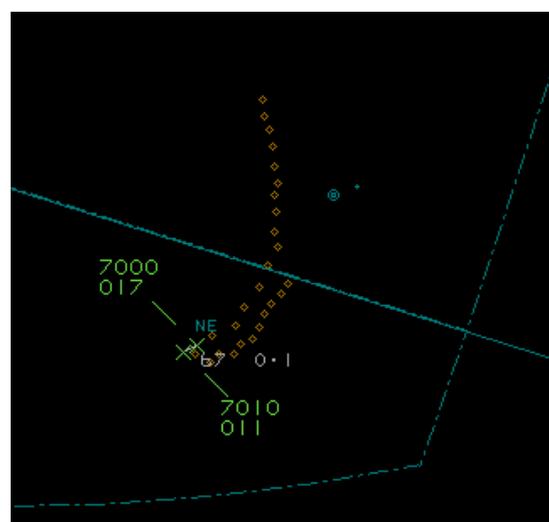
Figure 2

At 1228:24 both aircraft turned right onto the crosswind position (Figure 2).

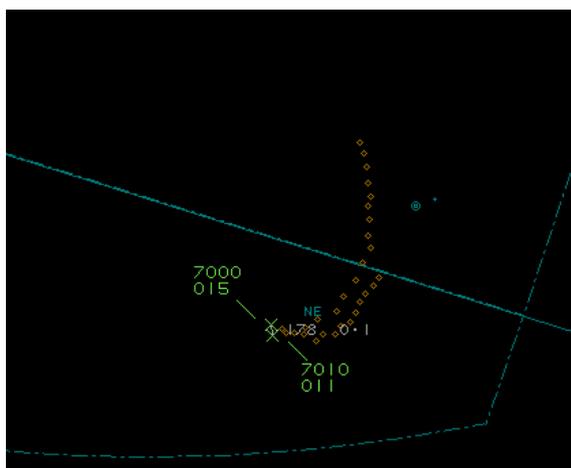
Figure 3

At 1228:32 the C182 descends into the visual circuit. The C152 has climbed to circuit altitude (Figure 3).

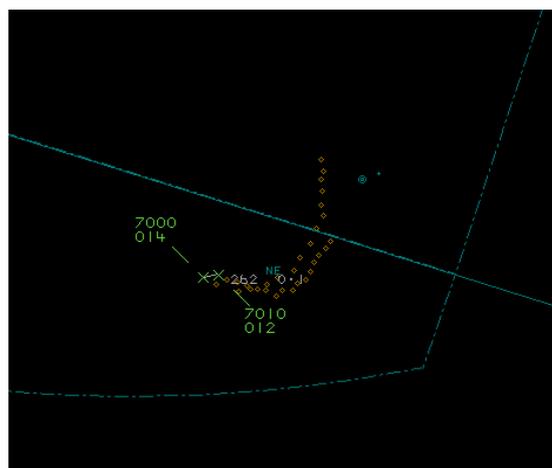
Figure 4

At 1228:41, CPA occurs (Figure 4). The aircraft are separated by 0.1NM laterally and 200ft vertically.

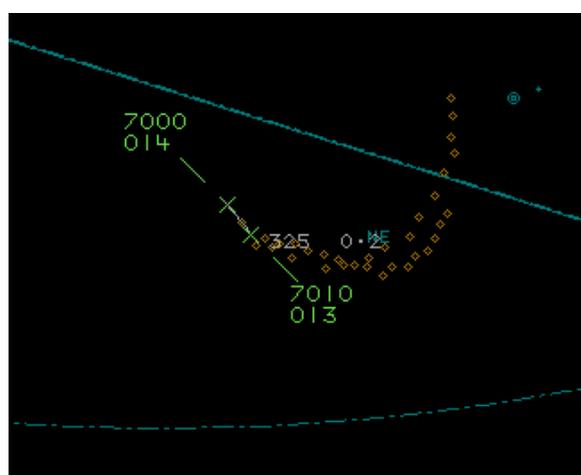
Figure 5

At 1228:52, aircraft separation increased as the C182 pilot opted to leave the circuit (Figure 5).
