**AIRPROX REPORT No 2019317**

Date: 17 Nov 2019 Time: 1100Z Position: 5150N 00215W Location: 4NM SW Gloucestershire Airport

**PART A: SUMMARY OF INFORMATION REPORTED TO UKAB**

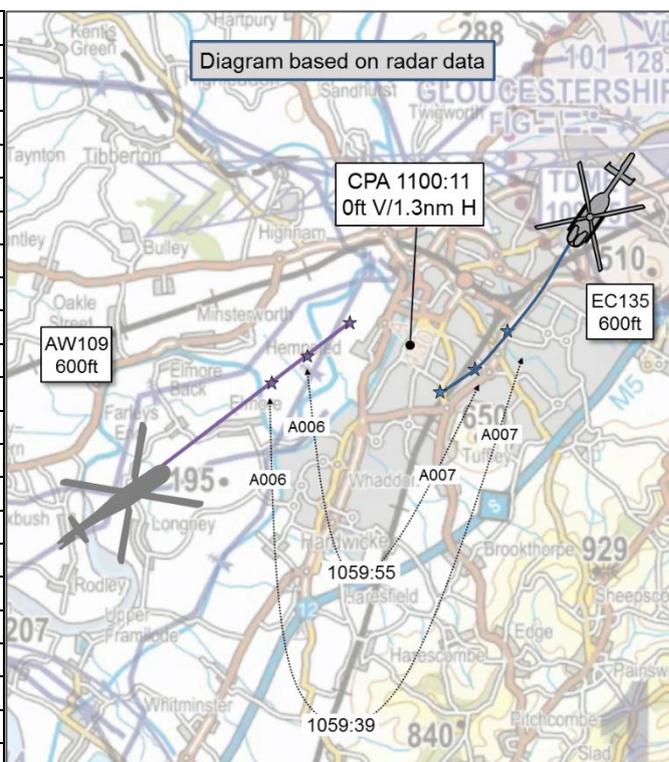
Recorded	Aircraft 1	Aircraft 2
Aircraft	EC135	AW109
Operator	NPAS	Civ Comm
Airspace	London FIR	London FIR
Class	G	G
Rules	VFR	VFR
Service	Basic	Basic
Provider	Gloster App	Gloster App
Altitude/FL	600ft	600ft
Transponder	A, C, S	A, C, S
<b>Reported</b>		
Colours	Blue, Yellow	White, Blue
Lighting	Strobes, HISL, Nav	'all lights on'
Conditions	VMC	VMC
Visibility	8km	5km
Altitude/FL	600ft	750ft
Altimeter	Rad Alt	QNH
Heading	226°	040°
Speed	110kt	130kt
ACAS/TAS	TCAS I	Unknown
Alert	TA	Unknown
<b>Separation</b>		
Reported	100ft V/NK H	Not Seen
Recorded	0ft V/1.3NM H

on radar, the pilot reported breaking left due to TCAS. A second reciprocal track was then seen about 1NM NW of the EC135's track. The pilot phoned later to report filing an Airprox.
