AIRPROX REPORT No 2019322

Date: 27 Nov 2019 Time: 1355Z Position: 5314N 00424W Location: Mona

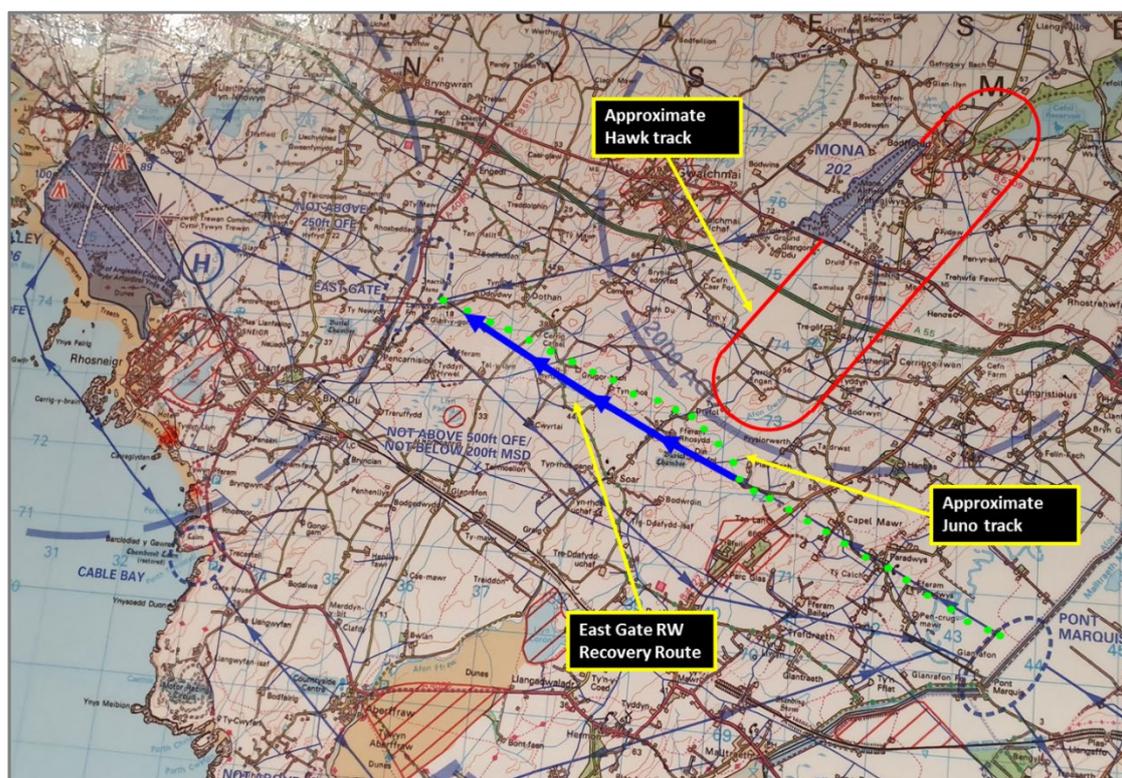
Figure 1

13:54:40 – To avoid a farm situated directly on the East Gate RW recovery route and approximately 1NM on the extended centreline of Mona RW04RH, the Juno instructor instructed his student to turn right and head towards the left-hand edge of a solar farm. This would take them approximately 400m

to the north of the published route and clear of the farm, whilst remaining just outside the Mona ATZ (see Figure 1).

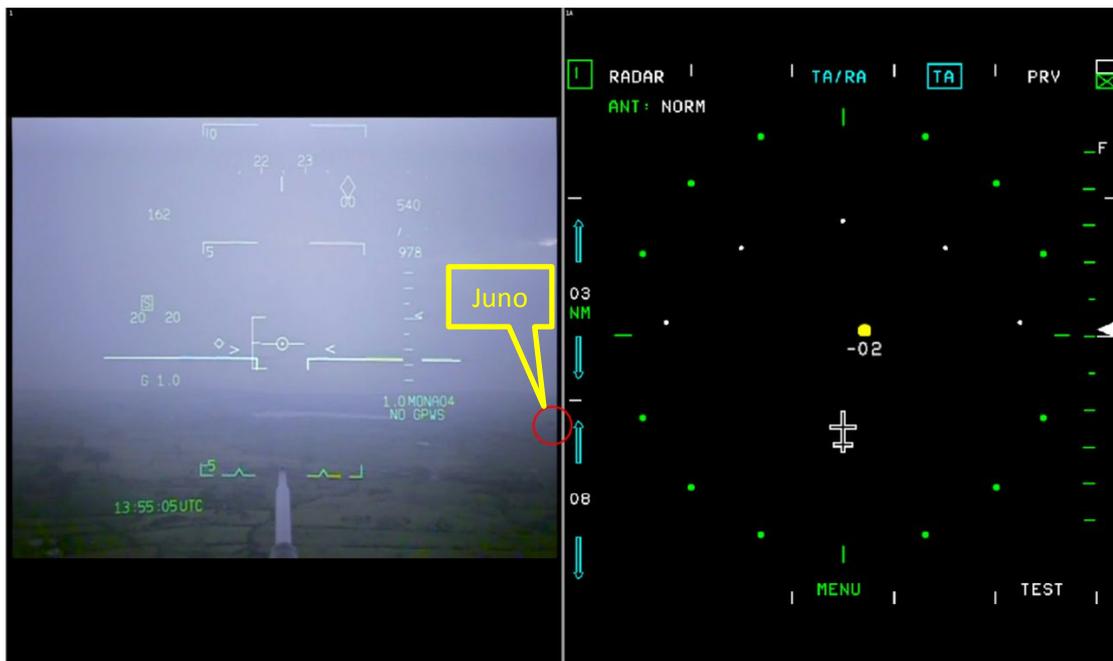
Figure 2

13:54:58 – Approaching the end of the downwind leg, the Hawk T2 TCAS gave an audio alert for the contact, which was now displayed on the nose within 2NM and 200ft below. The Hawk pilot announced "Looking not visual" (see Figure 2).
