AIRPROX REPORT No 2019329

Date: 05 Dec 2019 Time: 1428Z Position: 5757N 00103W Location: 50NM NE Aberdeen

PART A: SUMMARY OF INFORMATION REPORTED TO UKAB

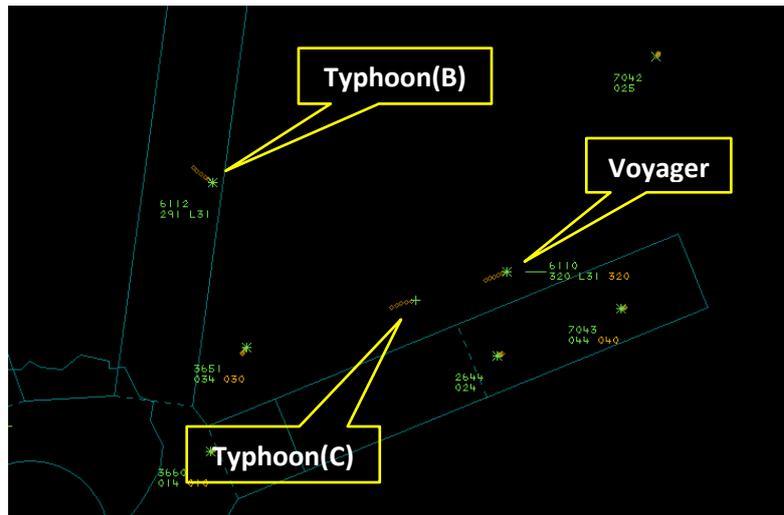
Figure 1 – Typhoon(B) at FL290

In preparation for the join with the tanker, Typhoon(B) was descended to FL290. At this point, the Typhoon(C) pilot had already been transferred to the boom frequency and was under the control of the tanker. Typhoon(A) formation was not yet on frequency.

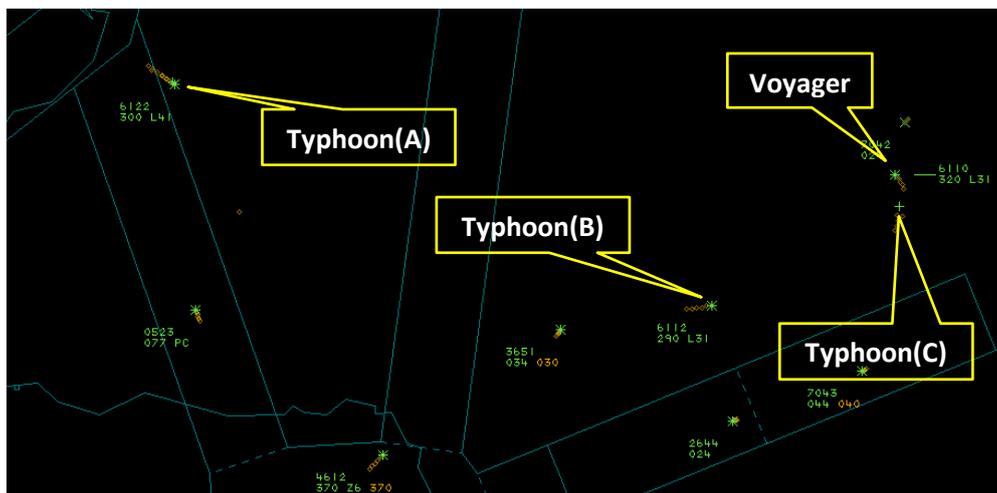
Figure 2 – Typhoon(A) formation on handover

The Typhoon(A) pilot was handed over to Swanwick(Mil) at FL300, was passed the appropriate tanker joining instructions and was issued a descent to FL280 in order to build in separation with Typhoon(B).

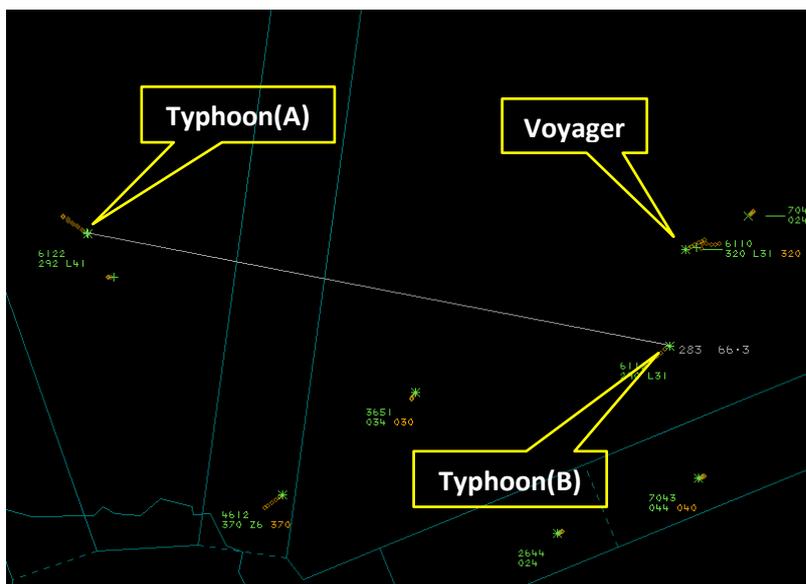
Figure 3 – Typhoon(B) pilot transferred to boom frequency

Some 2min later, at 1243:25, the Typhoon(B) pilot requested a change to the boom frequency, which was approved by the Swanwick(Mil) controller. Typhoon(B) was still at FL290 and separation between the incident aircraft was in excess of 65NM.

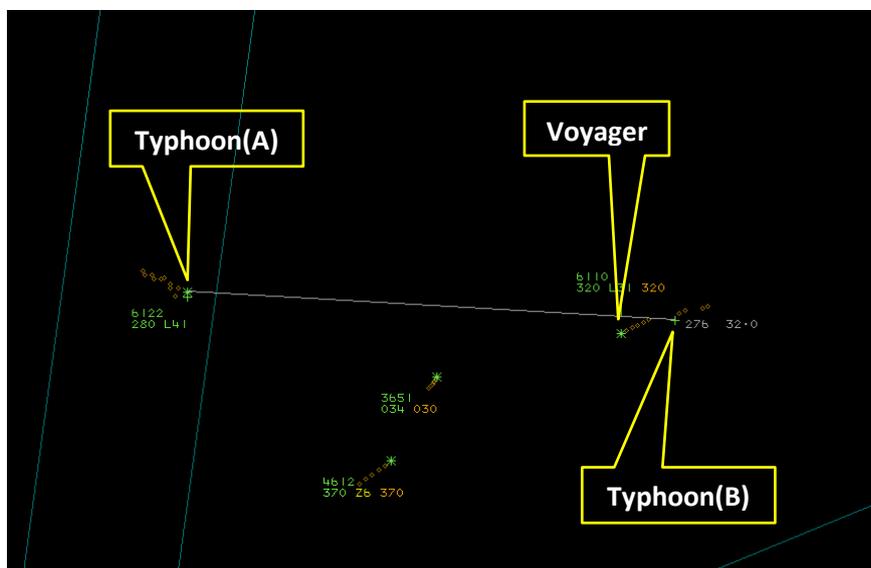
Figure 4 – FL310 reported clear

At 1246:03, the Voyager pilot reported to Swanwick(Mil) that FL310 was clear. This call came approximately 3min after the Typhoon(B) pilot was transferred to the boom frequency and the Swanwick(Mil) controller believed that Typhoon(B) had now climbed to FL320. The unit investigation found that this ‘flight level clear’ call from the tanker was late and related to Typhoon(C), which was now refuelling. Because aircraft are instructed to squawk standby as part of the refuelling process (to avoid TCAS alerts), there was no visual clue for the controller to alert them that Typhoon(B) had not climbed and, as a result, issued a clearance to Typhoon(A) to climb to FL310. Separation at this point had decreased to 32NM.

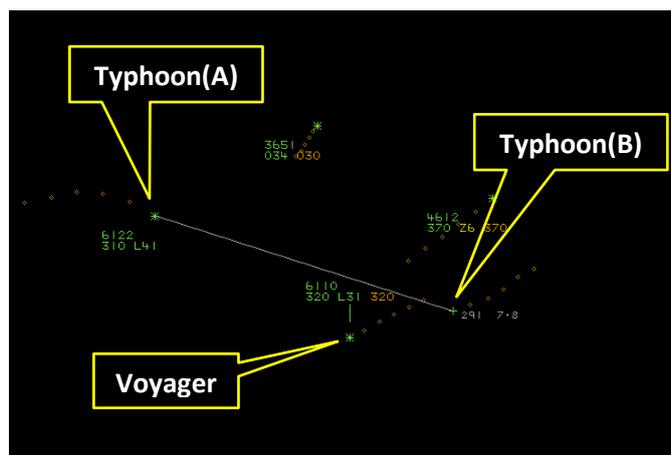
Figure 5

At 1247:28, the Typhoon(A) pilot reported visual with the tanker and was cleared to join by the Swanwick(Mil) controller, who still believed that the joining level of FL310 was clear. Separation at this point was 7.8NM.

Typhoon(A) transferred to boom frequency at FL310

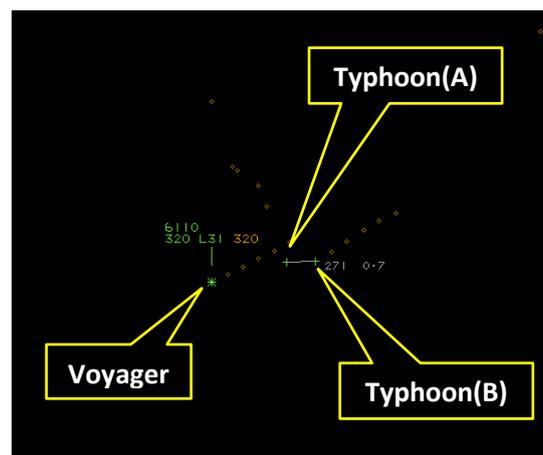
Figure 6 – CPA

Believing that there was no traffic ahead of them, the Typhoon(A) formation turned towards the tanker to effect the join and, in doing so, cut across the flightpath of Typhoon(B) which had not yet joined. For his part, the Typhoon(B) pilot realised that the Typhoon(A) formation was joining from ahead and to the right, and gained visual contact with the pair. The Typhoon(B) pilot selected idle

and initiated a weave to increase separation. CPA occurred at 1248:09 and was measured at 0.7NM.

CPA was measured by Military ATM as occurring at 1248:09 with a lateral separation of 0.7NM. Using the same radar sources, the UKAB Secretariat measured CPA at 1248:22 with a lateral separation of 0.2NM. Due to the close proximity of all aircraft involved, and the distance from the radar head, the radar picture was unstable and suffered from significant jitter. Of note, the transponder of Typhoon(B) is seen to be set to standby at a range of 7.5NM from the tanker.
