AIRPROX REPORT No 2019335

Date: 30 Dec 2019 Time: 1552Z Position: 5139N 00037W Location: 1NM SW Amersham

PART A: SUMMARY OF INFORMATION REPORTED TO UKAB

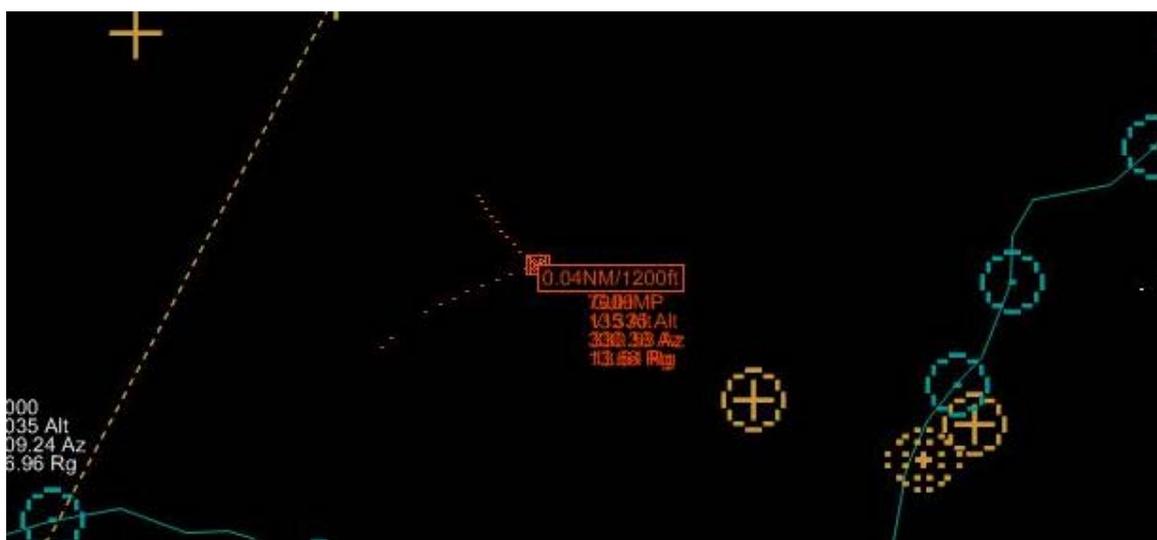
Figure 1: CPA occurred at 1552:04³

The controller noticed the confliction and transmitted to the TB20 pilot at 1551:49 "[TB20 c/s] Traffic on your left". At 1552:00 the TB20 pilot replied "[TB20 c/s] Visual with traffic".

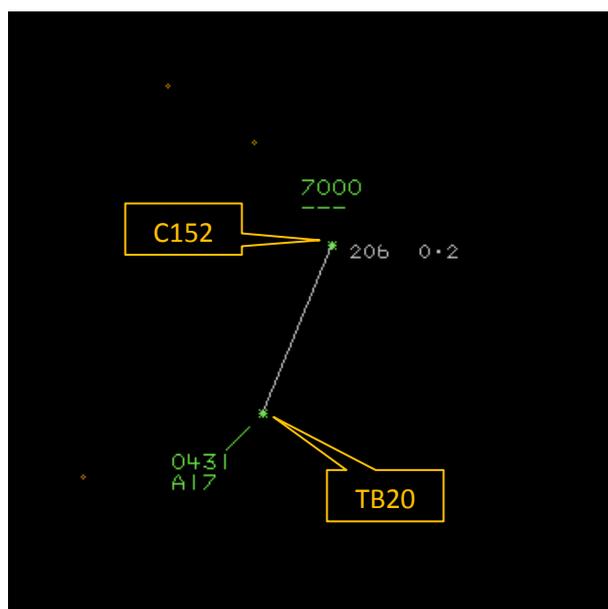
Figure 3: 15:52.00

At 15:52.00 the Farnborough LARS West controller passed the following warning to the TB20 pilot: “[TB20 c/s] traffic on your left”. The pilot responded: “[TB20 c/s] visual with traffic”. The controller responded with “[TB20 c/s] with that traffic in sight squawk 7000 and freecall Denham Radio”.

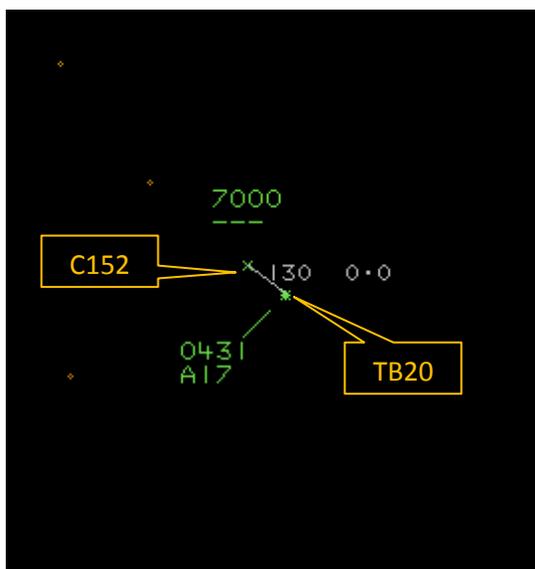
Figure 4: 15:52.03 CPA

CPA occurred at 1552:03 (Figure 4) with the radar indicating 0.0NM lateral separation. The reported vertical separation being 500ft, the vertical separation has been assessed from the C152 pilot reporting that they were at altitude 2200ft at the time.
