AIRPROX REPORT No 2020008

Date: 19 Jan 2020 Time: 1411Z Position: 5229N 00145W Location: Bexhill-on-Sea, Sussex

PART A: SUMMARY OF INFORMATION REPORTED TO UKAB

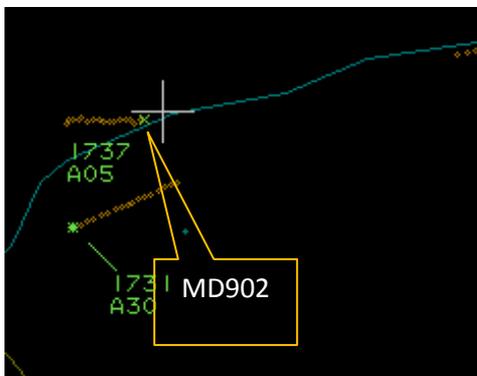
Figure 1: 1336:36

The NATS radar indicates that the MD902 flew within the vicinity of the kites twice, firstly, at 1336z, (see Figures 1 and 2), when the profile matched that described by the kite operator. The centre of the NOTAM is marked by the white cross. Figure 3 shows the MD902 at around 1410z, just before he reported the incident to the Farnborough controller.
