AIRPROX REPORT No 2020025

Date: 02 Mar 2020 Time: 1650Z Position: 5056N 00046W Location: South Downs

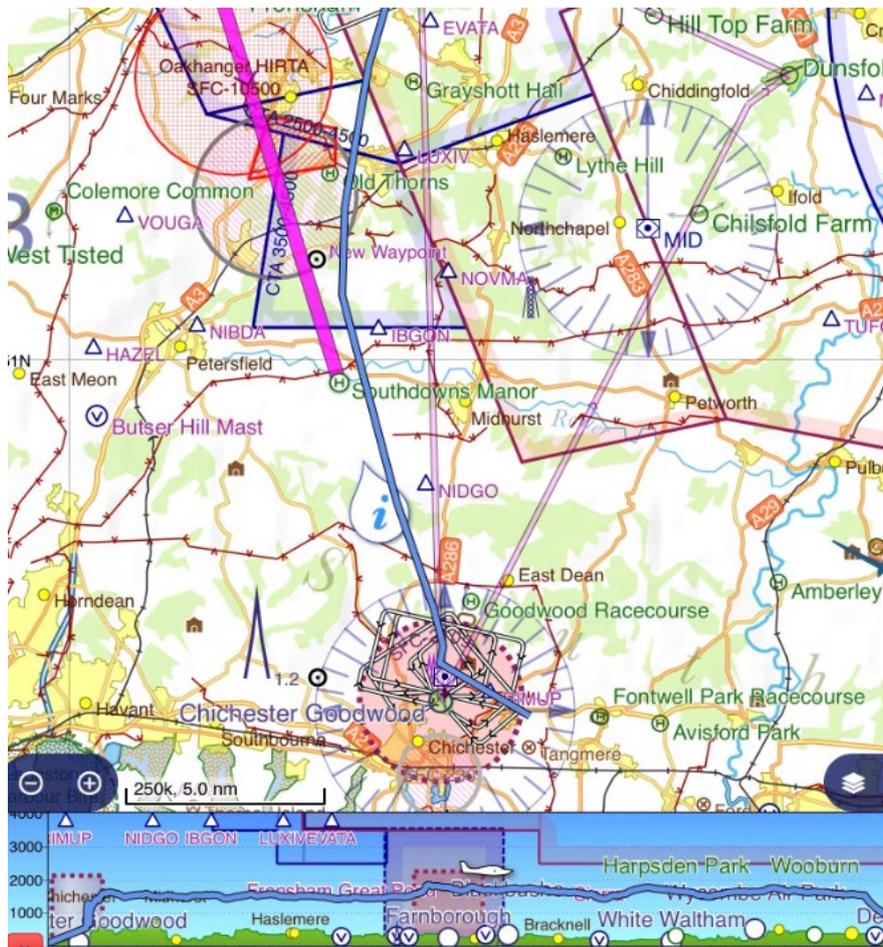
Figure 1

THE AS350 PILOT reports that they were in the cruise with both pilots looking out, flying between 1500-1700ft QNH to avoid the common altitudes. They saw a Chinook in the 11 o'clock position, low-level, flying on an easterly direction along the ridge line of the northern edge of the South Downs. The PF commented to the PM on the excellent camouflage against the forest back drop and that it was perhaps not a good place to be as that area is popular with hang-gliders and microlights. However, they did not perceive there to be a conflict, they observed the Chinook pass ahead from the 11 o'clock to the 1 o'clock approximately 1000ft below. The pilot provided a screenshot of his SkyDemon route, see Figure 1. A further screenshot provided (Figure 2) indicated the height of the AS350 at 1532ft, 2min and 29sec after take-off (which had been at 1647Z), at the point they assessed they passed overhead the Chinook.

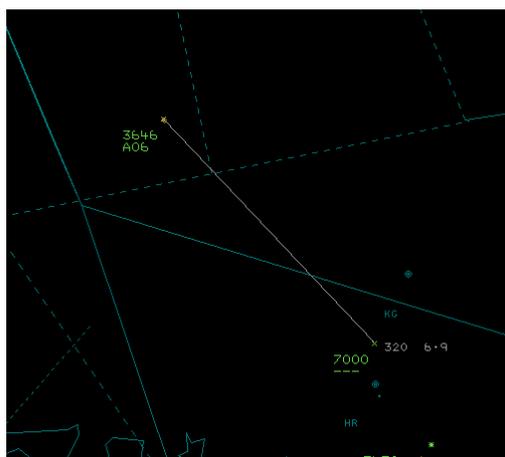
The following radar screenshots are taken from NATS sources and are therefore not representative of the picture available to the Odiham Approach Controller at the time of the incident. The AS350 first showed on radar at 1647:39 separation at this point was approximately 7NM (Figure 1).

Figure 3: AS350 appears on radar

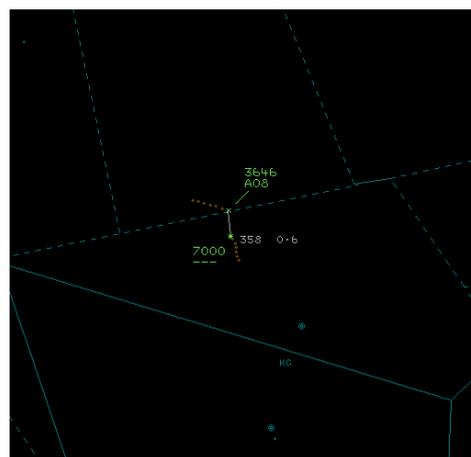
Figure 4: AS350 turn

At 1650:14, shortly prior to the CPA, the AS350 can be seen to start manoeuvring left and may be concurrent with the pilot's report about becoming visual with the Chinook. Separation at this point was 0.6NM. CPA occurred at 1650:20 and was measured at 0.5NM.

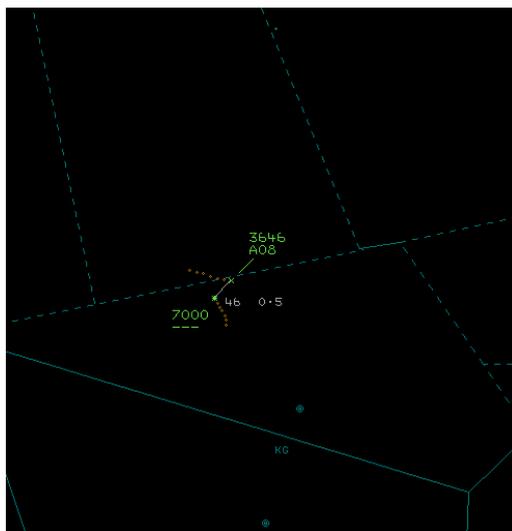
Figure 5: 1650:20 – CPA
