## AIRPROX REPORT No 2020050

Date: 04 Jun 2020 Time: 1010Z Position: 5126N 00106W Location: 4NM WSW of Reading

### PART A: SUMMARY OF INFORMATION REPORTED TO UKAB

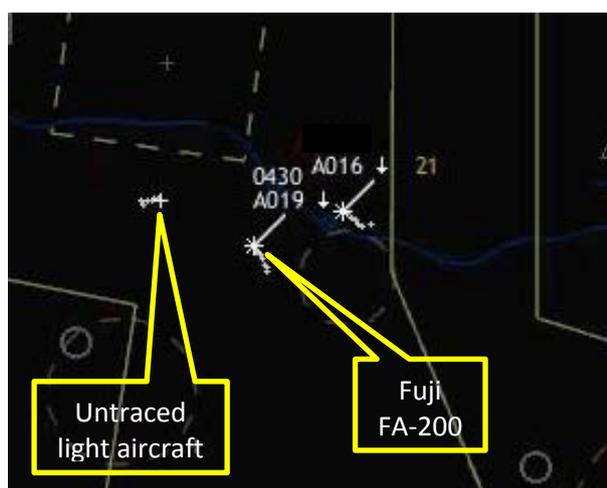
Figure 1 – 1009:10

A few minutes later, at 1009:10 (Figure 1), the controller spotted a potential confliction between the Fuji and a primary-only contact and passed Traffic Information (TI): "[Fuji C/S], traffic ahead of you, just off to your left, no altitude, crossing left to right, keep a good look out". The Fuji pilot responded to the TI but stated that they were not visual. The primary contact was in the Fuji pilot's 11 o'clock, approximately 2.5NM, and tracking left-to-right on a converging track.

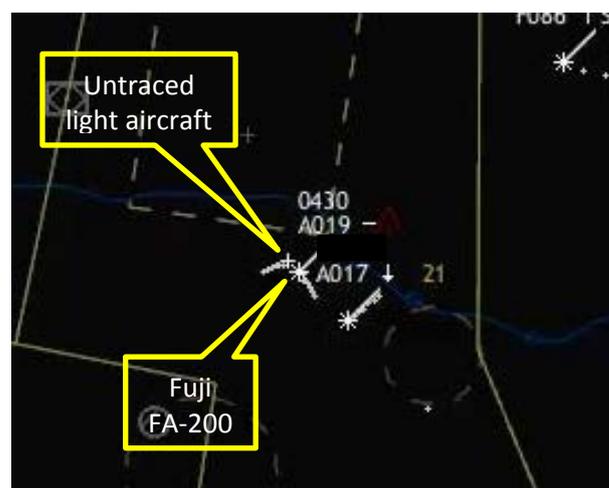
Figure 2 – 1010:09

At 1010:09 (Figure 2), the Fuji pilot stated that they had seen the contact:

Fuji pilot: "Traffic in sight, [Fuji C/S]."  
 Farnborough controller: "Roger."  
 Fuji pilot: "And it was close."  
 Farnborough controller: "[Fuji C/S] sorry say again?"  
 Fuji pilot: "And it was reasonably close. Same altitude. [Fuji C/S]."
