AIRPROX REPORT No 2020052

Date: 18 May 2020 Time: 1453Z Position: 5058N 00433W Location: 8NM N of Bude

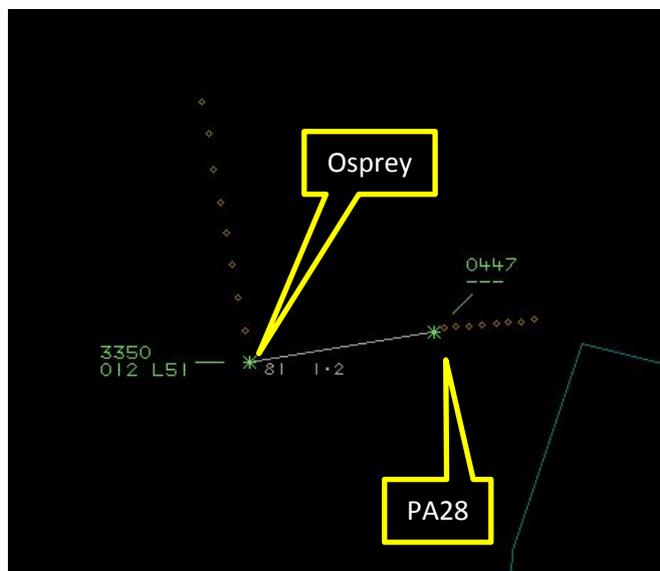
Figure 1 – 1450:18

Analysis Cell reviewed the NATS radars for the entirety of the PA28 pilot's flight and established that an Osprey aircraft was near to the PA28 at the times and locations reported by the PA28 pilot. On the 2 occasions that are not reported as Airprox, the Osprey and the PA28 passed each other at a range of 2.6NM on the first occasion and, on the second occasion, the Osprey crossed the nose of the PA28 at a range of 1.2NM and approximately 1000ft below (see Figure 1).

This second encounter occurred off Hartland Point some 3 minutes prior to the Airprox, as the PA28 was heading west and the Osprey heading south and, although the pilot recalls receiving TCAS contacts after this time, the geometry is such that, in all likelihood, the TCAS contacts to which the Osprey pilot refers were received during their southbound leg towards Hartland Point.

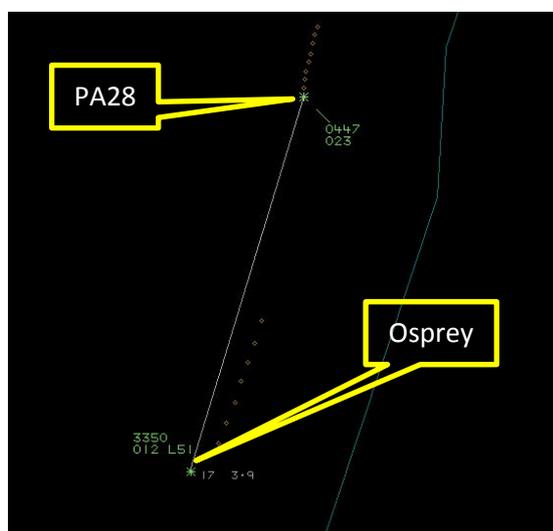
Figure 2 – 1452:07

The Osprey then continued to head south until, at 1452:07, the Osprey pilot commenced a right-hand turn with the intention of heading to the east towards their refuelling site (Figure 2). This right-hand turn eroded the separation between the PA28 and the Osprey until CPA was reached – 0.7NM lateral and 700ft vertical separation – at 1453:00 (Figure 3).
