AIRPROX REPORT No 2020054

Date: 20 Jun 2020 Time: 1511Z Position: 5302N 00026W Location: Cranwell

PART A: SUMMARY OF INFORMATION REPORTED TO UKAB

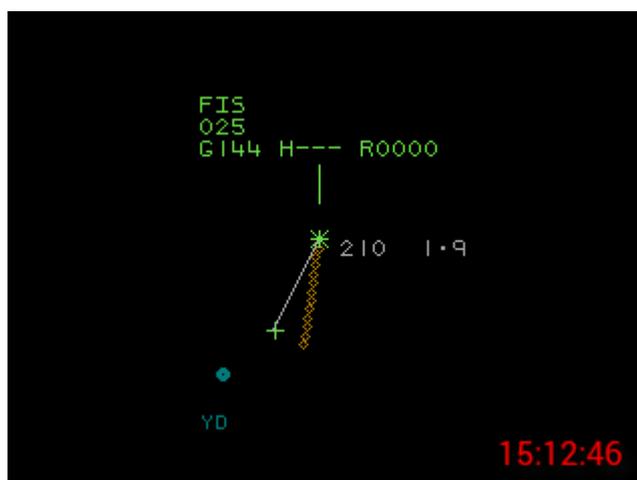
Figure 1

Analysis of radar data showed a primary return appear in the vicinity of Cranwell (Figure 1), after the aircraft had passed. This return was only present for three radar updates, Safety Investigations Swanwick has been unable to determine the identity of this radar return. There were no other radar returns visible within a 5NM radius of Cranwell whilst the C182 was in the vicinity.
