AIRPROX REPORT No 2020055

Date: 24 Jun 2020 Time: 1205Z Position: 5252N 00256W Location: 3NM E of Oswestry

PART A: SUMMARY OF INFORMATION REPORTED TO UKAB

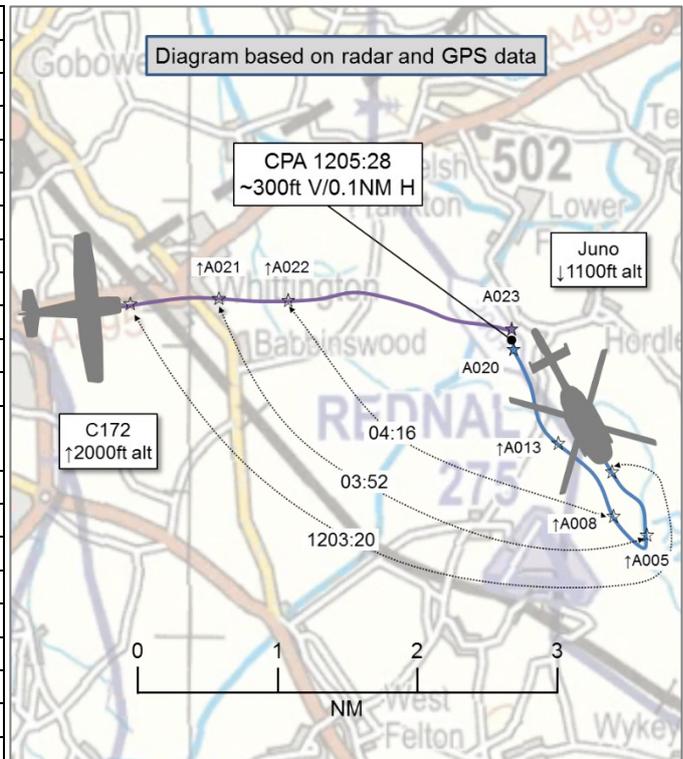
Recorded	Aircraft 1	Aircraft 2
Aircraft	Juno	C172
Operator	HQ Air (Trg)	Civ FW
Airspace	London FIR	London FIR
Class	G	G
Rules	VFR	VFR
Service	Basic	None
Provider	Shawbury LL	
Altitude/FL	2000ft ¹	2300ft
Transponder	A, C, S	A, C, S
Reported		
Colours	NR	White/Red
Lighting	Strobes, HISLs, Nav, Landing lights	Nav, Landing lights
Conditions	VMC	VMC
Visibility	25km	>10km
Altitude/FL	2400ft	2000ft
Altimeter	QNH (1020hPa)	QFE
Heading	320°	110°
Speed	65kt	90kt
ACAS/TAS	TCAS I	PCAS ²
Alert	TA	None
Separation		
Reported	100ft V/200m H	500ft V/600m H
Recorded	~300ft V/0.1NM H

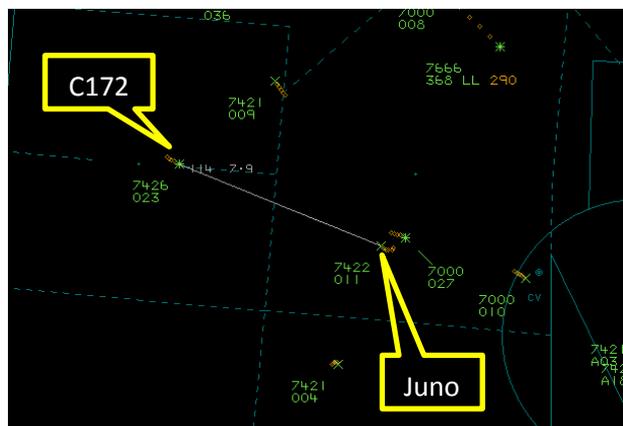
Figure 1 – Controller Handover

The C172 pilot free-called Shawbury Zone requesting a Basic Service inbound to Sleaf; the Service was agreed at 1148:48. Shortly afterwards, at 1200, the Zone Control position was handed over to another controller. During the handover, comment was made about the C172 and the fact that it was in an area of known poor radar performance and had not displayed on the radar screen. (Note: this area of poor radar performance was previously noted in Airprox 2019278). Separation at this point was 8NM and 1200ft (see Figure 1). At 1204, the C172 pilot reported changing frequency to Sleaf radio and was instructed to squawk 7000. Separation at this point was 3NM and 1400ft. The Juno can be seen climbing away from an autorotation at this point (see Figure 2).

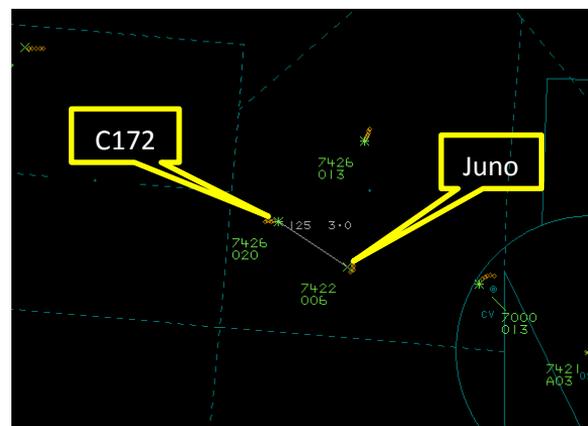
Figure 2 – C172 Frequency Change

Up until the point of this frequency and squawk change, the C172 squawk had been visible on the radar replay provided. Following the change to Sleaf, the C172 squawk was no longer visible, possibly because the transponder was turned to standby while the pilot selected the code to 7000. This may account for the Juno pilot reporting that no ACAS warning was received. Allowing the radar replay to run shows that the radar returns merged at 1205:30 but no estimation of vertical separation could be given due to the lack of a squawk from the C172. Following CPA, the Juno pilot reported the Airprox to the Shawbury Low-Level Controller who reported that neither aircraft were displaying on their surveillance systems.

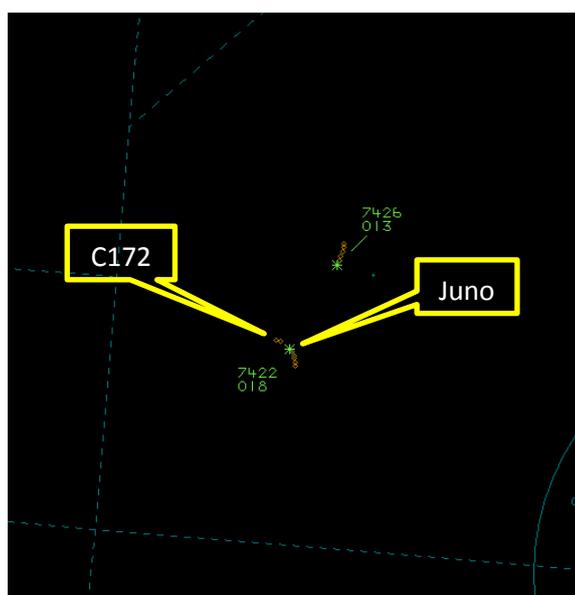
Figure 3 – CPA

This incident took place in an area of known poor radar performance with neither aircraft displaying on Shawbury surveillance systems, meaning that no action could be taken by the controllers involved to prevent the incident from occurring.

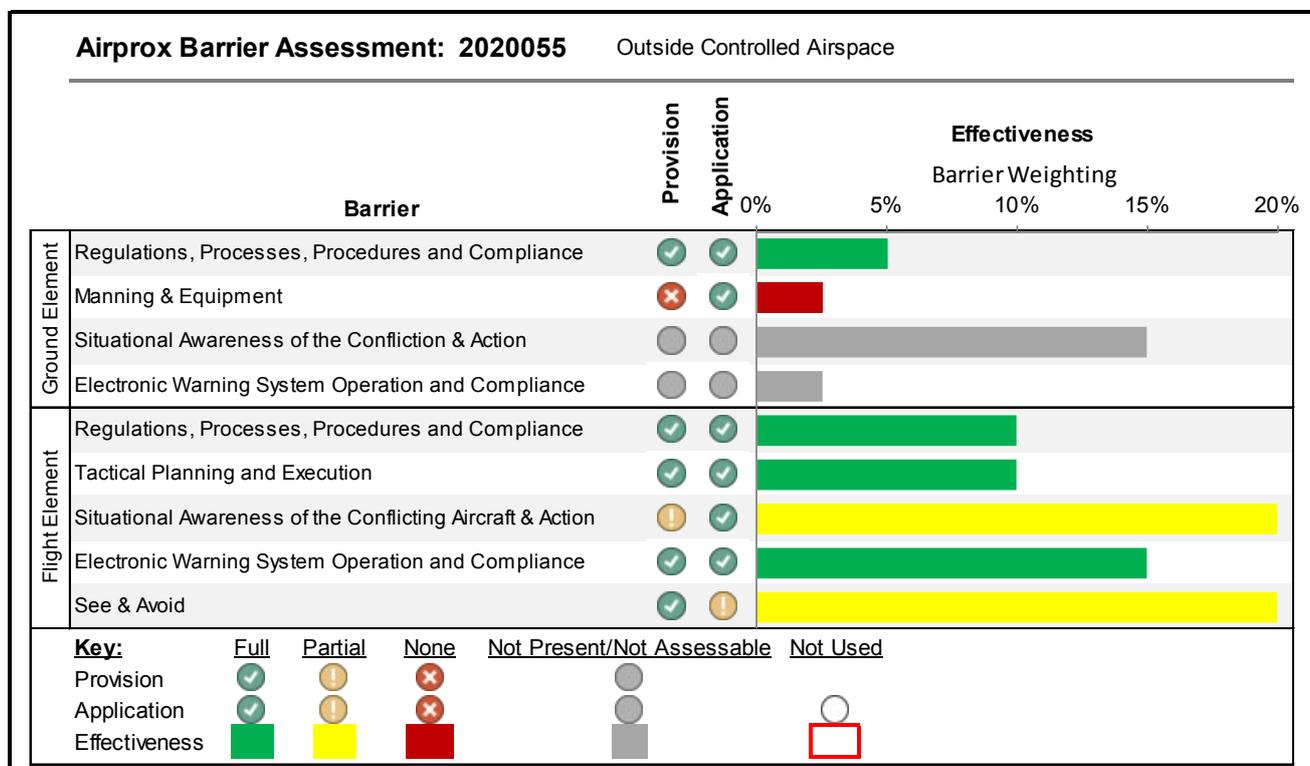
Manning and Equipment were assessed as **ineffective** because the Shawbury controllers were working with SSR only and neither aircraft appeared on the Shawbury controllers’ radar screens due to the Airprox occurring in an area of known poor radar performance.

Situational Awareness of the Confliction and Action were assessed as **not used** because neither controller was required to monitor the aircraft under the terms of the agreed Service.

Situational Awareness of the Conflicting Aircraft and Action were assessed as **partially effective** because the Juno pilot had no awareness of the presence of the C172 as they had not received any Traffic Information nor did the C172 appear on the Juno’s ACAS.

See and Avoid were assessed as **partially effective** because the Juno pilot did not see the C172 until immediately prior to CPA due to their searching for a different TAS contact and, when the Juno pilot manoeuvred, the C172 pilot then had to take late avoiding action.
