AIRPROX REPORT No 2020057

Date: 01 Jul 2020 Time: 1337Z Position: 5106N 00213W Location: 2NM SE Warminster

PART A: SUMMARY OF INFORMATION REPORTED TO UKAB

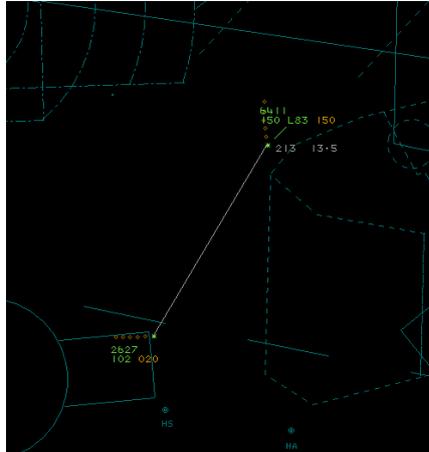
Figure 1:
Traffic Information between the controllers

Having identified the potential conflict, the Swanwick (Mil) controller contacted Boscombe to ascertain the intentions of the Hunter pilot. Having passed Traffic Information and established that both parties were under a Traffic Service no further action was taken by either controller. Separation at this point was 13.5NM.

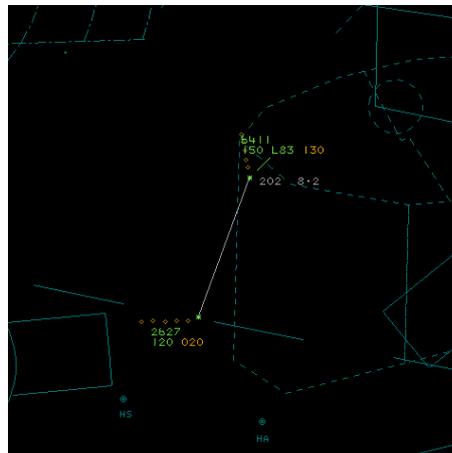
Figure 2:
Traffic Information to both aircraft

Shortly after this exchange, both controllers passed Traffic Information to their respective pilots on each other. The Swanwick (Mil) controller also issued a descent instruction to FL130 which built in 1000ft of separation from the indicated altitude of the Hunter. Separation at this point had decreased to 8NM.

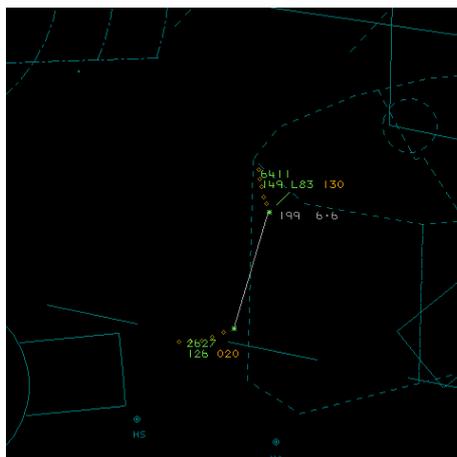
Figure 3:
Swanwick vector the FR20 away

The FR20 pilot reported as only having TCAS contact on the Hunter which prompted the Swanwick (Mil) controller to offer a turn to the west to route behind the Hunter. For their part, the Hunter pilot reported not being visual with the FR20 and informed the Boscombe controller that they intended to turn west via a right hand turn. Separation at this point had decreased to 6.6NM.

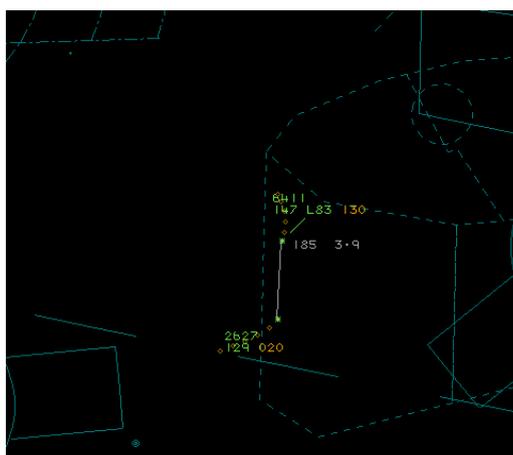
Figure 4:
Traffic Information passed to both aircraft

Having seen the Hunter continue its climb, the Swanwick (Mil) controller amended the descent instruction to the FR20 pilot to stop at FL140 and again passed Traffic Information. At this point, the pilot reported being visual with the Hunter. Having informed Boscombe of their intention to turn west via a right hand turn, the Hunter pilot actually initiated a left hand turn prompting the Boscombe controller to pass Traffic Information for a second time to which the Hunter pilot reported having a TCAS contact and then 4sec later being visual. Separation at this point was 3.9NM and 1700ft.

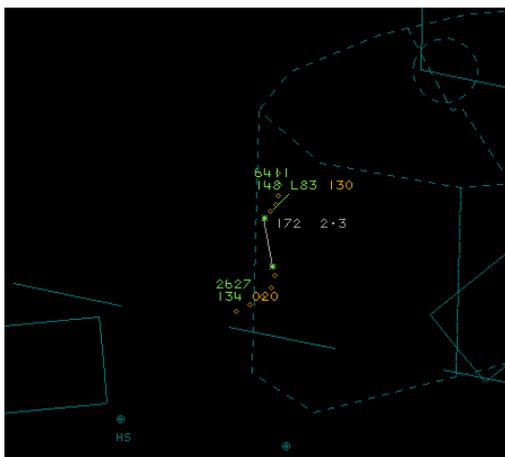
Figure 5: FR20 TCAS RA

Having reported visual with the Hunter, the FR20 pilot was instructed by the Swanwick(Mil) controller to descend to FL100 and 17sec later the pilot reported a TCAS RA. Separation at this point was 2.3NM and 1400ft. The radar contacts merged 26sec after the TCAS RA report resulting in a vertical separation of 2000ft.

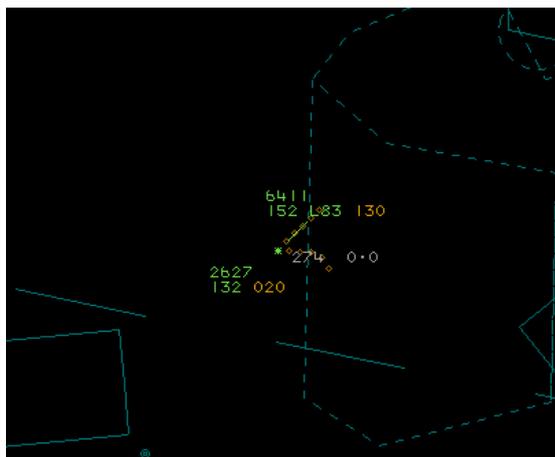
Figure 6: CPA

There was appropriate liaison between the controllers involved in this incident which allowed them to pass timely and accurate Traffic Information to the aircraft under their control. The Swanwick (Mil) controller should be commended for initiating a stepped descent to maintain separation as well as initiating a turn to alleviate the conflict. It is unfortunate that despite both aircraft being visual with each other they still flew close enough to trigger a TCAS RA in the FR20.
