AIRPROX REPORT No 2020082

Date: 29 Jul 2020 Time: 1126Z Position: 5212N 00027W Location: 4NM N of Bedford

PART A: SUMMARY OF INFORMATION REPORTED TO UKAB

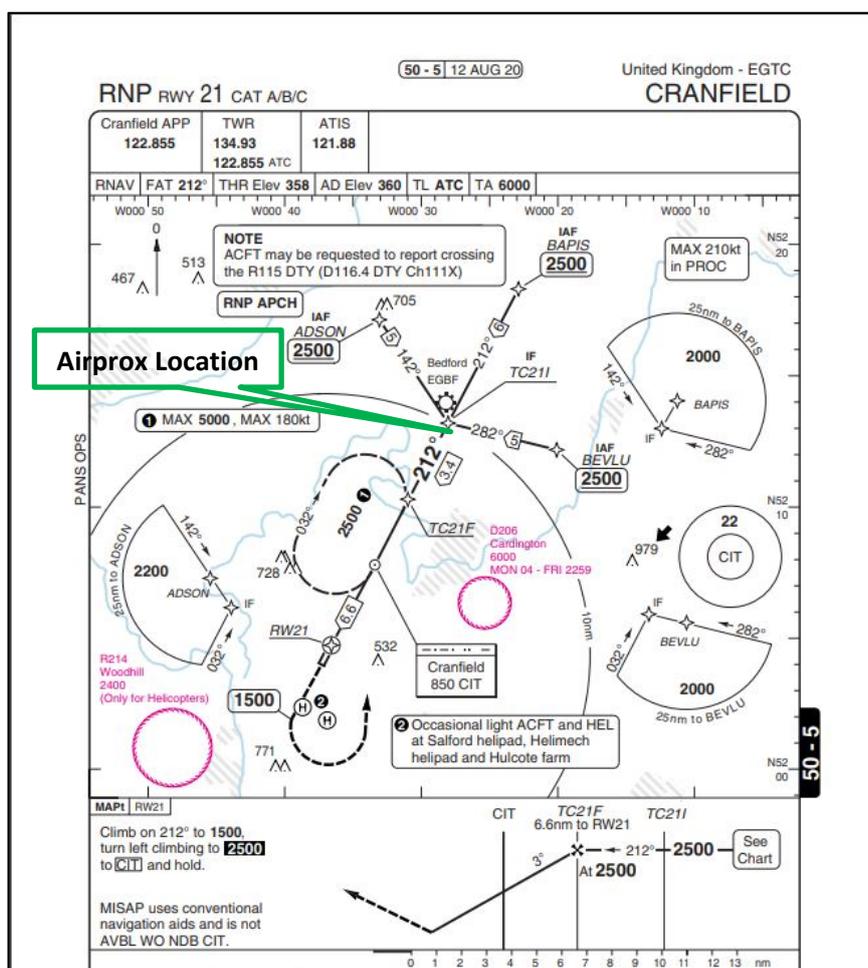
Figure 1 – Extract of Cranfield RNP RW21

This Airprox happened some distance from the IAP 'feathers' as marked on VFR charts, but nevertheless on the procedure that was being followed by the PA34. UKAB has previously recommended (ref 2014097 and 2014126) that the CAA make it simpler for GA pilots to visualise Instrument Procedures located in Class G, and this incident reinforces that need. The LS6 would have been well advised to contact Cranfield, especially in view of their track leading up to the Airprox, but as there is no Radar at Cranfield the best service that could have been provided was generic Traffic Information.
