## **AIRPROX REPORT No 2020087**

Date: 03 Aug 2020 Time: 0844Z Position: 5242N 00027W Location: 6NM N Wittering

### **PART A: SUMMARY OF INFORMATION REPORTED TO UKAB**

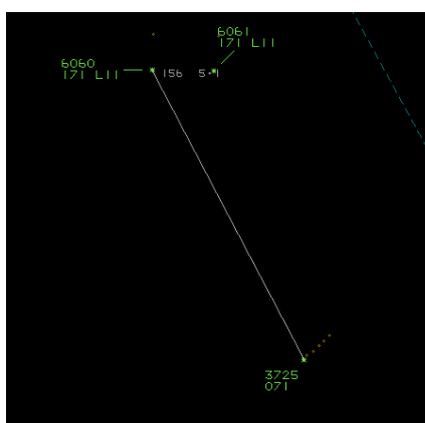
The F15s had been operating to the NE and N of Wittering prior to altering their flight profile to transit towards the Wittering overhead. This was the second observed racetrack profile flow by the F15 formation. The Tutor had begun to track in a SW direction. Separation at this point was 5.1NM and 10,000ft.

Figure 1:  
Separation and flight profile of F15s and the Tutor.

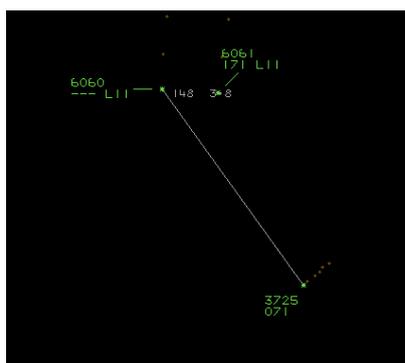
During the transit the Mode C on the No1 F15 dropped off the radar replay, which is normally associated with a rapid climb or descent. Separation at this point had decreased to 3.8NM.

Figure 2:  
No1 F15 loss of Mode C data.

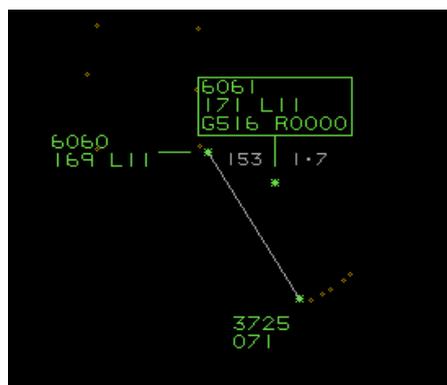
Seventeen seconds after the Mode C data had dropped out on No1 F15, it reappeared displaying FL169. Separation decreased to 1.7NM.

Figure 3:  
No1 F15 Mode C data reappears.

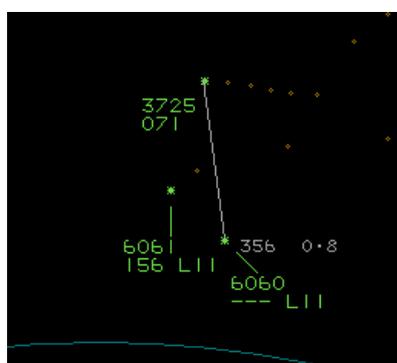
A further eighteen seconds elapsed before the No1 F15 Mode C data dropped out again. Of note this was one second after the controller engaged in a landline conversation with Lakenheath. Separation decreased to 0.8NM.

Figure 4:  
No1 F15 Mode C data disappears again.

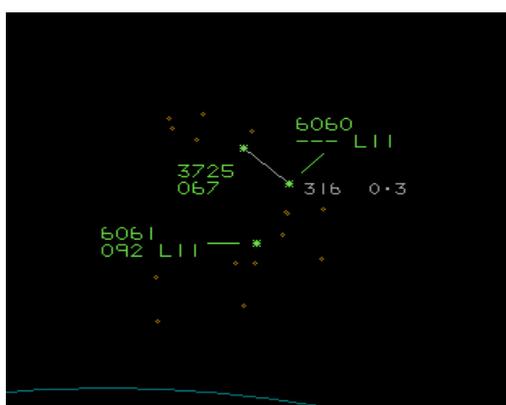
The Mode C data dropped out on No2 F15 13 seconds after No1 F15. Separation to the closest F15 remained at 0.8NM. Twelve seconds later CPA occurred. CPA was measured at 0.3NM and unknown height between No1 F15 and 0.5NM and 2500ft between No2 F15.

Figure 5: CPA.

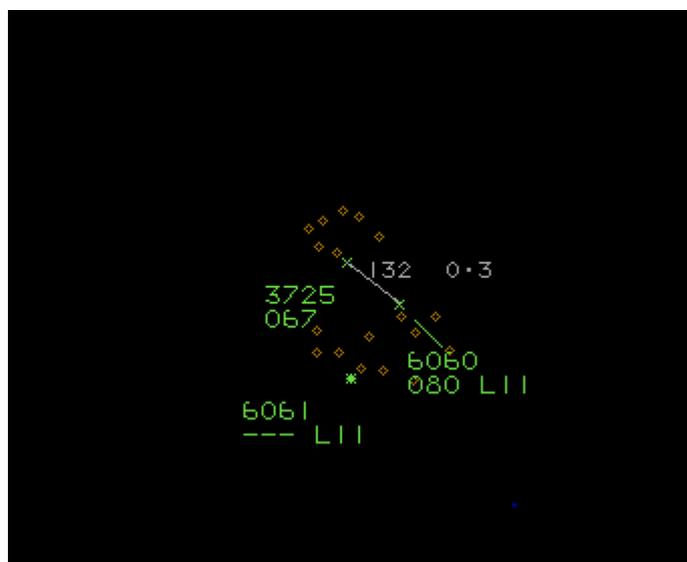
Figure 6: 0844:01 (Clee Hill radar)

Although the Swanwick 'all radar' setting did not display a height on the F15s, by interrogating a single radar source it was intermittently possible to see a height on the F15s for the purposes of assessing the Airprox. The Swanwick(Mil) controller was unlikely to be operating on a single radar source and so the Mode C data would not have been available to them. Figure 6 is taken from the Clee Hill radar at CPA and shows 0.3NM and 1300ft between the two aircraft. The Cromer radar 10sec later shows the two aircraft 0.7NM apart at the same level.
