AIRPROX REPORT No 2020104

Date: 29 Aug 2020 Time: 1254Z Position: 5109N 00152W Location: 5NM W Boscombe Down

PART A: SUMMARY OF INFORMATION REPORTED TO UKAB

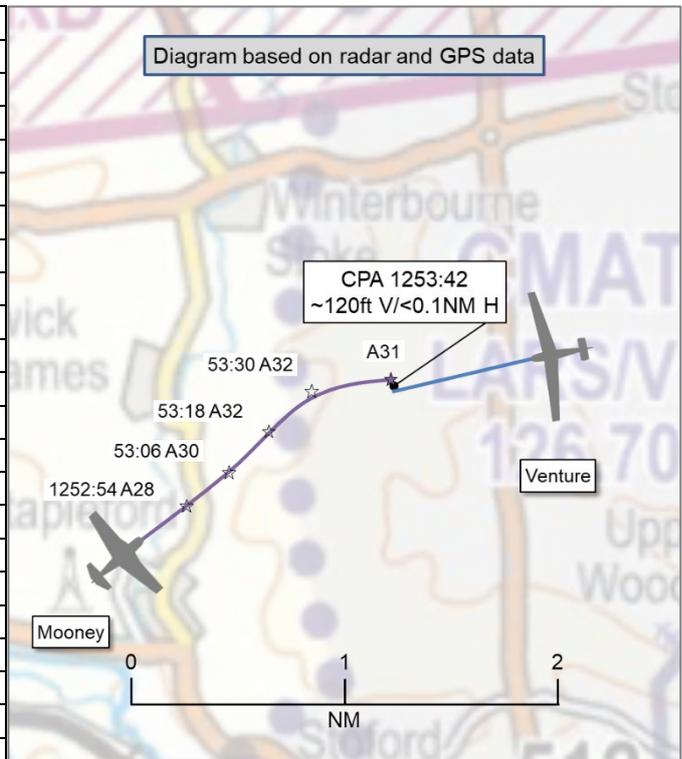
THE VENTURE PILOT reports being in straight and level cruise when he suddenly became aware of a PowerFLARM alert with distance information of 1km rapidly counting down over three or four flashes to virtually nothing. He looked ahead to left and right and saw another aeroplane in a banked turn to its right, which was tending towards a head on situation. He immediately banked hard to the left and the other aircraft passed out of sight below the right wing. The pilot stated that had he done nothing or turned right there would almost certainly have been a collision.

THE M20 INSTRUCTOR reports in straight and level cruise when he saw a red glider [sic] pass down the right hand side. A recently qualified PPL was flying the aircraft after having practised instrument approaches at another airfield. They were preparing for recovery to home base and, because the grass runway was in operation (which was normally not used because of the low prop clearance on a Mooney), the Instructor was studying the airfield chart and wrongly believed that the pilot flying was keeping a good lookout. He noted that, in hindsight, the flying pilot though no longer ‘under the hood’ after practising instrument approaches, may not have mentally transitioned from a simulated IFR environment to VFR and this may have affected his judgment to keep a good lookout. Also, because the instructor hadn’t considered this possibility, he was content for the other pilot to fly the aircraft during the cruise phase of the flight, the instructor planning to take over for the landing because the other pilot had no landing experience on a Mooney. The instructor noted that there were no external services available to offer Traffic Information inside the Boscombe Zone.
