AIRPROX REPORT No 2020132

Date: 25 Sep 2020 Time: ~1003Z Position: 5437N 00249W Location: 3NM SW of Penrith

PART A: SUMMARY OF INFORMATION REPORTED TO UKAB

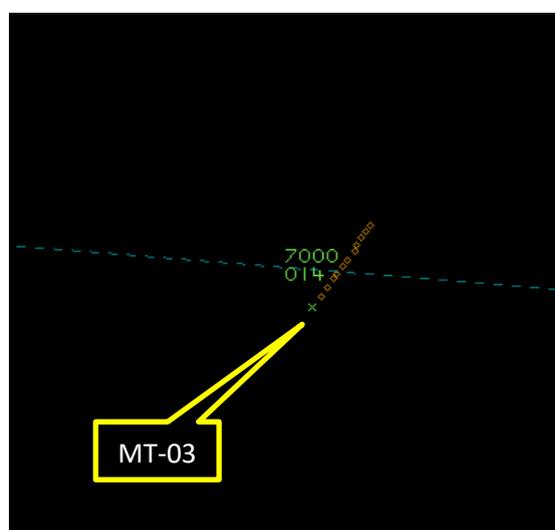
Figure 1 – 1003:21

Analysis of the NATS radar replay showed the MT-03 autogyro tracking southwest towards Ullswater, at an altitude of 1100ft (FL014) in the moments preceding the Airprox. The final radar sweep before the aircraft faded from radar is timed at 1003:21 (approximately 5-10sec prior to CPA) and can be seen at Figure 1. No other radar returns were observed within at least 10NM of the MT-03. The radar return of the Hawk first appeared at 1003:33 and at an altitude of 1300ft (FL016). A screenshot of the radar replay, taken at 1003:38, is at Figure 2 and showed the Hawk tracking towards the east, which is coherent with the pilot's report that they executed a climbing right-hand turn on sighting the autogyro. The radar return of the MT-03 was still not visible on the replay at this time.

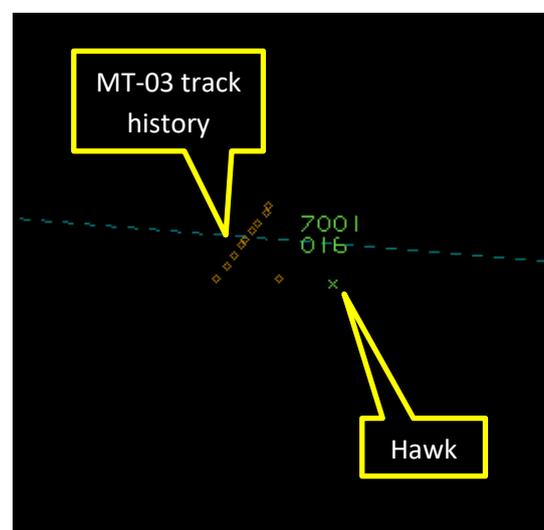
Figure 2 – 1003:38

Although both aircraft were detected by the NATS radar, these detections were not coincident with the time of the Airprox and so an accurate measurement of CPA was not possible.

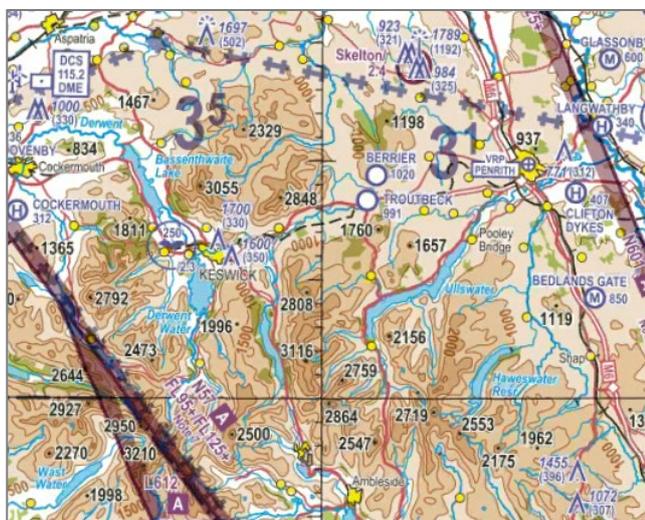
Figure 3 – Civil 1:500,000 VFR Chart

was encouraged by the efforts taken by the Hawk pilot's unit to inform users of local airfields of common military activity in the Lake District, including the flow arrows in certain lakes that are mandatory for military pilots but which are not depicted on the civil VFR charts (see Figures 3 and 4 below). Notwithstanding, the Board wished to draw to the attention of civil pilots that these flow arrows can be found in the UK eAIP ENR 6-76.

There then followed a brief discussion on whether or not these flow arrows should be depicted on the civil VFR charts even though civil pilots do not need to follow them, somewhat akin to the depiction of Military Aerodrome Traffic Zones (MATZs); this could increase civilian pilots' awareness of the flow arrows' existence. The Board stopped short of making a Safety Recommendation in this regard, but Director UKAB undertook, on behalf of the Board, to approach the organisation responsible for the Military Low-Flying System to specifically highlight this discussion and to offer relevant Airprox data as examples to support any educational campaign they may wish to consider running. Returning to the event itself, members agreed that, without any form of CWS on-board the Hawk, the pilot had had no means of gaining situational awareness of the presence of the autogyro (CF1). Thus, the pilot had been relying solely on visual detection of any conflicting aircraft. Given the heights at which the 2 aircraft were flying, and the reduction in line-of-sight due to the topography, members agreed that, although the Hawk pilot had seen the autogyro as soon as could have reasonably been expected, this had nevertheless been a late sighting on the part of the Hawk pilot (CF3).

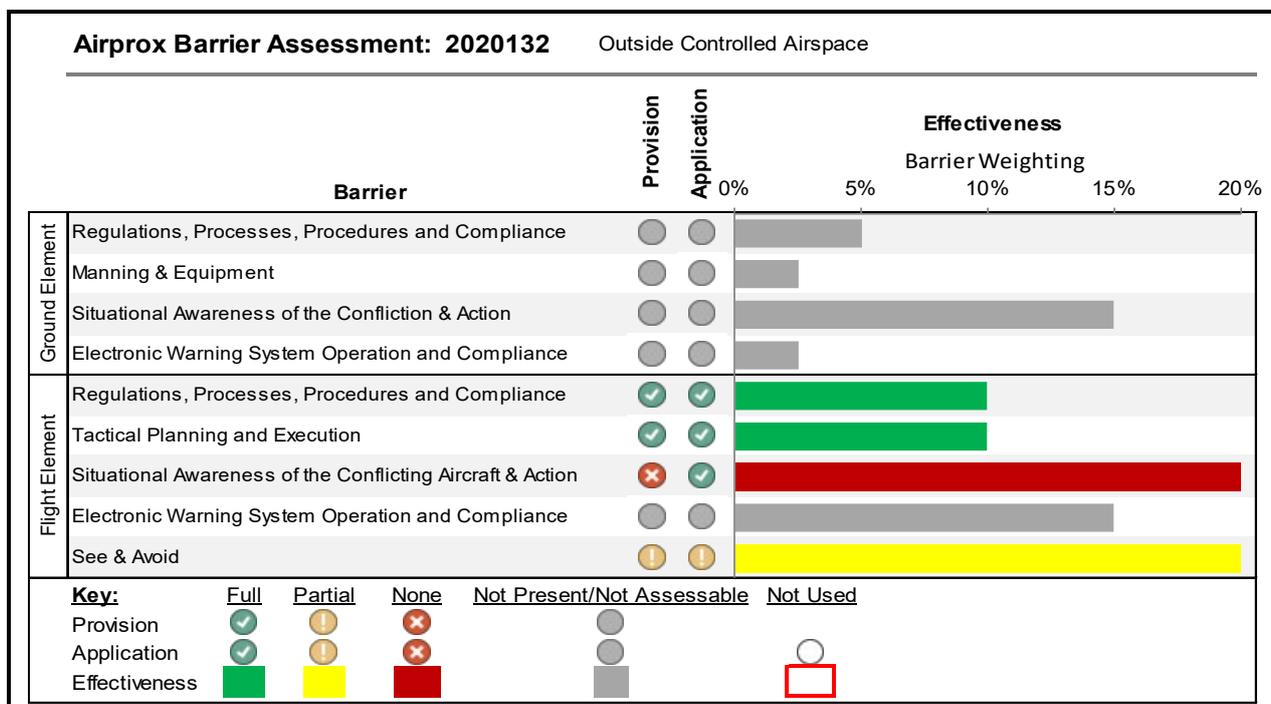
Safety Barrier Assessment⁴

Situational Awareness of the Conflicting Aircraft and Action were assessed as **ineffective** because neither pilot had any situational awareness of the presence of the other aircraft.

See and Avoid were assessed as **partially effective** because the MT-03 autogyro pilot did not see the Hawk in time to take any action that would have materially affected the separation between the 2 aircraft, and the Hawk pilot only saw the MT-03 autogyro in time to take immediate avoiding action.
