**AIRPROX REPORT No 2020136**

Date: 11 Sep 2020 Time: 1427Z Position: 5043N 00325W Location: Exeter Airport – elev 102ft

**PART A: SUMMARY OF INFORMATION REPORTED TO UKAB**

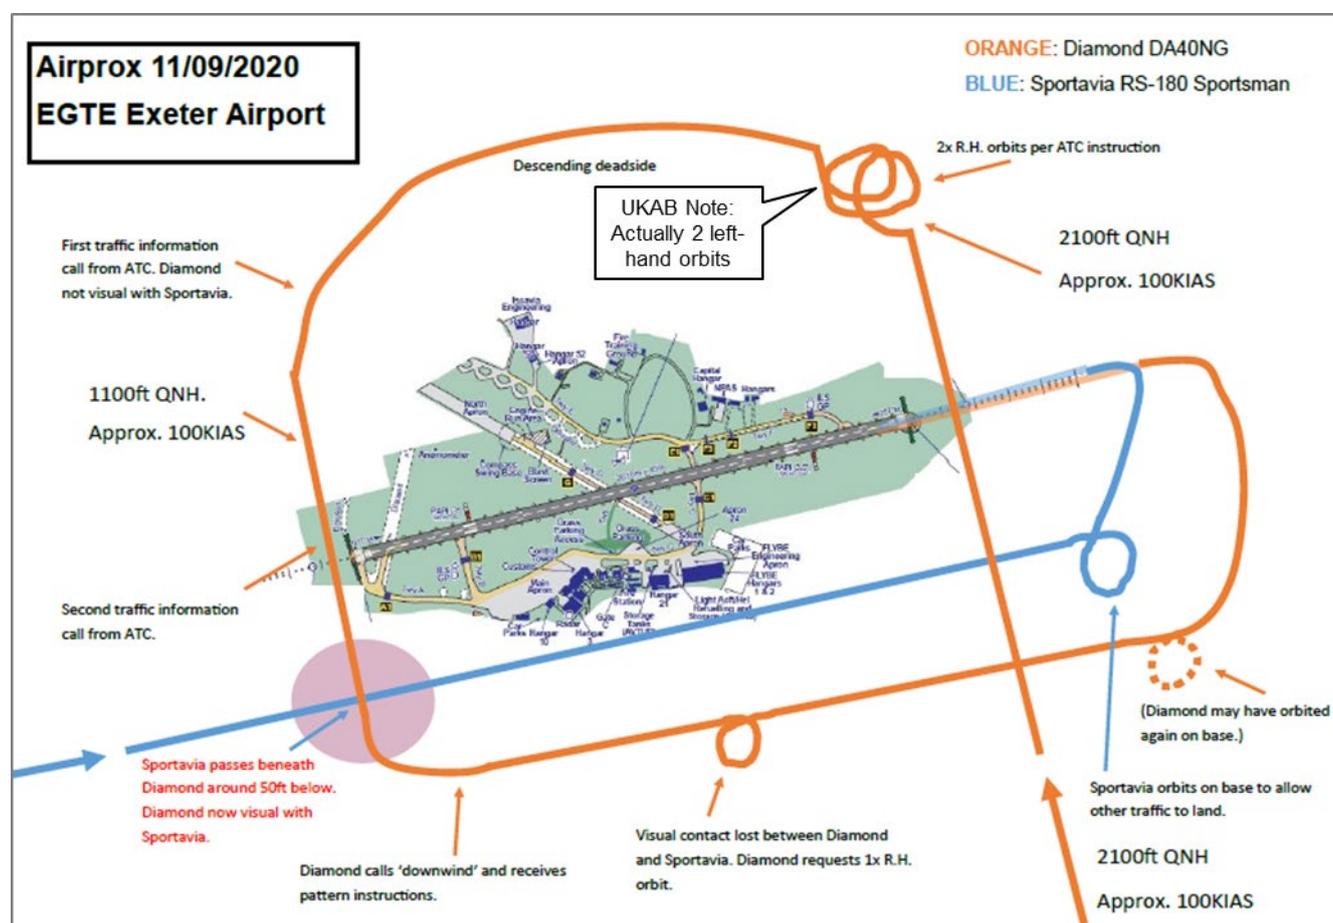
Diagram provided by DA40 pilot

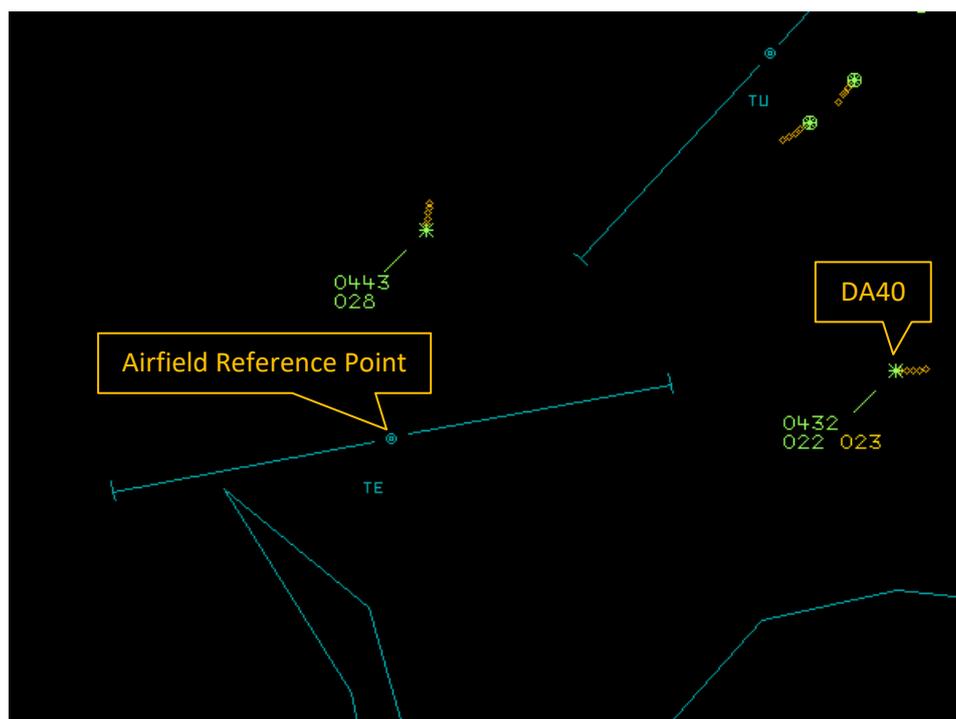
Figure 1 – 1416:06 (radar replay displaying FL – add 100ft for altitude)

The DA40 pilot made their initial call to Exeter Radar at 1415:12. The controller was busy vectoring a DA42 under a Traffic Service, and so did not answer the DA40 pilot until 1416:06 at which time a Basic Service was agreed, and the runway, QNH and surface wind were all confirmed. The DA40 pilot then requested a "Standard Overhead Join from the south" which was acknowledged by the controller (Figure 1).

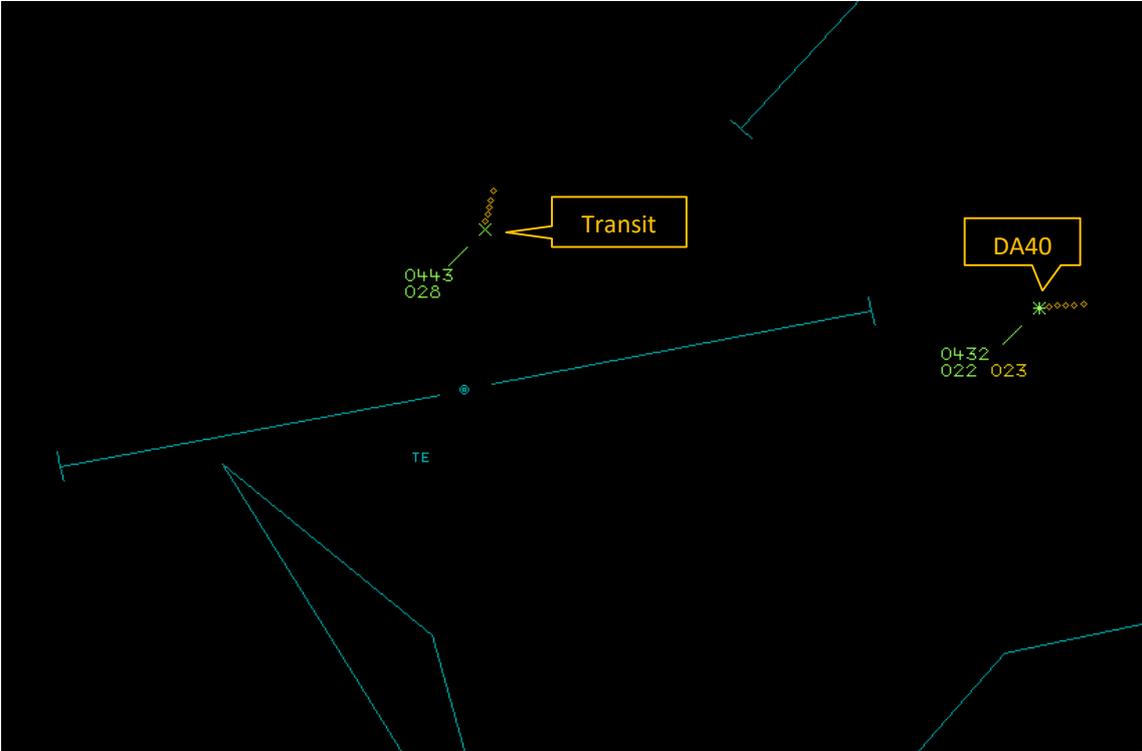
Figure 2 – 1417:17

At 1417:17, the radar controller confirmed that the DA40 could continue for an overhead join from the south, and went on to pass Traffic Information on an aircraft in transit, north to south through the overhead at 2700ft, all of which was acknowledged by the DA40 pilot (Figure 2).

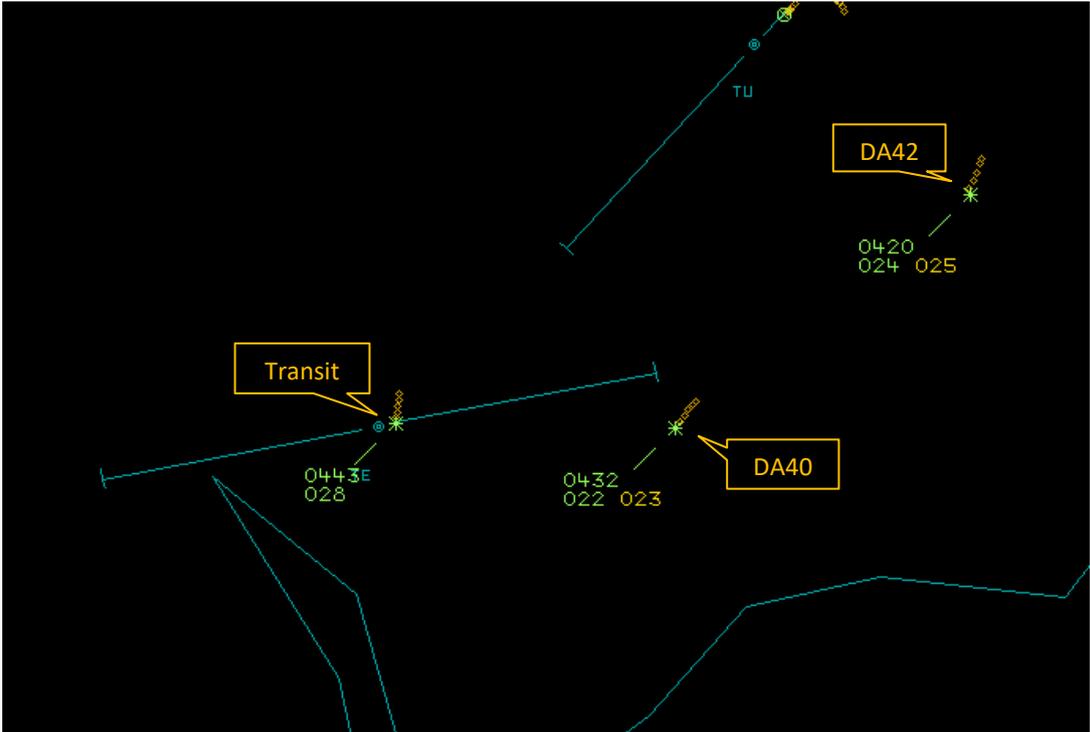
Figure 3 – 1418:30

At 1418:30, the Radar controller asked the DA40 pilot if they had the airfield in sight, which the pilot confirmed they had. The controller updated them on the transit traffic which was now at 2900ft, and instructed them to contact Exeter Tower, all of which was again acknowledged by the pilot (Figure 3).

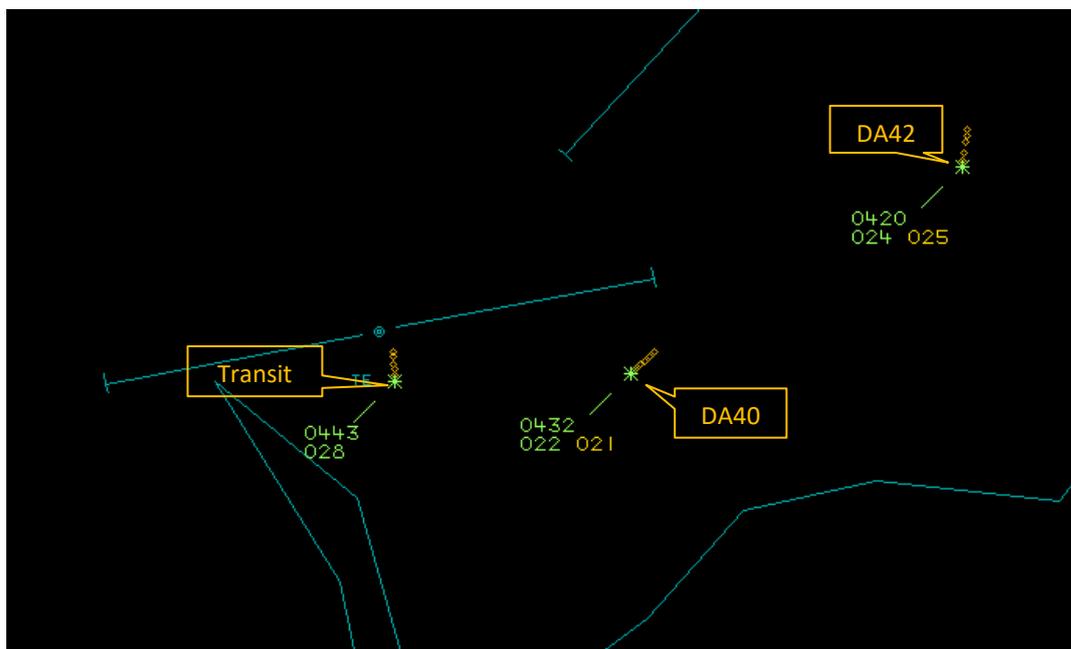
Figure 4 – 1419:06

At 1419:06, the DA40 pilot called Exeter Tower reporting that they were inbound for a standard overhead join from the south. The Tower controller requested they report in the overhead which was acknowledged (Figure 4).

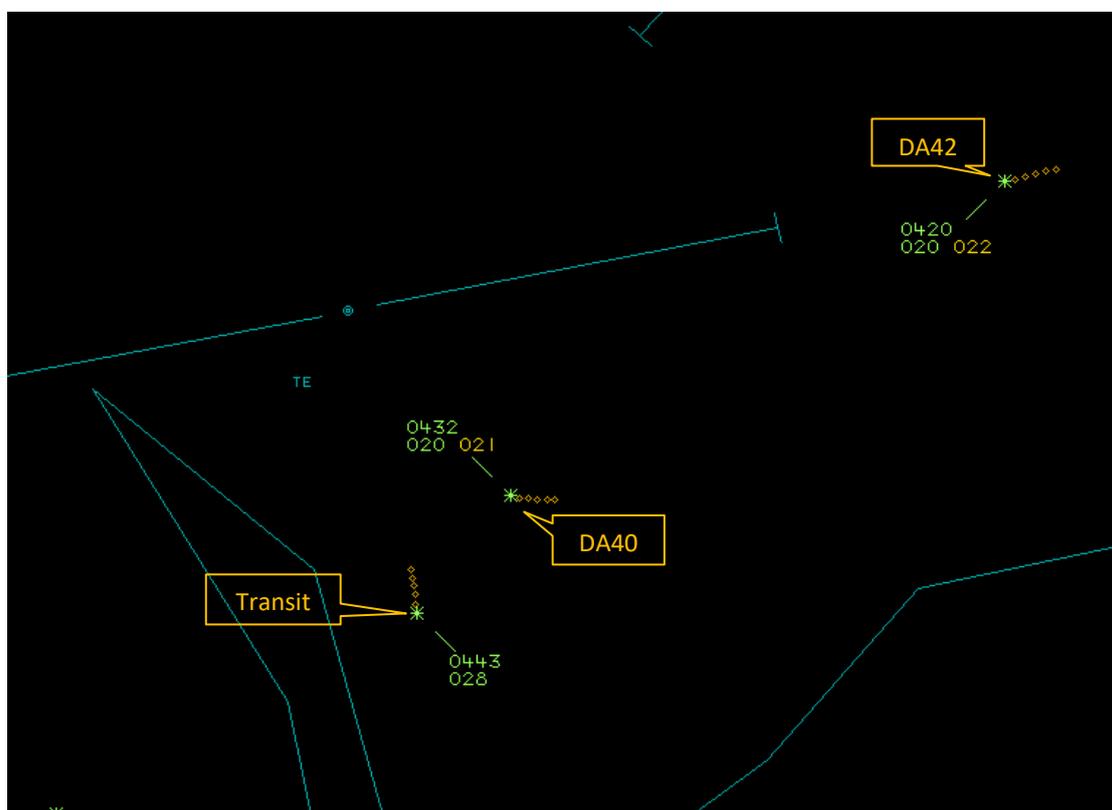
Figure 5 – 1421:00

At 1421:00, the DA40 pilot called the Tower controller, who replied by instructing the pilot to hold in the overhead as there was traffic on a 7NM final, (the DA42), advising they would be Number 2 to that aircraft, which was acknowledged. The DA40 pilot then asked the controller to confirm that it was a left-hand circuit, which the controller did, adding that the descent on the deadside would be to the north of the airfield, which was acknowledged by the pilot (Figure 5).

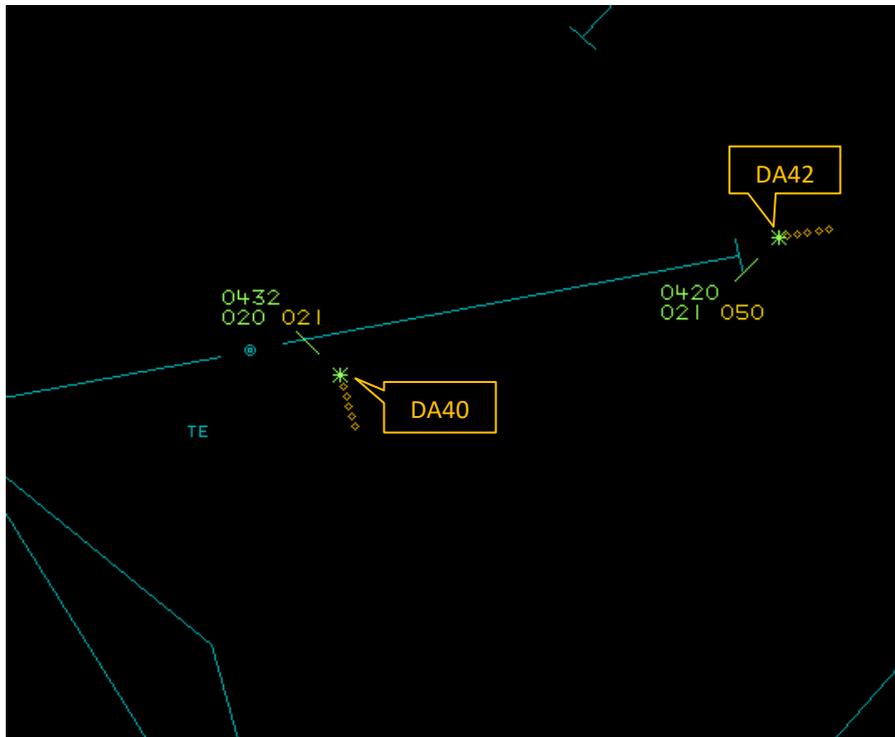
Figure 6 – 1422:20

At 1422:20, the DA40 pilot reported in the overhead. The Tower controller instructed them to carry-out two left-hand orbits *“for spacing while the aircraft on the final approach does his low approach beneath you”*. The DA40 pilot acknowledged the orbits but not the Traffic Information. The Tower controller then passed Traffic Information on the DA40 to the DA42 pilot, who was now on frequency, before then clearing them for a low approach (Figure 6).

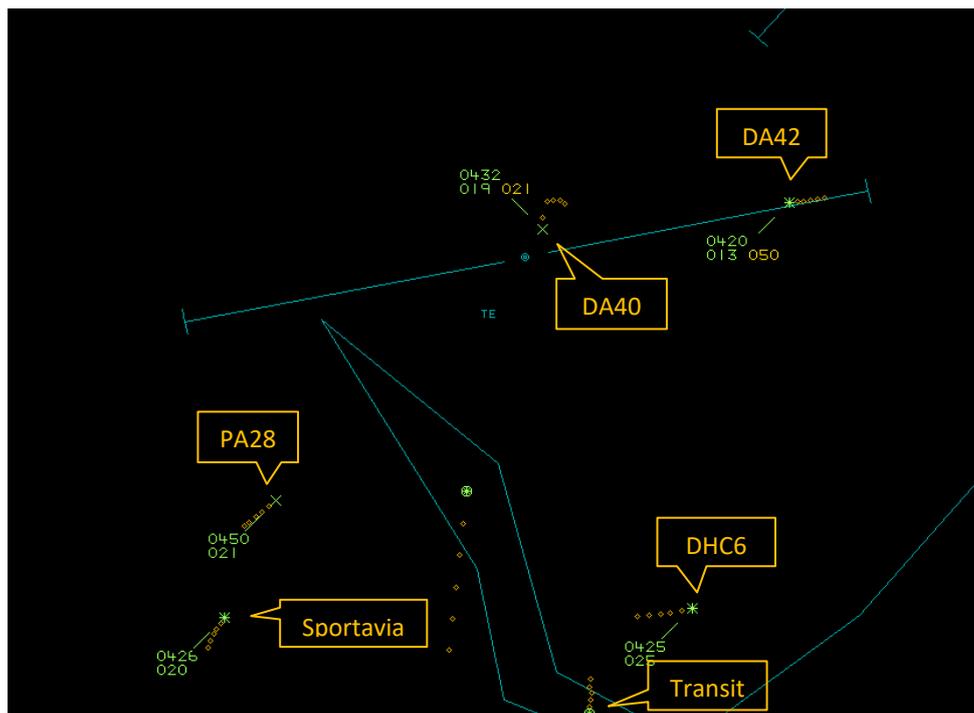
Figure 7 – 1423:20

The Radar controller in the meantime was vectoring a DHC6 in from the southwest and had a PA28 inbound from the south under VFR. At 1423:03, the Radar controller warned-in the PA28 to the Tower controller who confirmed a downwind left-hand join. At 1423:20, the Sportavia pilot called the Radar controller for joining instructions (Figure 7).

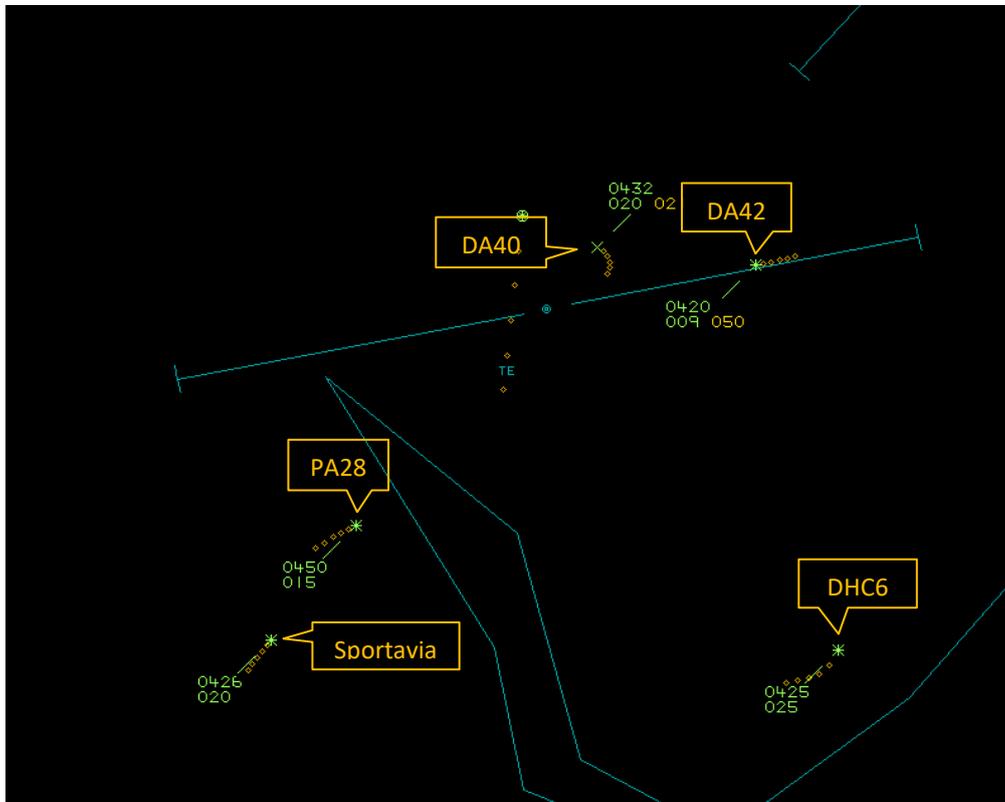
Figure 8 – 1424:00

The Radar controller was on the landline to the Tower controller about the PA28 and did not respond to the Sportavia pilot until 1424:00. They then warned-in the Sportavia to the Tower controller, who again confirmed a downwind left-hand join. The Radar controller informed the Sportavia pilot, passed Traffic Information on the PA28 and instructed them to contact Exeter Tower (Figure 8).

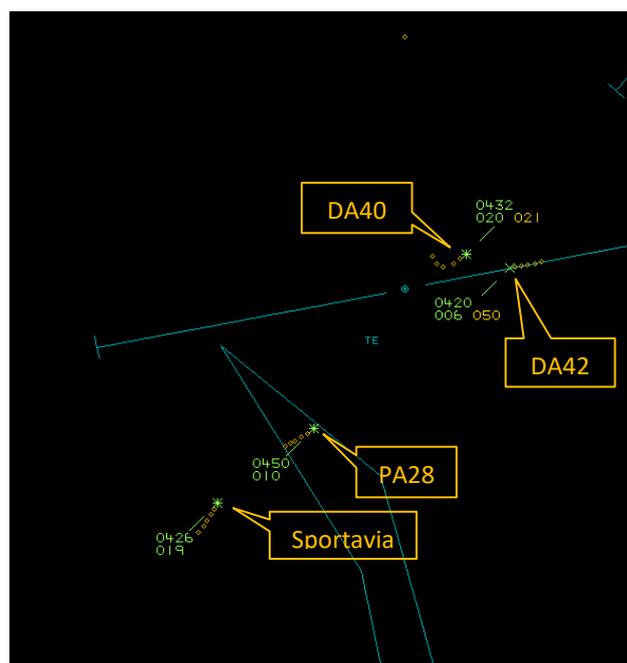
Figure 9 – 1424:45

At 1424:09, the PA28 pilot reported joining downwind to the Tower controller and was instructed to report turning base, which was acknowledged. At 1424:45, the Sportavia pilot contacted the Tower. The Tower controller confirmed the downwind join and the PA28 ahead, and asked if they were visual with that aircraft to which the pilot of the Sportavia stated they were not (Figure 9).

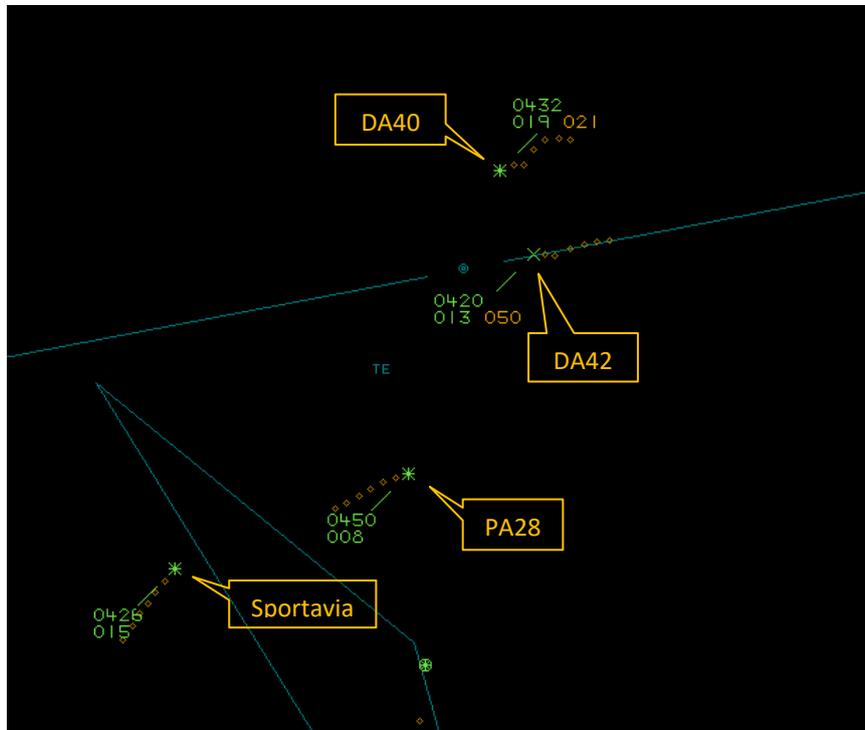
Figure 10 – 1425:28

At 1425:28, the DA40 pilot reported having completed their second orbit and the Tower controller passed Traffic Information on the DA42; “*the overlying aircraft is now overhead the airfield*”. The controller cleared the DA40 pilot to descend dead-side and passed Traffic Information to them on the two aircraft joining from the southwest; “*one mid downwind and one in the vicinity of Topsham*”, (Figure 10).

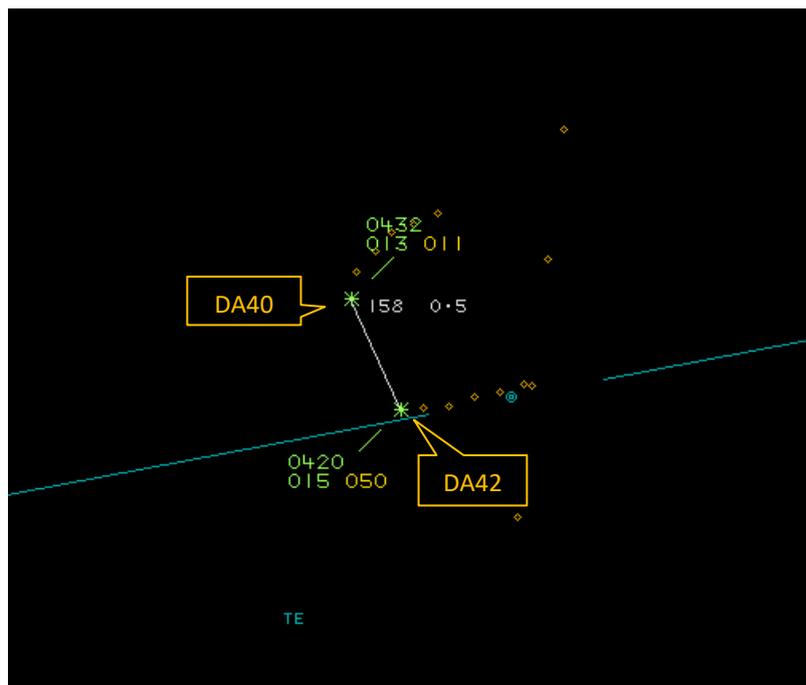
Figure 11 – 1426:13

At 1425:52, the PA28 pilot was instructed to report final as they were No 1, the DA42 having commenced their go-around. At 1426:13, the Tower controller passed Traffic Information to the DA42 pilot on the DA40; “*traffic descending on the dead-side crossing beneath you and behind you is a DA40*”. The DA42 pilot reported visual with the traffic (Figure 11).

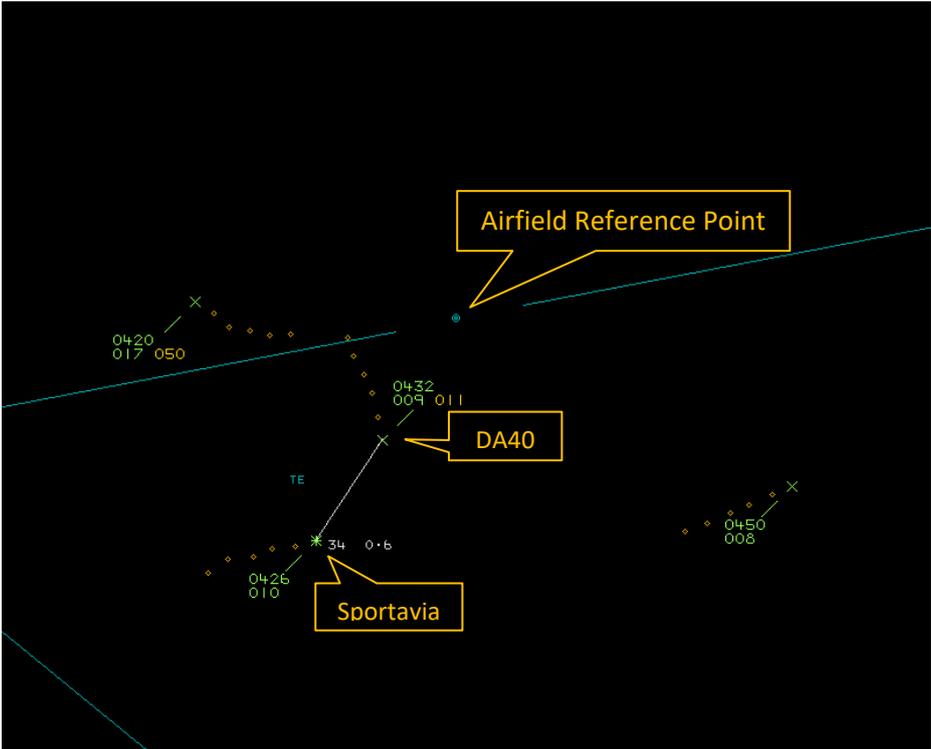
Figure 12 – 1426:48

At 1426:48, the Tower controller asked the DA40 pilot if they were “visual with the second aircraft, (the Sportavia), joining mid downwind”, (Figure 12).

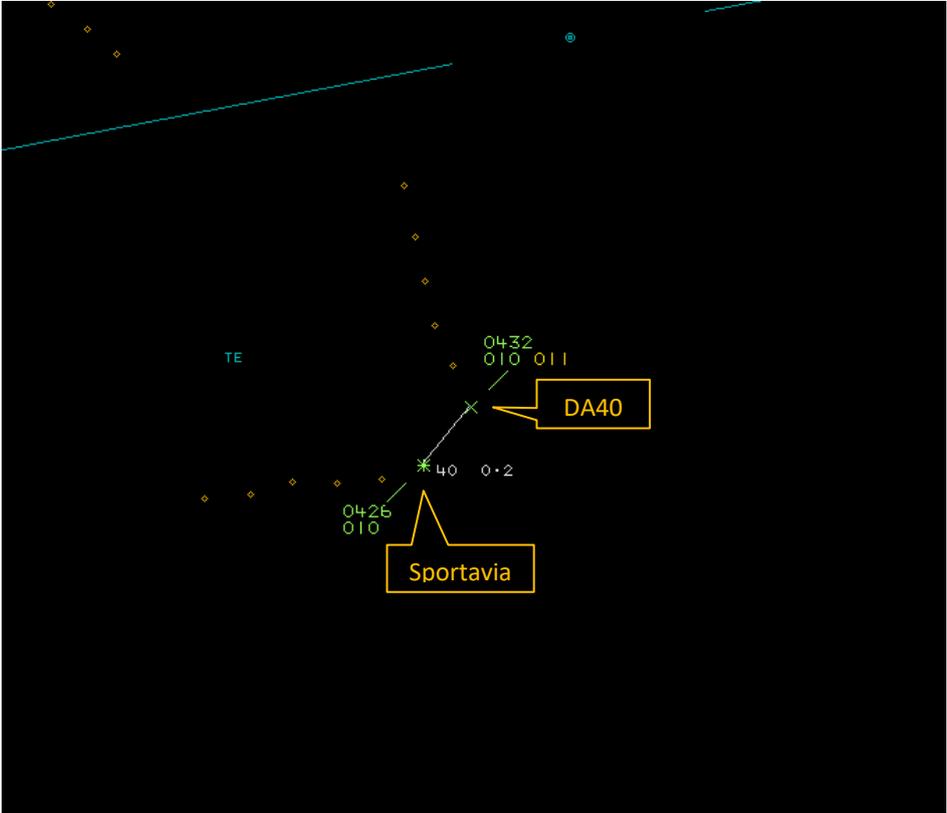
Figure 13 – 1426:59

The DA40 pilot reported that they were not and requested a position update which was given; “about a half a mile ahead of you, crossing from your right to left” (Figure 13).

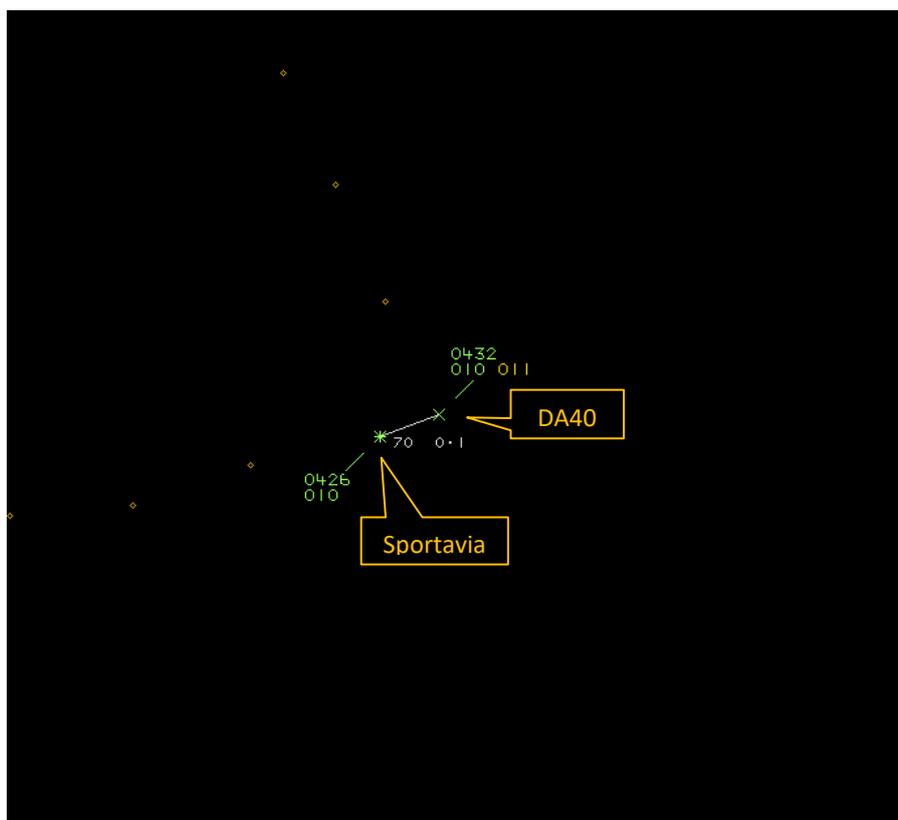
Figure 14 – 1427:04 CPA

There were then two simultaneous transmissions before a pilot was heard to say, at 1427:04; *“visual on the, three o’clock low just passing, clear to descend”* which was coincidental with CPA. After that transmission the DA40 pilot then reported visual (Figure 14).
