AIRPROX REPORT No 2020138

Date: 29 Sep 2020 Time: ~1313Z Position: 5443N 00314W Location: 5NM NE of Cockermouth

PART A: SUMMARY OF INFORMATION REPORTED TO UKAB

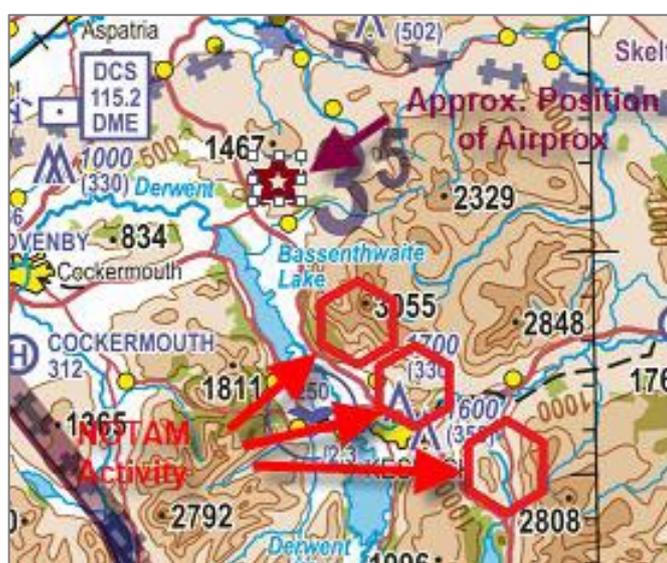
The paraglider pilot was a student, with an instructor observing, reported to be within the vicinity of Bassenthwaite. The Airprox report from the paraglider instructor provided a latitude/longitude position of the area they were flying. Four promulgated paragliding NOTAMs were active for this time; however, the paraglider was not flying within any of these areas. (see Figures 1 and 2).

L FIS was cognisant of the four separate paragliding activity areas notified by NOTAM, approximately 8NM south-east of position DCS, proceeding south-east along Bassenthwaite Lake and Derwent Water (see Figure 1 & 2). These were marked accordingly on their VFR chart with a single corresponding pin, as is the required process.

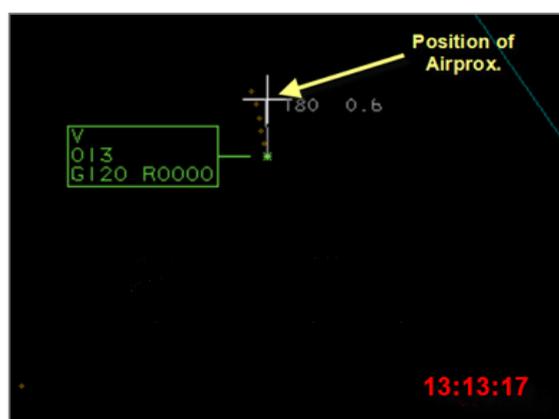
Based on the information provided within the two Airprox reports, it would appear that the Airprox incident occurred potentially concurrent with the pilot of [the AS355] contacting London Information. Figure 3 displays the position of [the AS355] at this time, with the position of the Airprox location (marked +) based on the paraglider pilot's Airprox report.

Note: The Airprox report from the pilot of [the AS355] provided a different latitude/longitude position from the pilot of the paraglider. This was within 1NM of the paraglider pilot's reported position radius. Safety Investigations has used the paraglider's position report for the basis of this investigation.

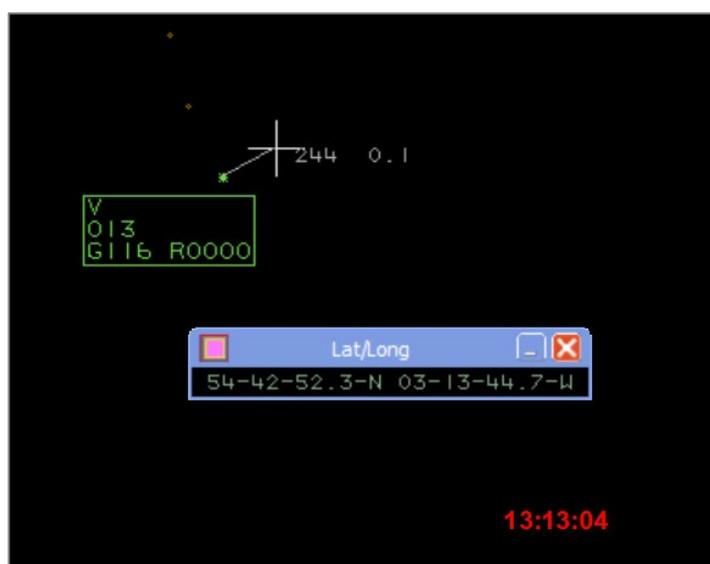
Figure 4

Using the position report from the paraglider pilot, Safety Investigations estimated the topography elevation of the reported latitude/longitude position by use of Google Maps, as 760ft AMSL. The paraglider pilot report stated that their Above Ground Level (agl) was 50ft. The report from the pilot of [the AS355] stated that their altitude was 1350ft. This calculation, based on the provided GPS information from the paraglider pilot, would suggest that the distance between [the AS355] and the paraglider was an estimated 640ft vertical, and 185m horizontal (see Figure 4).

Safety Investigations was unable to verify the distances between [the AS355] and the paraglider using the LTC Multi-Track radar as there were no primary radar returns associated with the paragliding activity.
