AIRPROX REPORT No 2020152

Date: 22 Oct 2020 Time: 1017Z Position: 5216N 00033W Location: 2NM SE of Rushden

PART A: SUMMARY OF INFORMATION REPORTED TO UKAB

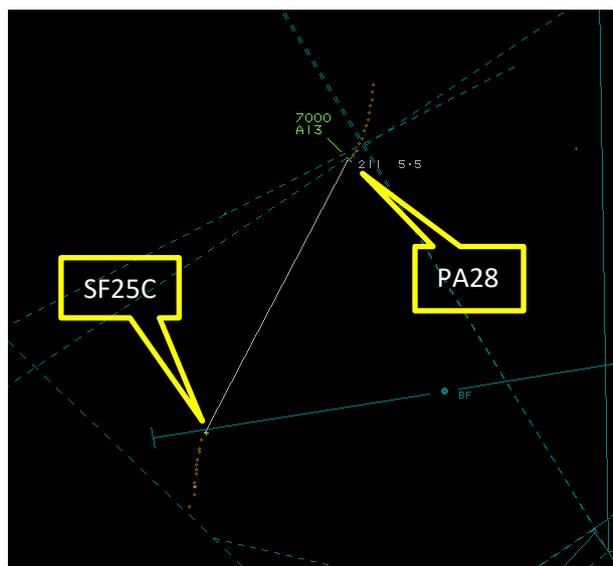
Figure 1 – 1015:00

Analysis of the NATS radar reply, coupled with the GPS log files provided by the SF25C glider pilot, was undertaken. A primary radar track could be seen heading northbound and passing approximately 4.3NM to the W of Bedford airfield, which correlated with the SF25C pilot's GPS log trace. At the same time, the PA28 – identified via its transponder returns on SSR – could be seen turning onto a south-westerly heading approximately 4.5NM NNW of Bedford airfield; the 2 aircraft were separated by 5.5NM at this point (see Figure 1).

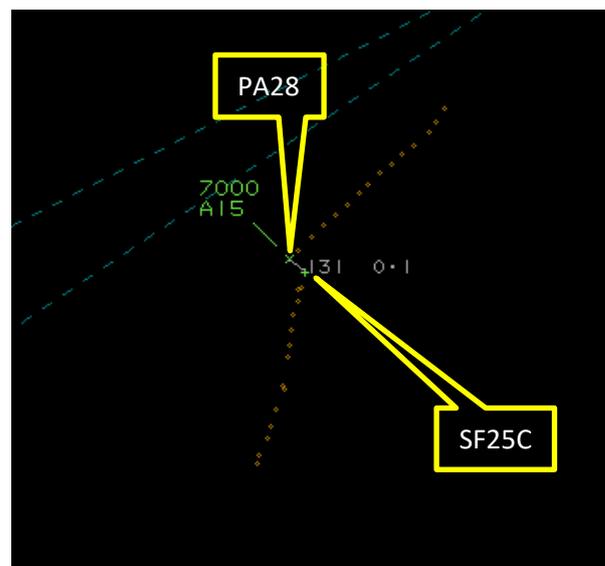
Figure 2 – 1016:48 – CPA

The 2 aircraft proceeded on near-reciprocal tracks, with minimal deviation from either aircraft, until reaching CPA at 1016:48 (see Figure 2). Whilst the primary radar return from the SF25C was still apparent at CPA, the radar track was deemed to be too inaccurate for the measurement of the CPA because the radar could be seen to 'coast' on numerous occasions whilst it attempted to maintain or predict the track of the primary return. This radar positional error, when compared to the track derived from the GPS log file for the SF25C glider, was at its greatest at or around CPA, so the GPS position of the SF25C glider was compared with the radar position of the PA28 for the measurement of CPA, which gave a vertical separation of ~100ft and a horizontal separation of <0.1NM (GPS position and altitude for the SF25C glider; radar position and SSR Mode C for the PA28).

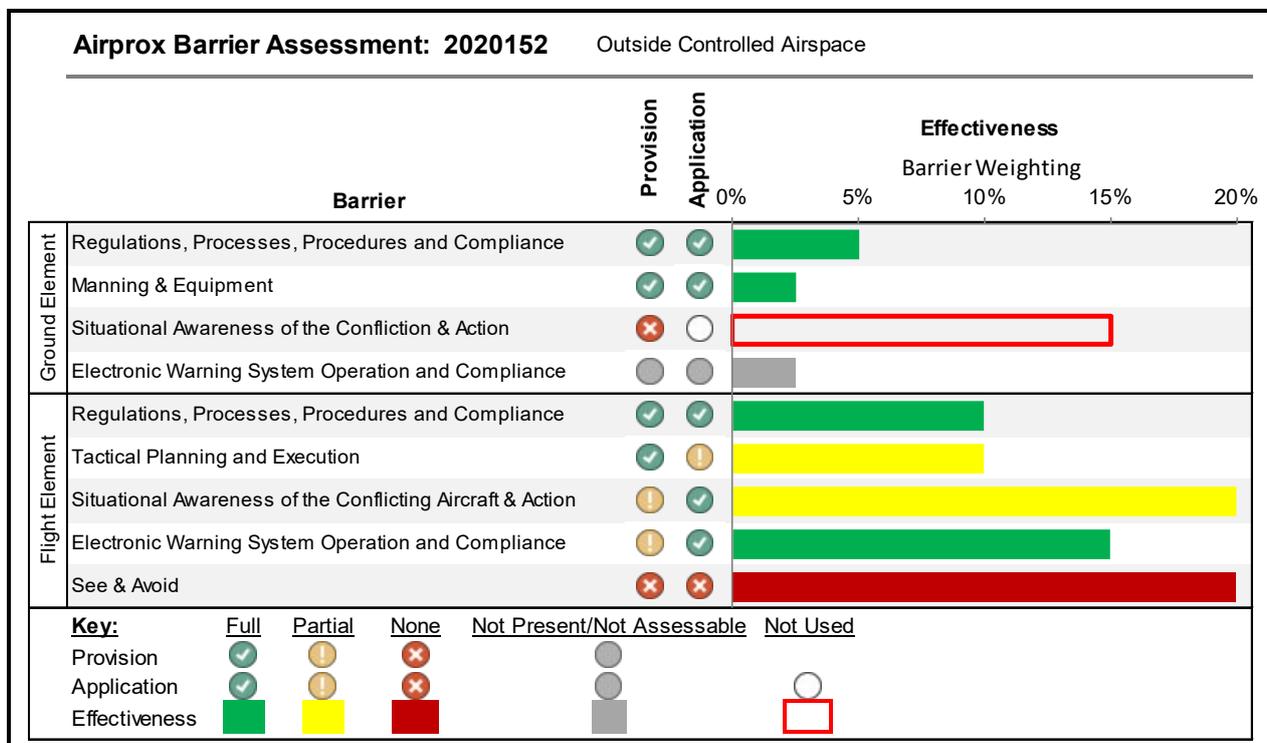
Situational Awareness of the Confliction and Action were assessed as **not used** because the Sywell AFISO was not required to monitor the PA28 under the terms of a Basic Service.

Tactical Planning and Execution was assessed as **partially effective** because the SF25C pilot chose not to seek an ATS after having spoken to Cranfield on their route northbound.

Situational Awareness of the Conflicting Aircraft and Action were assessed as **partially effective** because the PA28 pilot had no awareness of the presence of the SF25C, and the SF25C pilot had received only generic situational awareness of the presence of the PA28 from their PilotAware equipment.

See and Avoid were assessed as **ineffective** because neither pilot saw the other aircraft in time to materially increase the separation between the two aircraft.
