AIRPROX REPORT No 2020161

Date: 10 Oct 2020 Time: 1150Z Position: 5119N 00052W Location: Blackbushe circuit

PART A: SUMMARY OF INFORMATION REPORTED TO UKAB

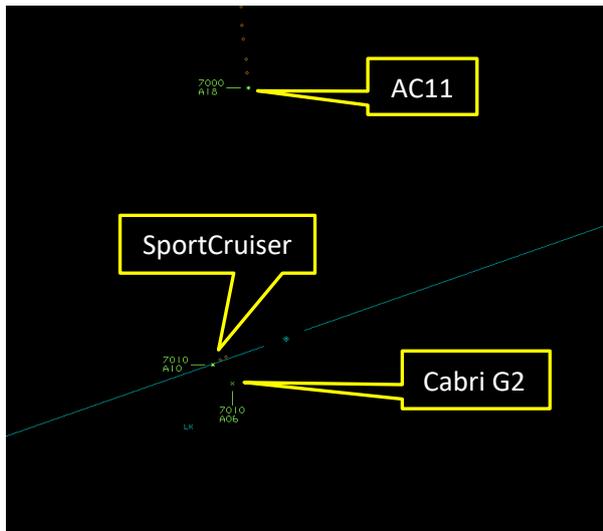
Figure 1 – 1148:45

At **1148:45** the AC11 pilot reported *“dead-side descending”*. The AFISO responded; *“roger, report downwind, squawk 7010, and one fixed-wing and two rotaries in the circuit ahead”*. The AC11 pilot readback the squawk and the instruction to report downwind but did not acknowledge the Traffic Information (Figure 1). The AFISO then dealt with an aircraft taxiing and the Cabri G2 and then the SportCruiser pilots reporting downwind. The AFISO passed Traffic Information on the Cabri G2 to the SportCruiser pilot. The R44 appeared on the radar replay at **1149:10** (Figure 2).

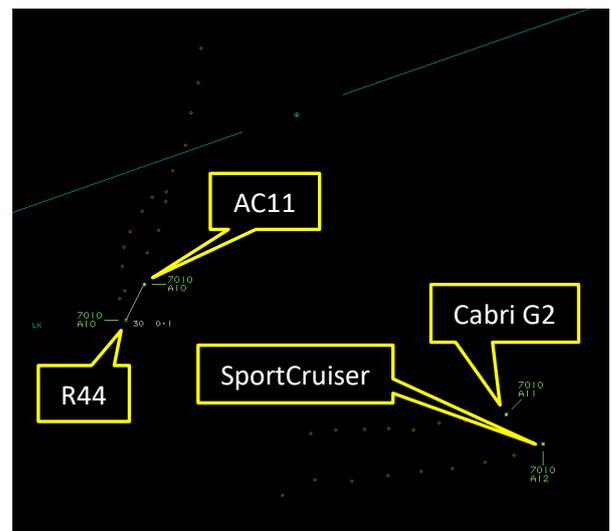
Figure 4 – 1150:15

The R44 pilot reported downwind at **1150:15**. The AFISO replied “*one fixed-wing, one rotary ahead – report final*”. The first part of the R44 pilot’s response was unintelligible but they did acknowledge the request to report on final (Figure 4).

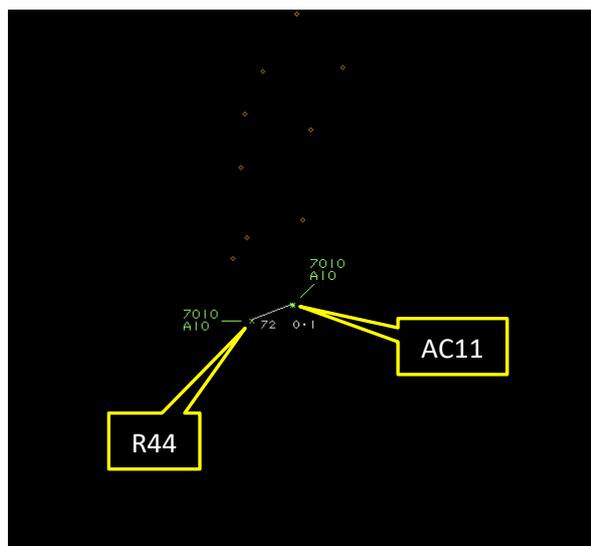
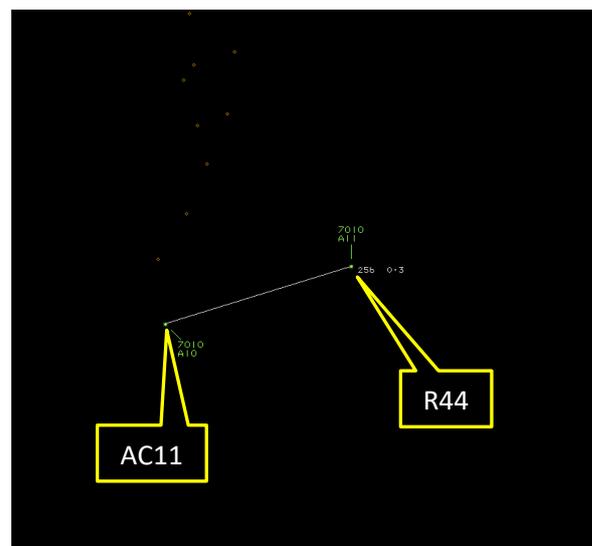
Figure 5 – 1150:19 – CPA

CPA took place at approximately **1150:20**. The radar return for the R44 disappeared between **1150:19** and **1150:36** (Figures 5 & 6). Between those times, the AC11 pilot was heard to say “....800ft turning downwind and the helicopter just came above me”. The AFISO replied; “*roger – you’ve got two rotaries and a fixed-wing in the circuit, report final*”.

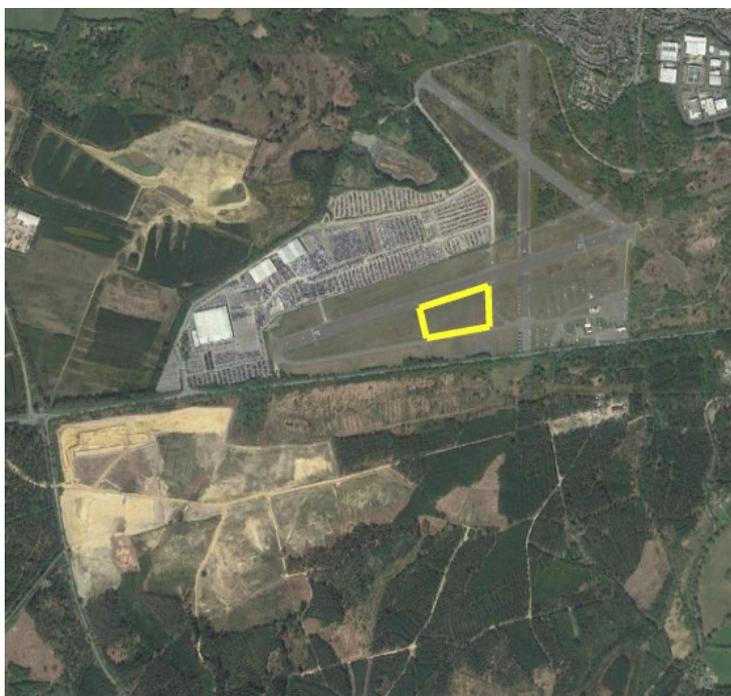
Figure 8 – Blackbushe HTA

The Board first considered the actions of the Rockwell Commander pilot and quickly agreed that, as the pilot joining the circuit, it had been for them to integrate with the traffic already established in the pattern. The Board considered that the R44 pilot, operating from the Helicopter Training Area (HTA) – see Figure 8 – had been established in the circuit and, therefore, the Rockwell Commander pilot had

not correctly integrated with that aircraft (**CF4, CF6**). Members discussed why this had been the case and agreed that the Rockwell Commander pilot had not been passed sufficient Traffic Information in response to their joining call to permit them to assimilate the presence of the R44 operating from the HTA (**CF7**). Furthermore, the Board also wondered if the Rockwell Commander pilot had actually digested this Traffic Information because there had been no acknowledgement of receipt of the information and, given the lack of passage of the positions of the circuit traffic, no request from the pilot for more precise positional information (**CF5, CF8**). Members agreed that the Rockwell Commander pilot had proceeded with their join in accordance with local procedures but had probably not assimilated that the R44 was operating in the area that they were about to fly into, leaving See and Avoid as the only viable barrier to mid-air collision. In this regard, the
