AIRPROX REPORT No 2020017

Date: 05 Feb 2020 Time: 1418Z Position: 5212N 00030W Location: 4NM NNW of Bedford

PART A: SUMMARY OF INFORMATION REPORTED TO UKAB

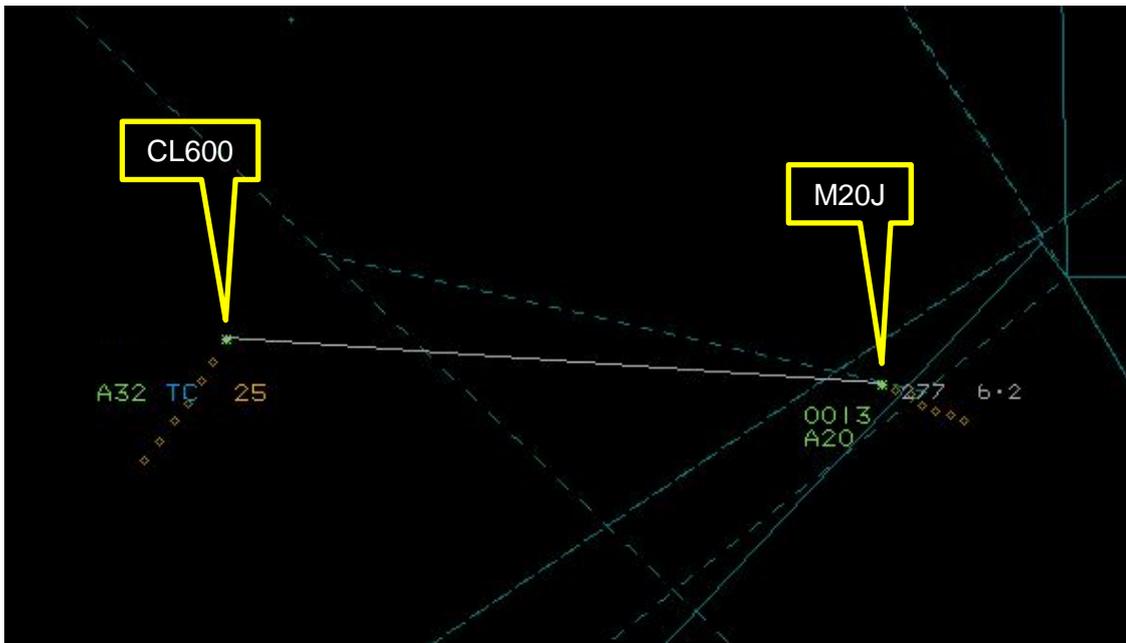
Figure 1 – 1416:30

At 1415.10 the Cranfield controller cleared the CL600 pilot for the ILS procedure, maintaining 3500ft until 'beacon outbound'. The CL600 pilot then announced "*beacon outbound*" at 1415:30 and, 30secs later, requested permission to descend to 2500ft, which was approved by the controller and the pilot was instructed to "*report reaching*". At 1416:30, the NATS radar replay showed the CL600 established on the outbound track and descending to 2500ft; the Mooney M20J is 8.3NM east of the CL600 at this point (Figure 1).

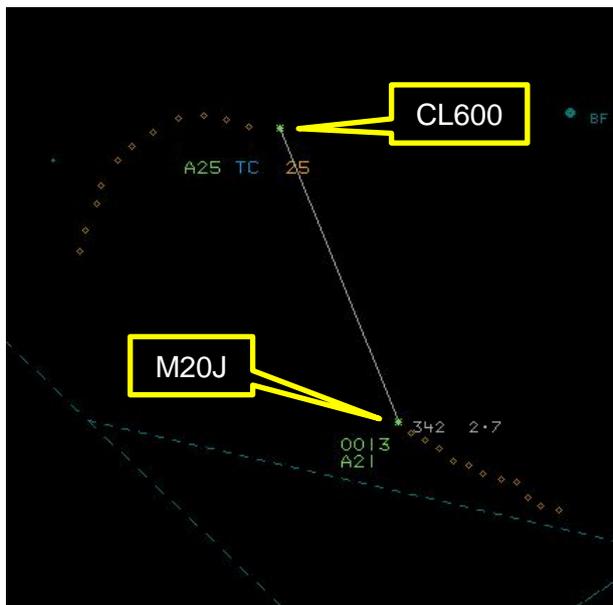
Figure 2 – 1417:54

In his report, the CL600 pilot states that he sighted an aircraft on TCAS and placed the aircraft into Heading Hold mode in order to steer around the TCAS contact (Figure 2); the 2 aircraft are separated by 400ft and 2.7NM. CPA occurred at 1418:18, with the aircraft 1.3NM and 300ft apart (Figure 3).

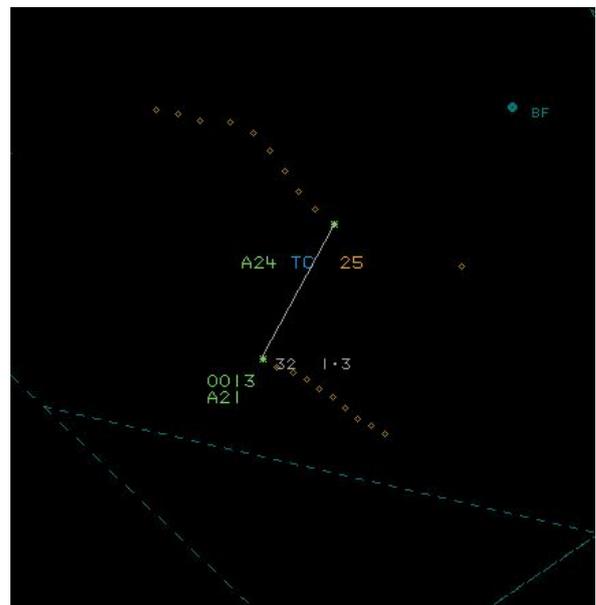
Figure 3 – 1418:18 (CPA)

In considering the risk, the Board took into account the distance between the 2 aircraft at CPA. Some members felt that a separation of 1.3NM and 300ft represented normal safety standards and parameters for flight in Class G airspace and so argued that a risk classification of E be assigned to this event. However, because risk category E represents 'normal operations' in the FIR, others felt that flying in IMC under VFR for an extended period of time without receipt of a formal surveillance-based Air Traffic Service could not be considered 'normal operations'. Therefore, after further discussion, the Board agreed that, although there had been no risk of collision, safety had been degraded and so assigned a risk category of C to this event.
