AIRPROX REPORT No 2020018

Date: 12 Feb 2020 Time: 1605Z Position: 5302N 00031W Location: RAF Cranwell circuit

PART A: SUMMARY OF INFORMATION REPORTED TO UKAB

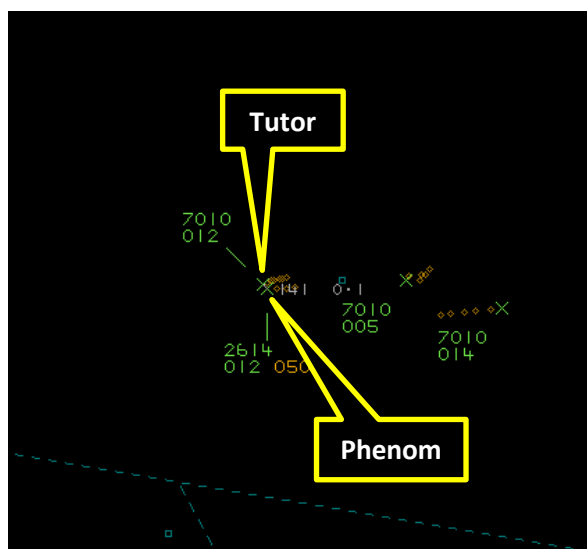
Figure 1 - CPA

For the majority of the incident, the Phenom was below radar cover. The Phenom was cleared for take-off with the Tutor established on the dead-side. At 1604:59 the Phenom QFI made a broadcast on the Tower frequency telling the Tutor pilot not to turn. This occurred below radar coverage. CPA occurred 16secs later at 1605:15 and was measured at 0.1NM with no vertical separation.

Although the CPA is measured at 0ft V and 0.1NM H, it should be noted that this particular radar sweep was while the Phenom pilot was in the process of arresting his climb and descending – one sweep of the radar (4sec) later, the separation is recorded as 400ft V and <0.1NM H.
